# **EXHIBIT 2:**

# **RATE BASE**

# Distribution System Plan

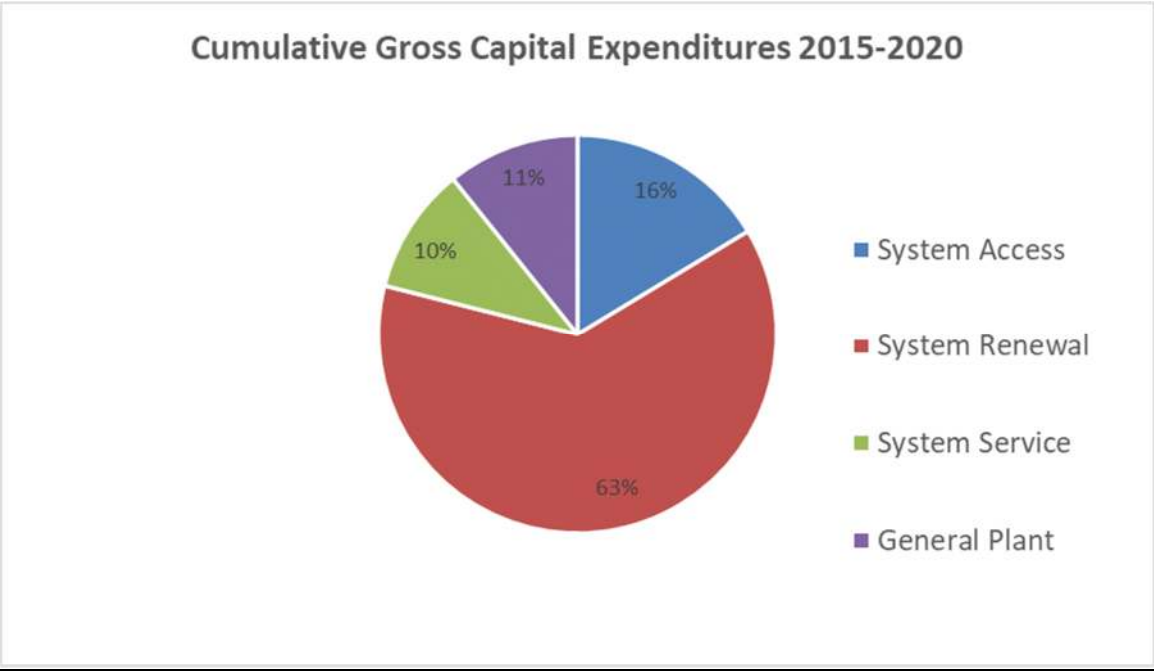
**Figure 2 - 1: Cumulative Gross Capital Expenditures 2015 – 2020**

Figure 2-1 shows the percentage of the cumulative gross capital expenditures incurred by NBHDL for the period 2015 through 2020 in each of the investment categories which represents total gross capital spending of \$39,751,456. Figure 2-2 shows the percentage of the cumulative gross capital expenditures

As shown in the above table and charts, NBHDL's main infrastructure focus is on renewal; this has been the driver of historical spending and is the driver of future spending.

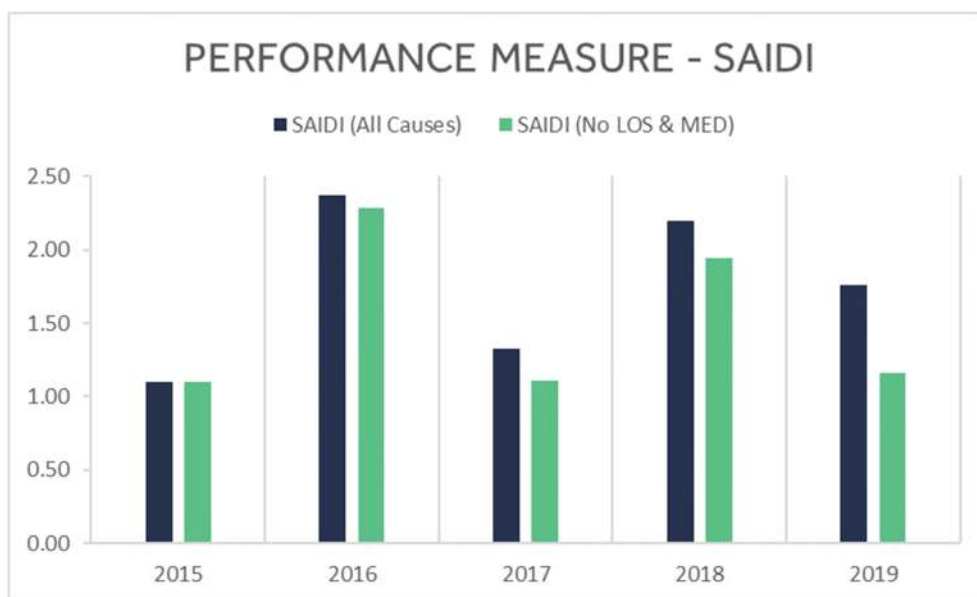
**Figure 2-1: Performance Measure - SAIDI**

NBHDL’s reliability indices for 2015-2019 are shown in the figures below. In 2019, NBHDL’s average number of hours in which power to a customer was interrupted (excluding LOS) was 1.16 and below the target range of 2.10. Additionally, NBHDL’s average number of customer interruptions (i.e. frequency) was 1.35 and well below the target range of 1.99. NBHDL’s goal is to have its system reliability trend in an improved manner over five years; however, it is important to note that in any given year, outage hours will correlate with storm occurrences and severity.

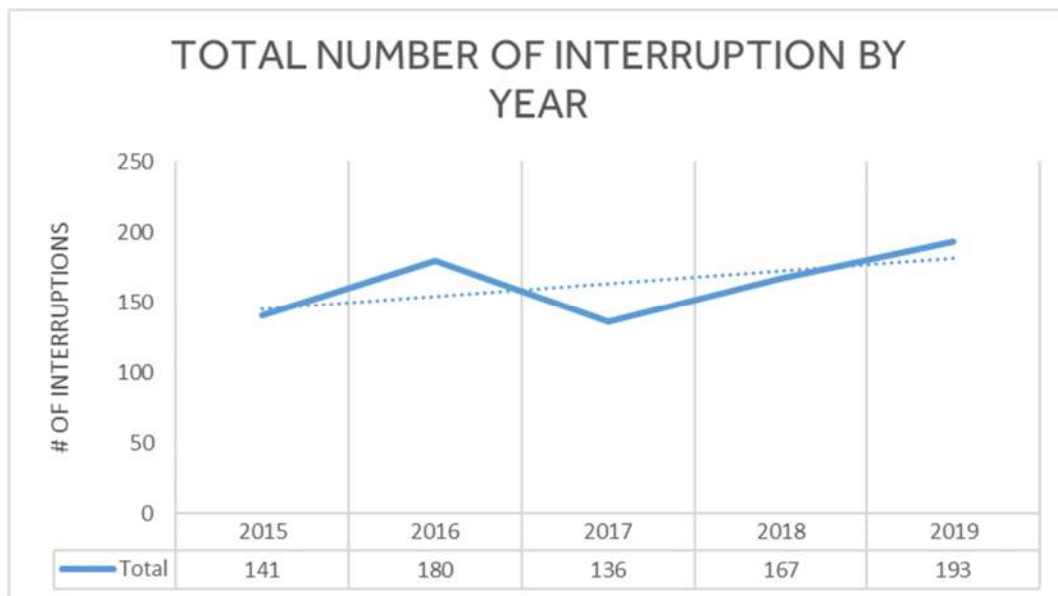
**Figure 2-3: Total number of outages by year (2015-2019) - Excluding MEDS**

The total number of interruptions over the historical period varies from a low of 136 to a high of 193 in the recent year, with the overall trend increasing in the period. This represents an average of 0.37 to 0.52 interruptions per day. The average is small enough that NBHDL's customers have not raised major concerns that would spark NBHDL to aggressively plan capital projects to address the

deteriorating asset base. However, the observed increasing trend indicates continuous renewal throughout the system in the correct places is needed to allow NBHDL to manage the number of interruptions it has control of. The contributing cause codes that account for the increasing number of uncontrollable interruptions in recent years include *Loss of Supply*, *Tree Contacts*, and *Foreign Interference*.

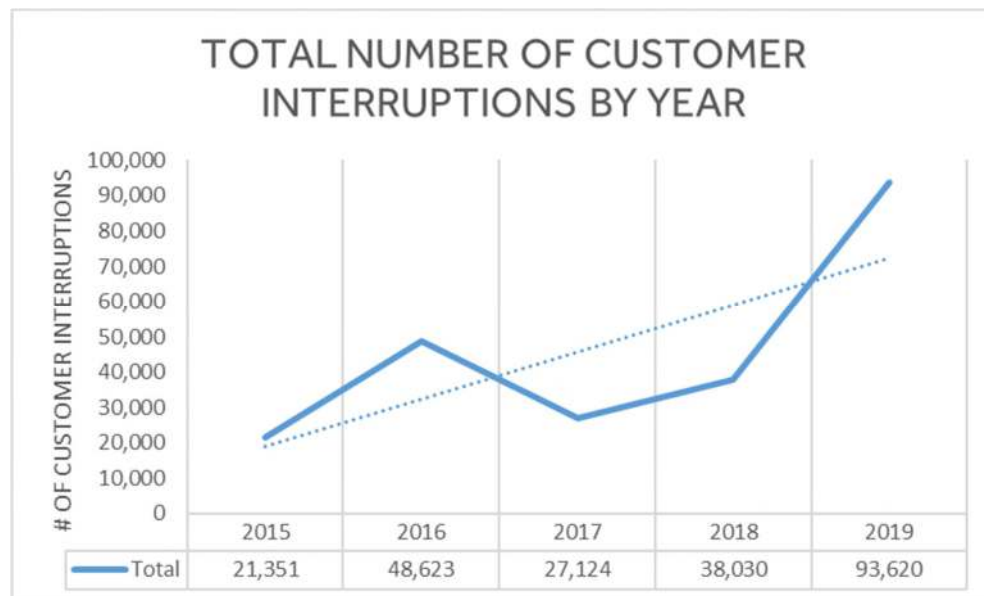
**Figure 2-4: Total number of customers interrupted by year (2015-2019) - Excluding MEDS**

An increasing trend can be seen for both the total customers interrupted and customer hours interrupted over the historical period. As seen in the tables, the top three common cause codes are *Foreign Interference*, *Defective Equipment* and *Tree Contacts*. NBHDL proposes continued investments into its AM strategy to manage the impact of outages on the total CI and CHI. NBHDL has recently increased its vegetation clearances with intentions to reduce outages from vegetation. However, while executing the vegetation management program, NBHDL follows regulations when managing unique tree species.

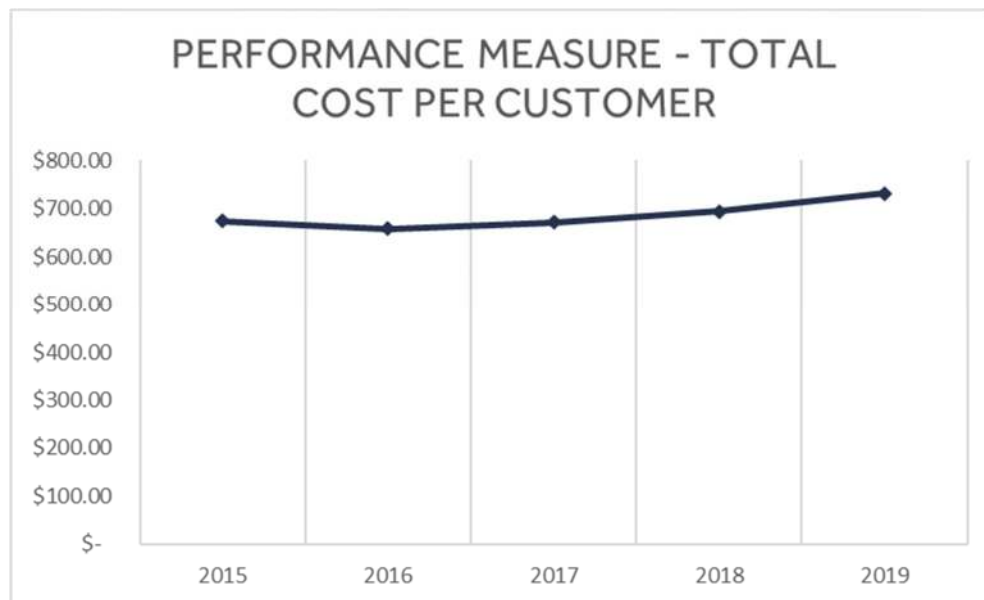
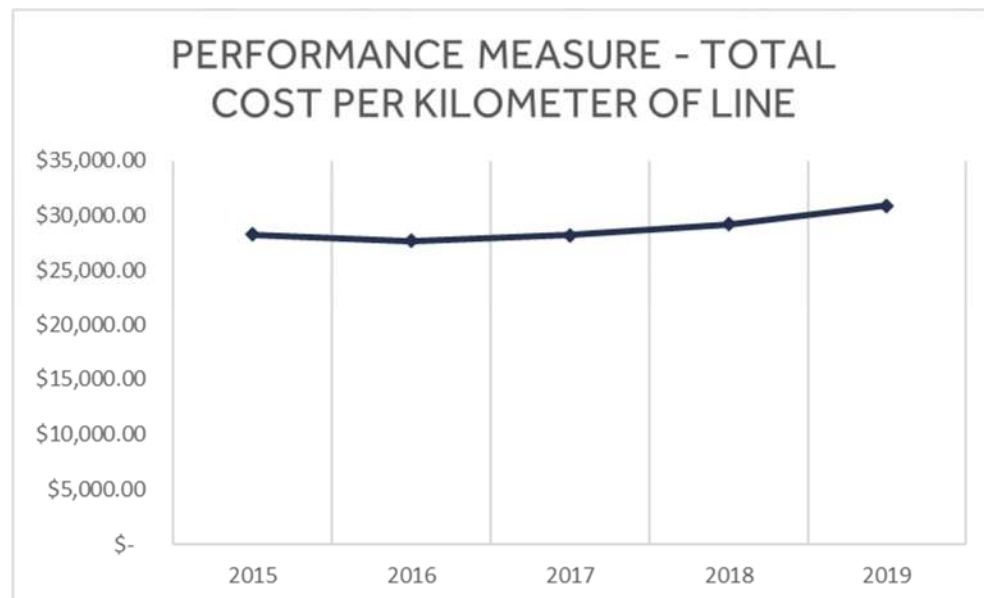
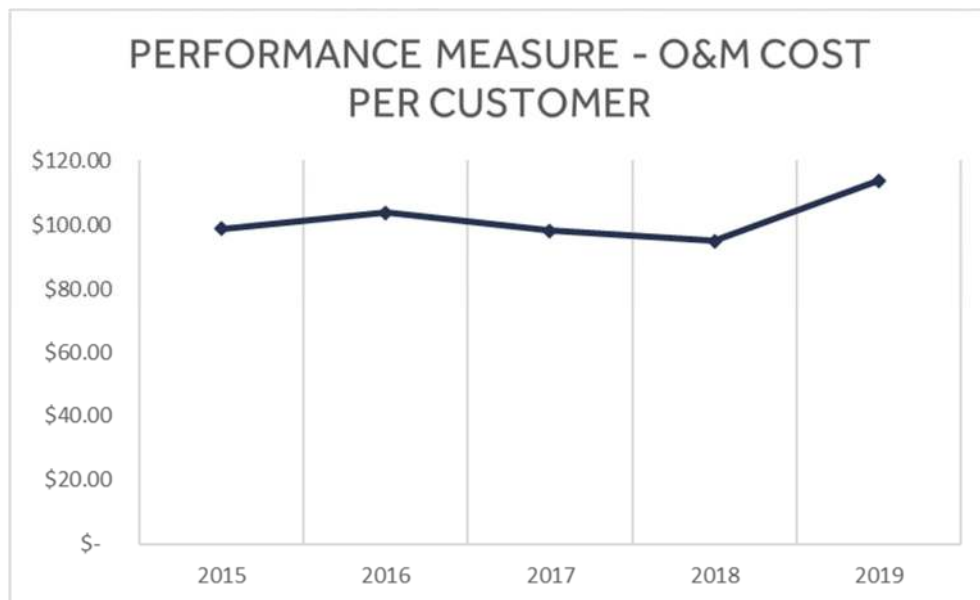
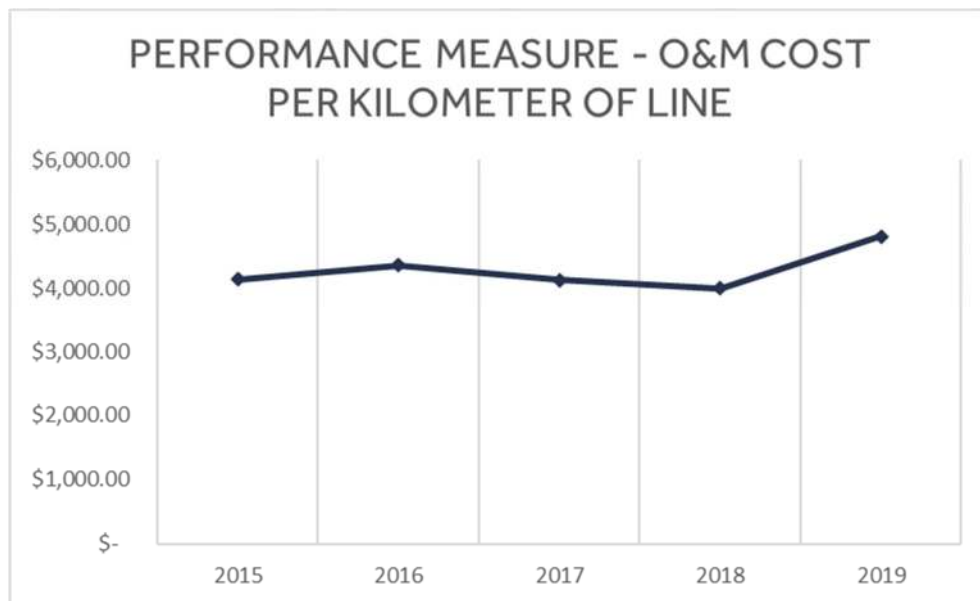
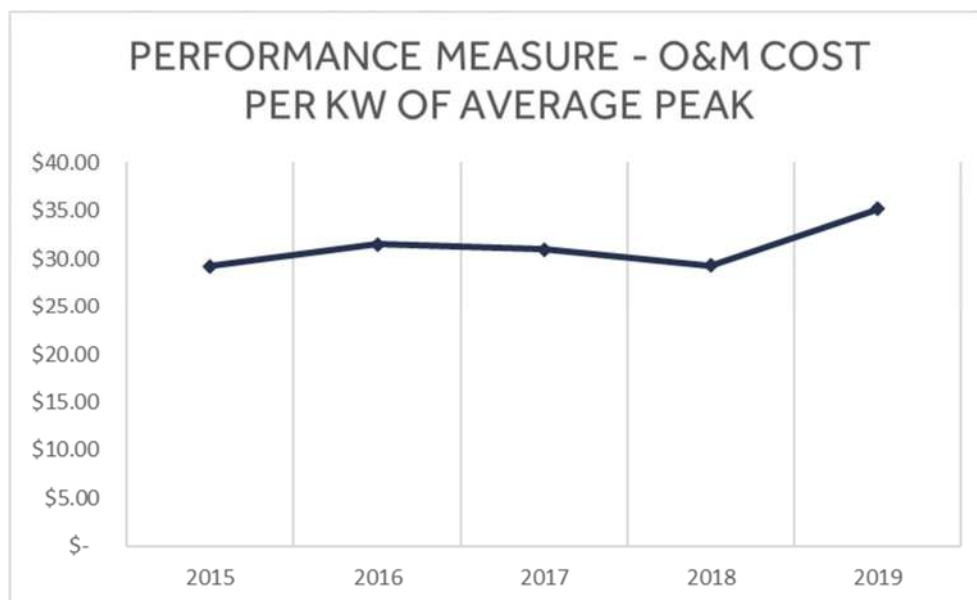
Operating costs are those associated with the maintenance, inspection, and operation of the system and those associated with metering, billing, and collections. NBHDL has experienced increases in the operating, maintenance, and administration ("OM&A") workload as a result of increased demand by customers for services and has managed the substantially increased workload without a major change to staffing levels. NBHDL is proposing to increase its vegetation management budget to manage the number of tree-related outages, invest in an upgrade to its GIS to stay current with the technology and continue to digitize its information, perform some underground cable testing for better asset management, arc-flash studies to improve overall system safety and a wood pole testing program to better manage the pole assets. These new initiatives for NBHDL are standard operating procedures in many utilities in Ontario and will allow NBHDL to manage its assets in a more efficient manner with a focused investment strategy that will benefit its customers. The O&M cost metrics are visualized below in their respective figures.

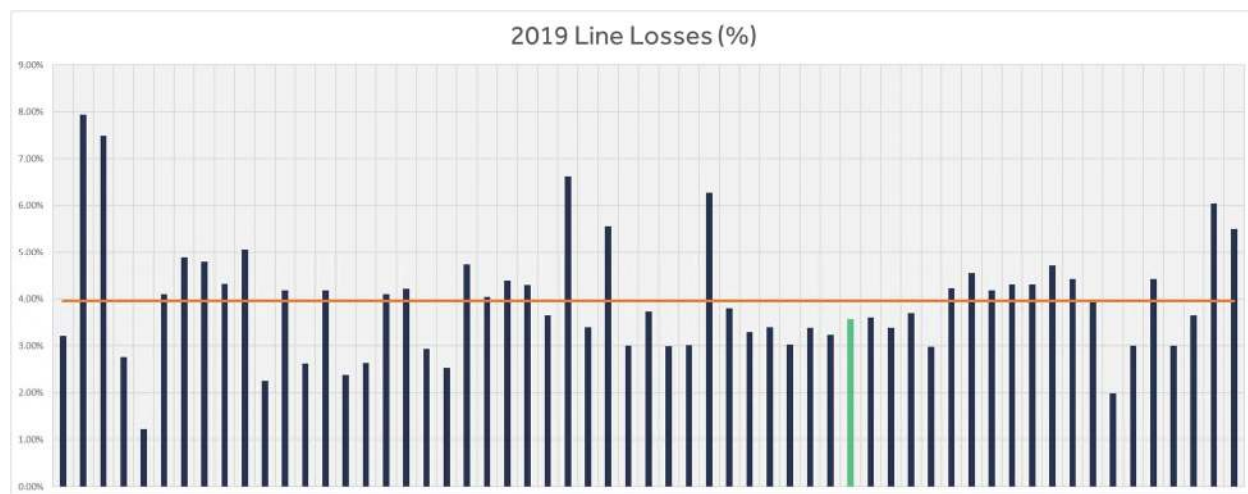
**Figure 2-11: 2019 OEB Yearbook of Ontario Electricity Distributors Average Annual Line Loss**

Losses are trending in the 3.5 – 4.0% range over the historical DSP period and are trending well within the OEB 5% threshold. According to data from the *2019 OEB Yearbook of Ontario Electricity Distributors*<sup>[1]</sup>, the average annual loss in Ontario was 3.91% in that year. NBHDL's system loss in 2019 was 3.6%, a system loss below the provincial average. The visible green bar in Figure 2-11 is NBHDL's line loss percentage in comparison to Ontario LDCs. It is evident NBHDL is performing well in this performance measure.

Historical performance is within the performance target set for line losses. Hence, there is no specific capital impact on the DSP. For the forecast period of the year, NBHDL continues to measure its line losses and manage investments to not exceed the maximum 5% system loss.

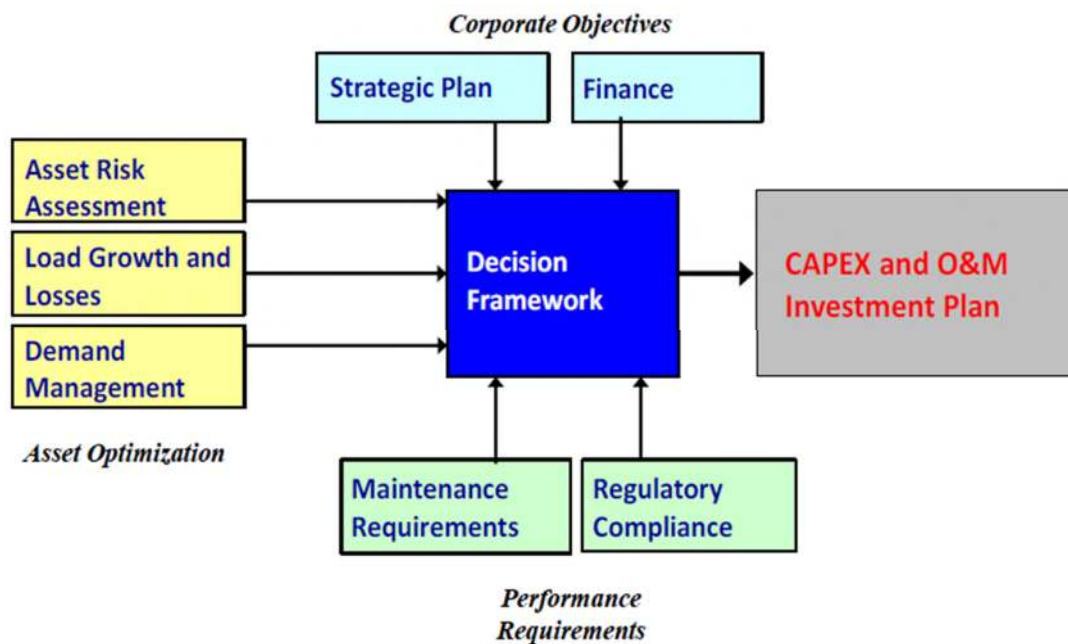
*Figure 3-1: Investment Plan Decision Framework*

In NBHDL’s previous rate application, it employed techniques leveraged from PAS-55 to ensure optimal asset planning. PAS-55, a specification for asset management, has been developed and replaced with the latest specification recognized as ISO55000. NBHDL’s AM plan is compliant with the PAS-55 AM standard and incorporates all the essential elements. The information found within PAS-55 is informative enough for NBHDL to develop and follow an appropriately sized strategy and plan. In preparing the consolidated DSP, NBHDL’s overarching objective was to develop capital and preventative maintenance investment plans, which could be effectively implemented to achieve optimal system performance by focusing on stakeholder needs. Figure 3-1 illustrates the necessary decision framework inputs that were required to develop the optimal CAPEX and O&M investment plans.

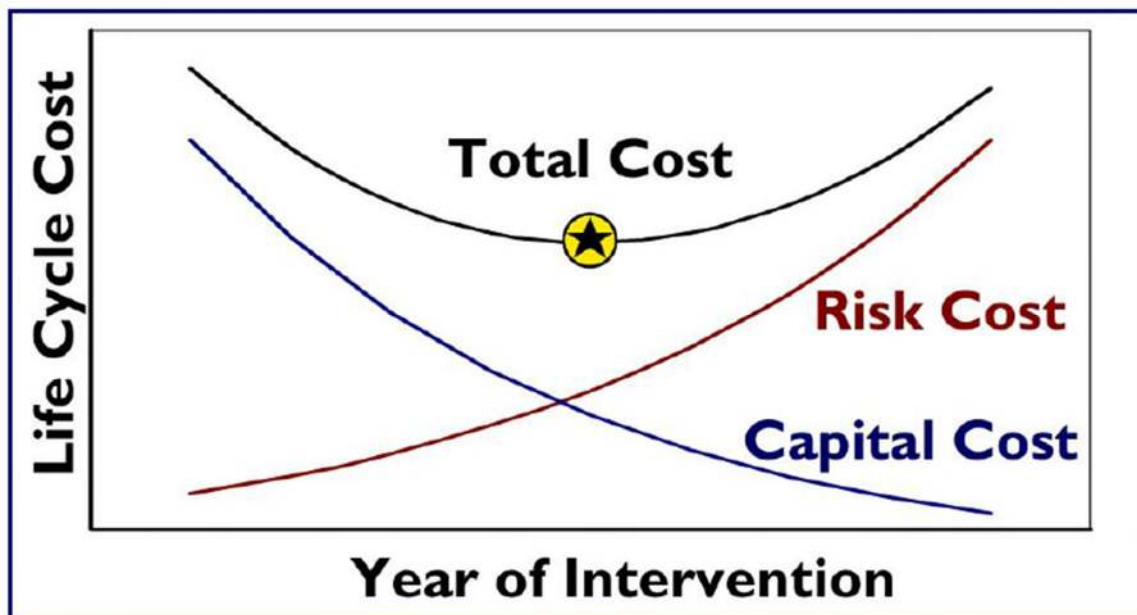
*Figure 3-2: Risk-Based Decision Support System*

Figure 3-2 shows the basic decision support model employed by NBHDL in preparing the DSP, determining the scope and timing of the investments and prioritizing the investments into specific projects. The timing and size of investments are selected to minimize the "Total Cost" of risk and risk mitigation initiatives.

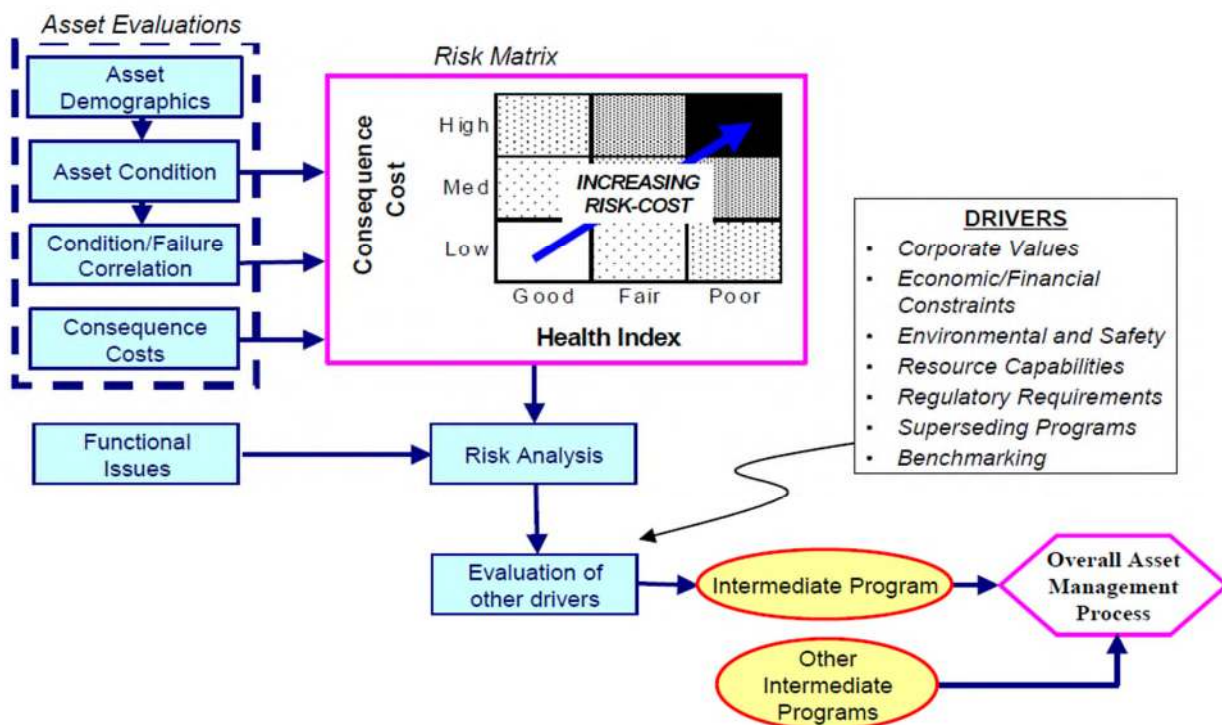
**Figure 3-3: Asset Management Decision Process Flow**

Figure 3-3 summarizes the risk matrix and decision process used to sift through a large number of assets and objectively identify the assets that present the highest risk of in-service failures so that the investments could be targeted into assets exhibiting the highest risk levels.

Numeric health indices, normalized to a scale of 100, have been used to express the health and condition of assets, further explained in section 3.2.3. This procedure allowed separation of the assets in “Very Good”, “Good” and “Fair” condition that requires minimal risk mitigation from those in “Poor” and “Very Poor” condition, requiring a higher level of investments. By following this process, the investment plan was prepared which is proposed to be implemented in this DSP for execution over the next five-year period.

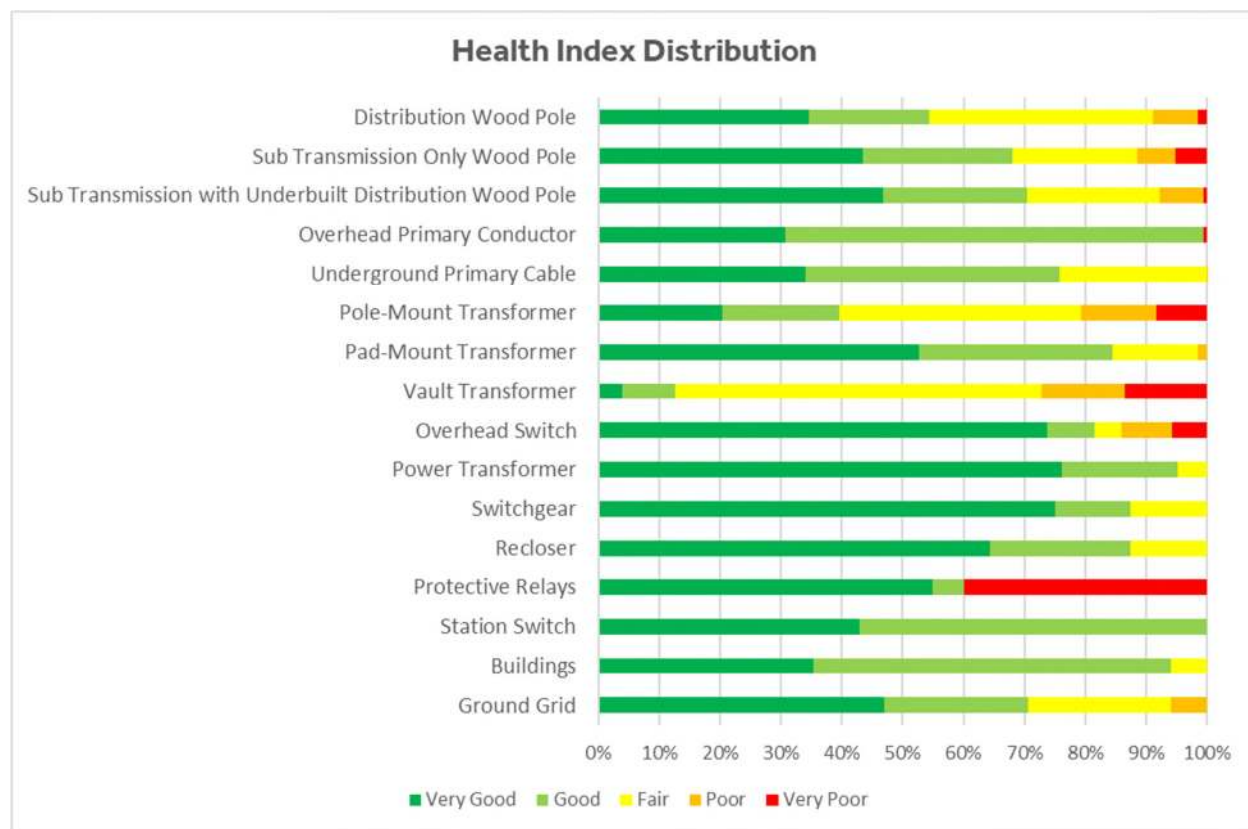
**Figure 3-5: NBHDL Health Index Distribution for Major Assets**

The Asset Condition Assessment ("ACA") study was carried out by METSCO for NBHDL to establish the health and condition of station and distribution assets in-service. The study was completed in September 2020. The study is supported by NBHDL's data collection processes through current maintenance practices, such as visual inspections, pole testing, and power equipment oil sampling. Figure 3-5 presents the summary results of the ACA.

As the figure above indicates, the majority of NBHDL's distribution system is in Good or better condition, with specific asset classes containing units found to be in Poor and Very Poor condition – most notably pole-mount transformers, vault transformers, overhead switches and station protective relays. The remaining assets exhibit a condition degradation pattern that can be expected of a mature utility and require periodic system renewal to mitigate additional failure risks of assets. Although some of the assets' condition may not report as "poor" or "very poor" in the ACA, the asset might be at an age that is typically considered the end of its useful life and would be prioritized for replacement. In order to perform proper resource planning and distribute investments evenly during the 5-year period of this DSP, NBHDL might choose to replace an asset based on its age to decrease the risk of failure. It is important for NBHDL to spread out its assets expenditures to avoid NBHDL having too many assets to replace in the same year. NBHDL does not have the capacity and resources to replace numerous assets at the same time. Leaving old assets in place would increase the risk of impacts to customers due to component failures and leave the system vulnerable to outages. Feeder information as explained in Section 2.3.1.3.2 does not drive NBHDL's capital investments in any significant way. NBHDL's experience with its worst performing feeders are primarily a result of tree contact, which is addressed through the vegetation management program within OM&A. For the 2021 test year, there are no specific capital projects related to feeder improvement.

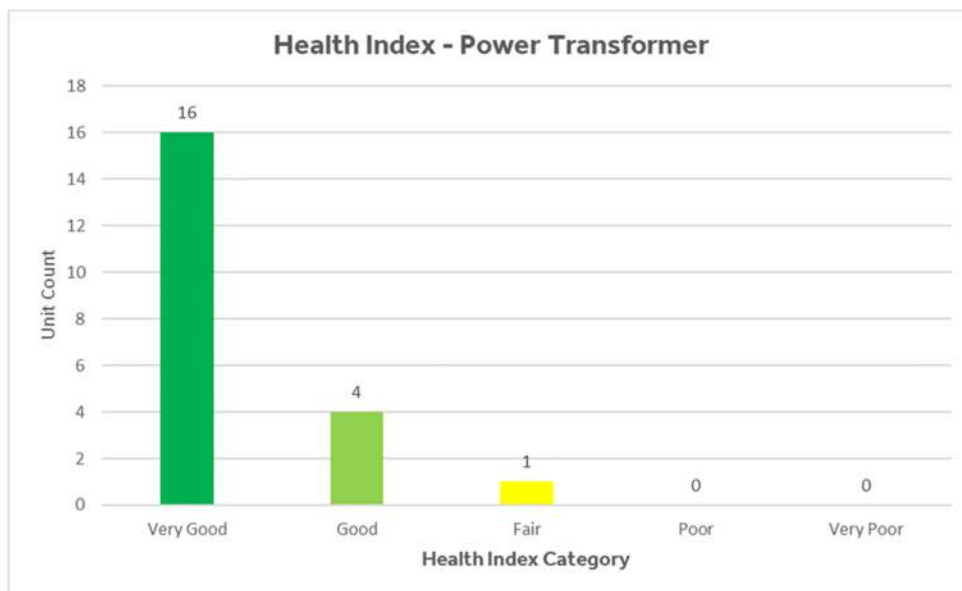
**Figure 3-6: Power Transformer Health Index Demographic**

service for more than 50 years and presents a risk of failing based on a typical useful life of 45 years. Figure 3-6 presents a detailed breakdown, with 95% of assets being in Good or better condition.

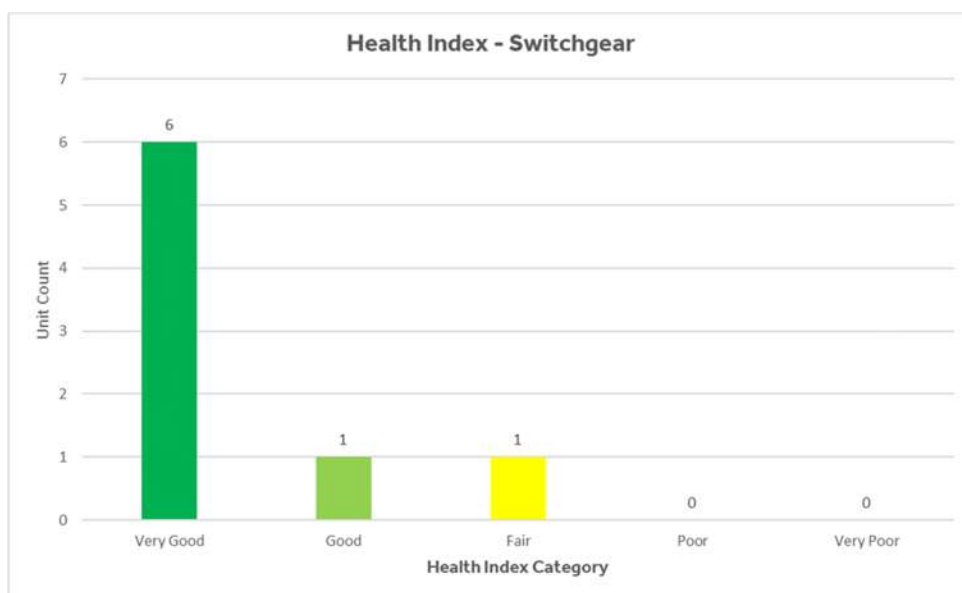
**Figure 3-7: Switchgear Health Index Demographic**

NBHDL distribution system employs a total of 8 switchgears. All the switchgears at the NBHDL system are in-service for less than 30 years. No risks associated with asset conditions are identified, with 87% of the asset class being Good or better condition, shown in Figure 3-7.

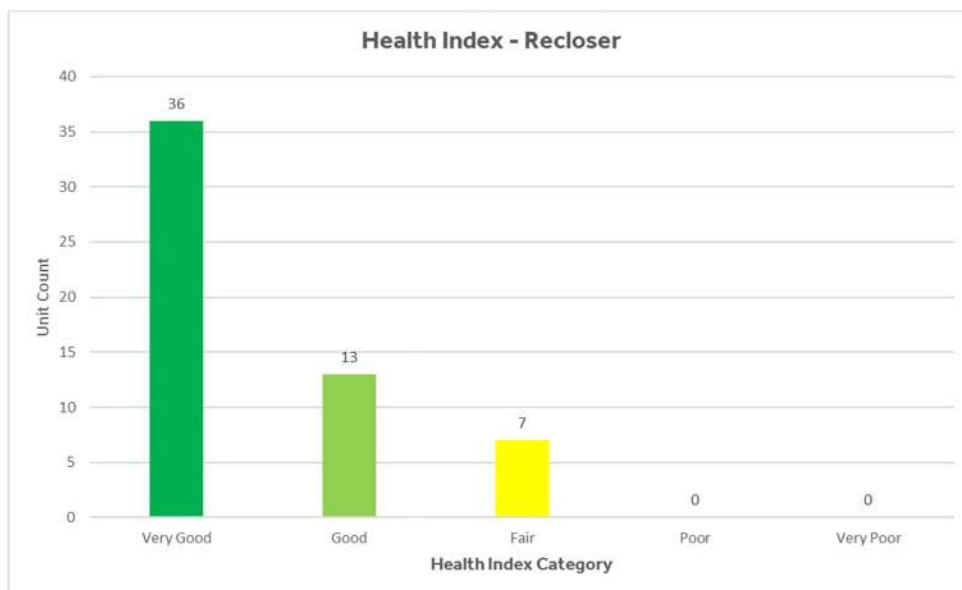
**Figure 3-8: Recloser Health Index Demographic**

Reclosers are installed on the distribution system to interrupt the circuit during a fault and are designed to automatically reclose to restore the normal operating conditions. NBHDL owns 31 oil type and 25 vacuum type reclosers within its service territory. All the reclosers are in-service for less than 30 years in service. No risks associated with asset conditions are identified, with 87% of the asset class being Good or better condition, shown in Figure 3-8.

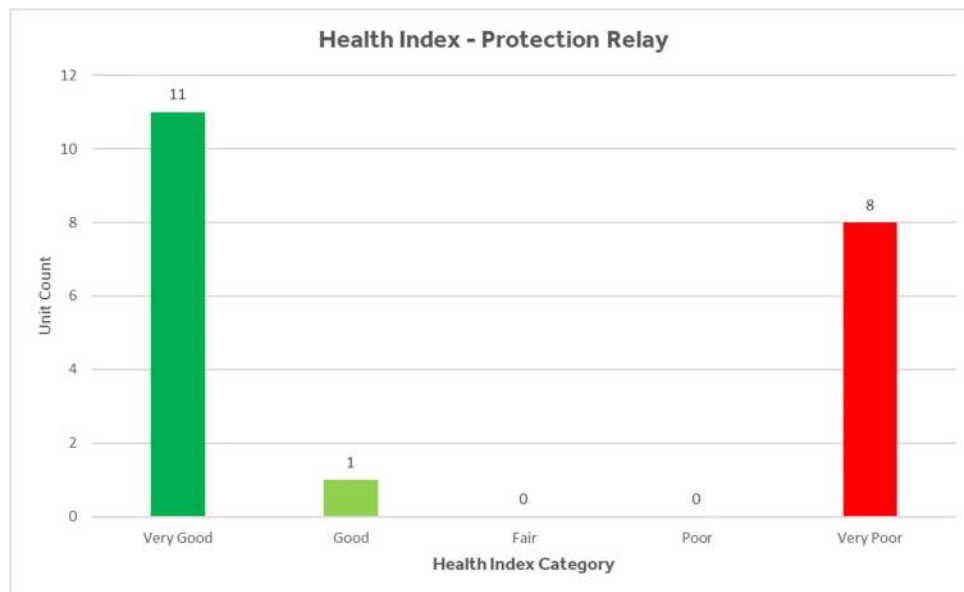
**Figure 3-9: Protection Relay Health Index Demographic**

NBHDL employs a total of 20 protection relays in its stations. All protection relays are in-service for less than 30 years. 40% of the relays are in Very Poor condition shown in Figure 3-9. The main factors driving these relays into Very Poor condition are discretionary and non-discretionary obsolescence considerations. NBHDL has identified several of the oldest relays to be obsolete and has planned investments to address the Very Poor assets.

The function of protection relays on distribution systems is to detect and annunciate abnormal operating conditions and initiate circuit breaker or recloser trip to isolate faulty circuits from healthy circuits. Protection relays obtain their input from instrument transformers, process the information, and automatically take corrective action with adequate speed and selectivity.

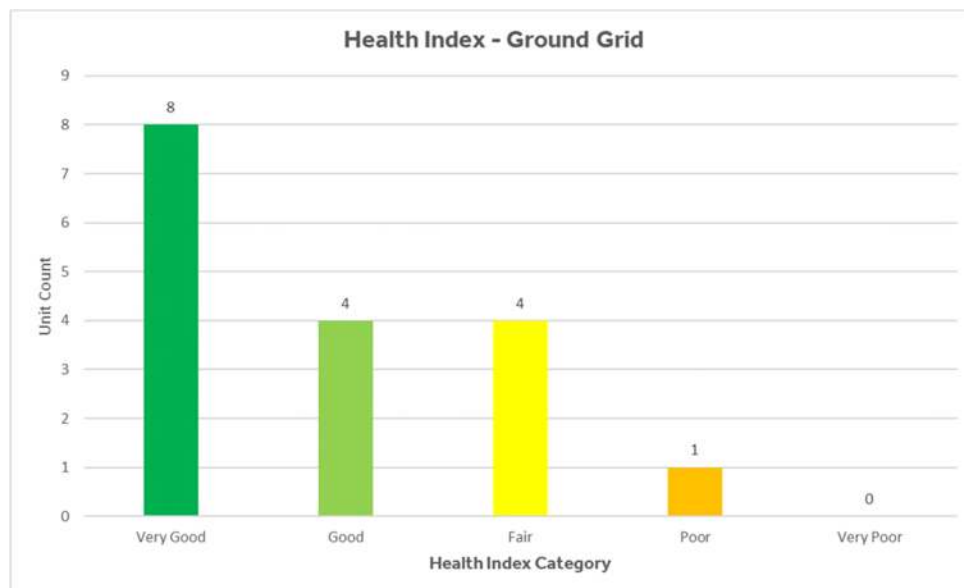
**Figure 3-10: Station Ground Grid Health Index Demographic**

The purpose of a substation ground grid is to provide a low resistance ground electrode for system neutral, for equipment case grounding and to maintain safe potential gradients within the station yards during abnormal operating conditions, i.e. line-to-ground faults. NBHDL owns 17 stations within its service territory, each equipped with a ground grid. More than half of the grids are younger than 40 years old. The recent assessment determined the majority of ground grids are in acceptable condition with few experiencing subpar conditions shown in Figure 3-10. Ground grids that are planned to be maintained over the DSP period to manage safety risks.

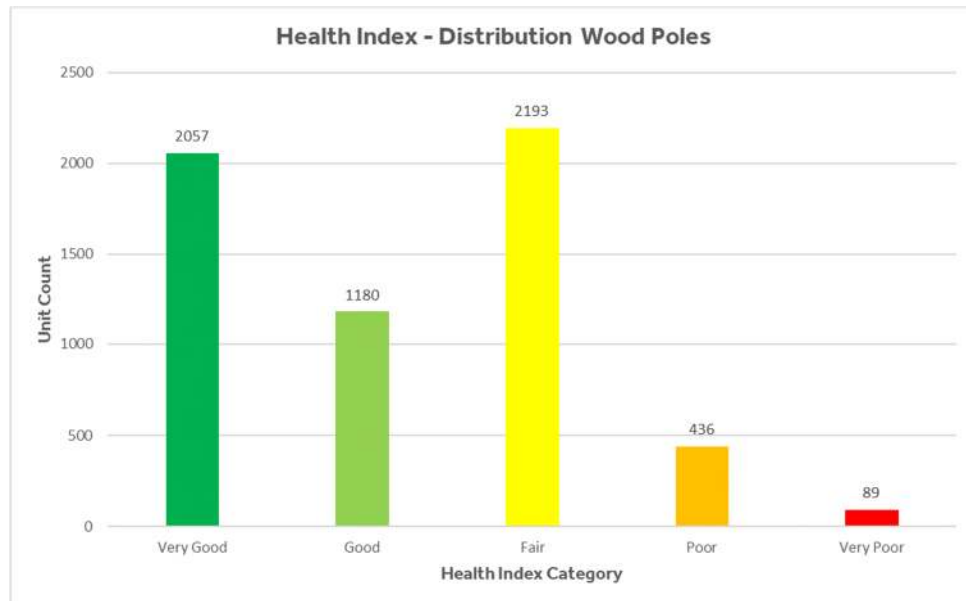
NBHDL owns approximately 10,384 distribution wood poles within its service territory. The recent assessment considered only poles with condition data to approximate a health value with a higher degree of confidence. The output of the assessment indicates that NBHDL's pole population experiences normal degradation which requires regular maintenance and renewal investments to maintain the existing health.

**Figure 3-11: Distribution Wood Pole Health Index Demographic**

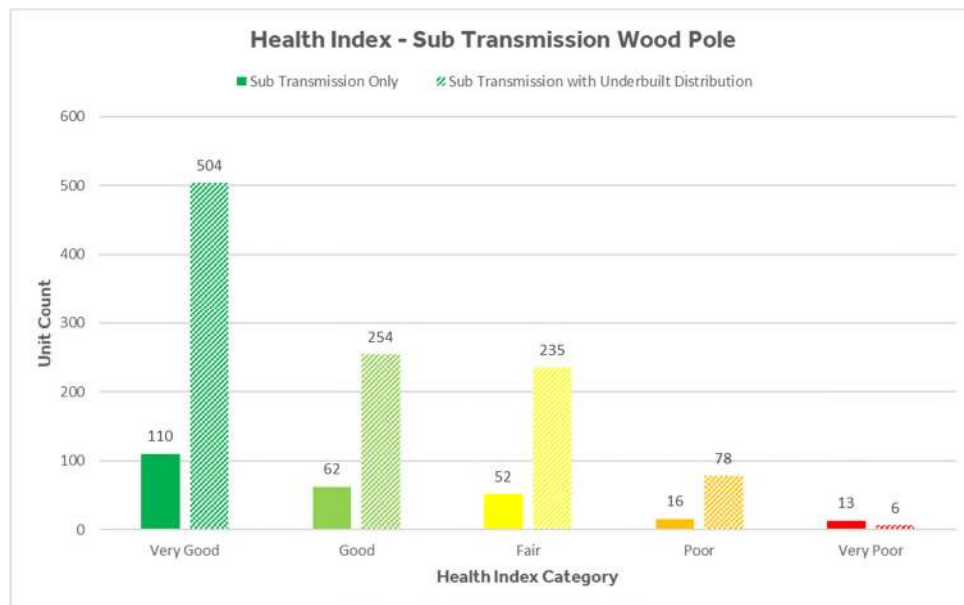
NBHDL owns 253 poles with sub-transmission lines only and 1,077 poles with sub-transmission and underbuilt distribution lines. The sub-transmission poles experience a similar degradation rate as distribution poles, in which NBHDL is required to regularly maintain and invest in asset renewal to manage the risk and health of the population.

**Figure 3-12: Sub-Transmission Pole Health Index Demographic**

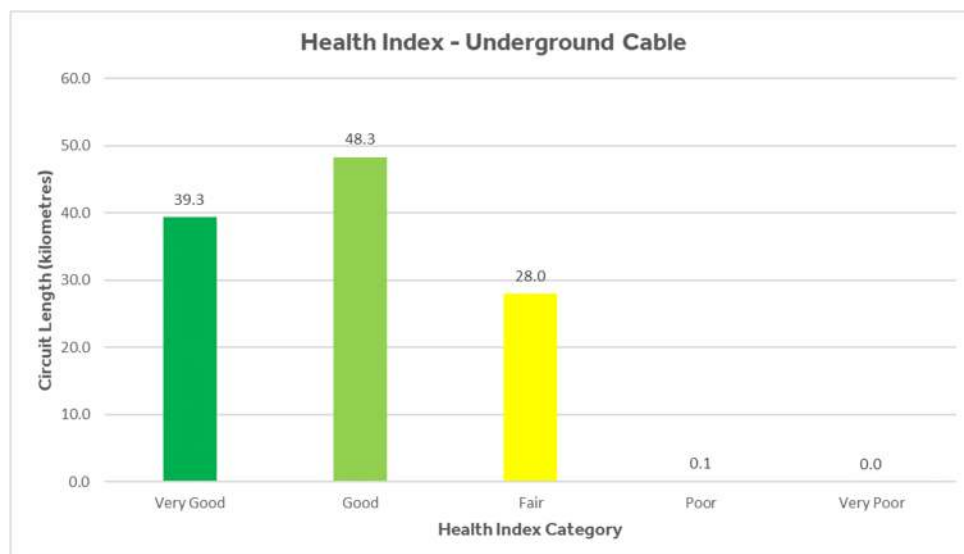
For the completed assessment, the underground cable length is measured in kilometres of the circuit, where a 1-km run of three-phase cable is measured as 1 km rather than 3 km. NBHDL owns 116 km of primary underground cables across its distribution system. The oldest cable installations date back to approximately 50 years ago. Figure 3-13 presents the Health Index condition for underground primary cables. NBHDL notes it will explore the possibility of testing their underground cable segments in areas exhibiting an increase in failures to proactively manage the failure risk and to prioritize the investments in ongoing cable renewal.

**Figure 3-13: Underground Primary Cable Health Index Demographic**

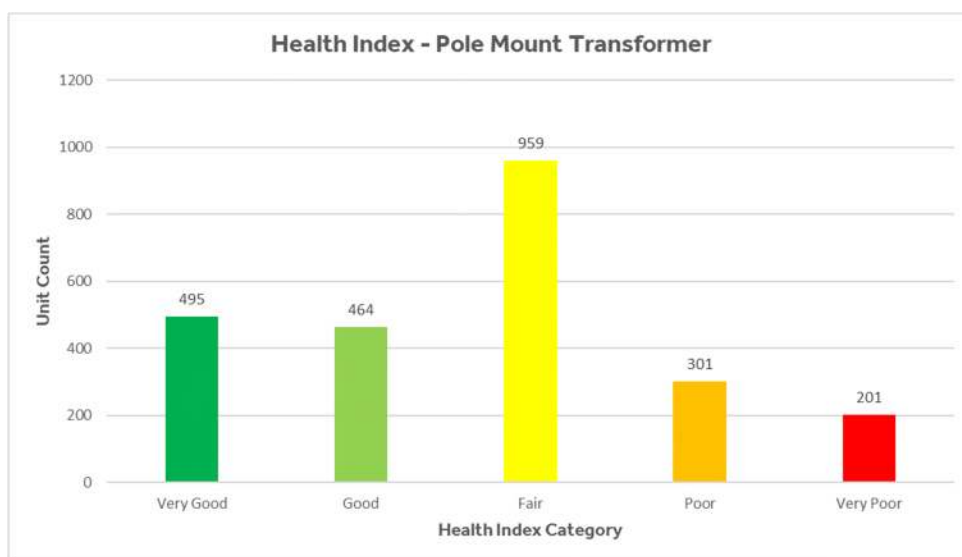
**Figure 3-14: Pole Mount Transformer Health Index Demographic**

NBHDL owns 2,419 pole mount transformers, 676 pad mount transformers, and 22 vault transformers within its service territory. Figure 3-14 presents the Health Index condition for pole mount transformers. Figure 3-15 presents the Health Index condition for underground transformers. NBHDL's distribution transformers experience a normal degradation pattern and require continuous monitoring and renewal investments to manage the population's health and failure risk.

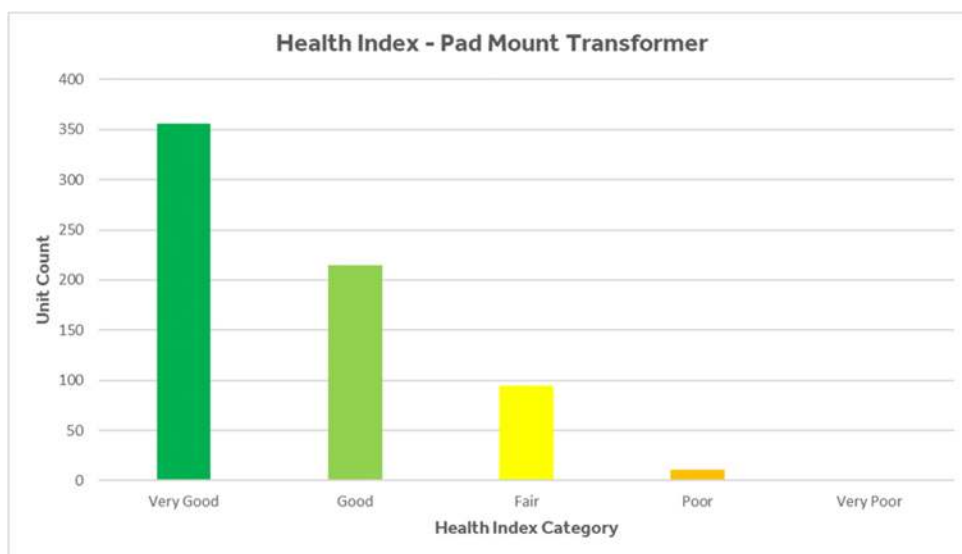
**Figure 3-15: Underground Transformer Health Index Demographic**

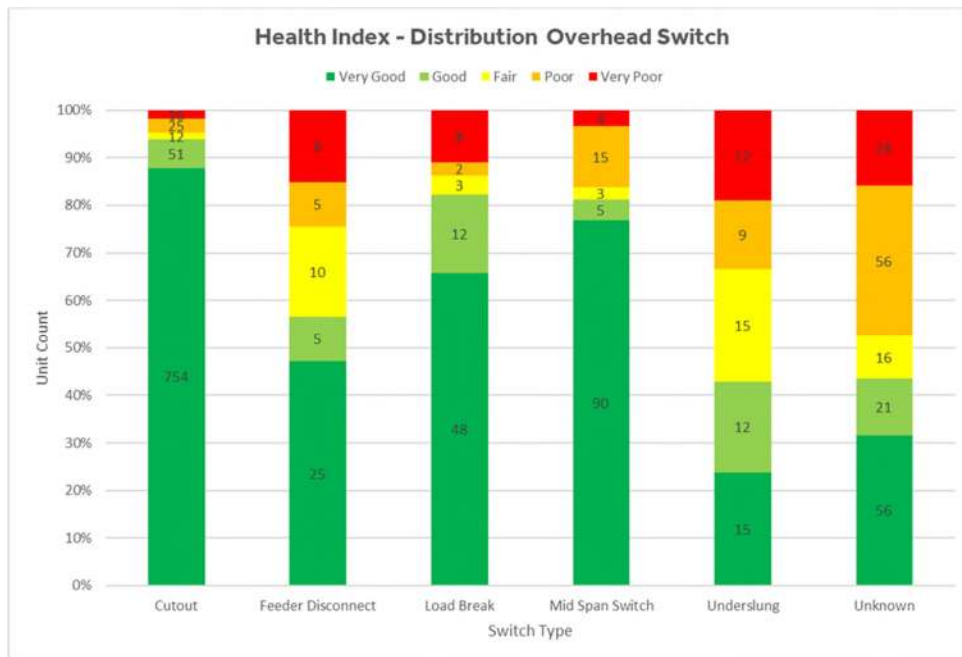
NBHDL's distribution overhead switch types include fused cutout and load break and are located on its service poles. NBHDL owns 1,141 overhead switches within its service territory. The overall Health Index distribution for the overhead switches is presented in Figure 3-16. Across all switch types, approximately 86% of the switches are in Fair or better conditions. NBHDL utilizes its asset lifecycle and maintenance practices to proactively manage the condition and associated risks of units that are below Fair condition.

**Figure 3-16: Distribution Switch Health Index Demographic**

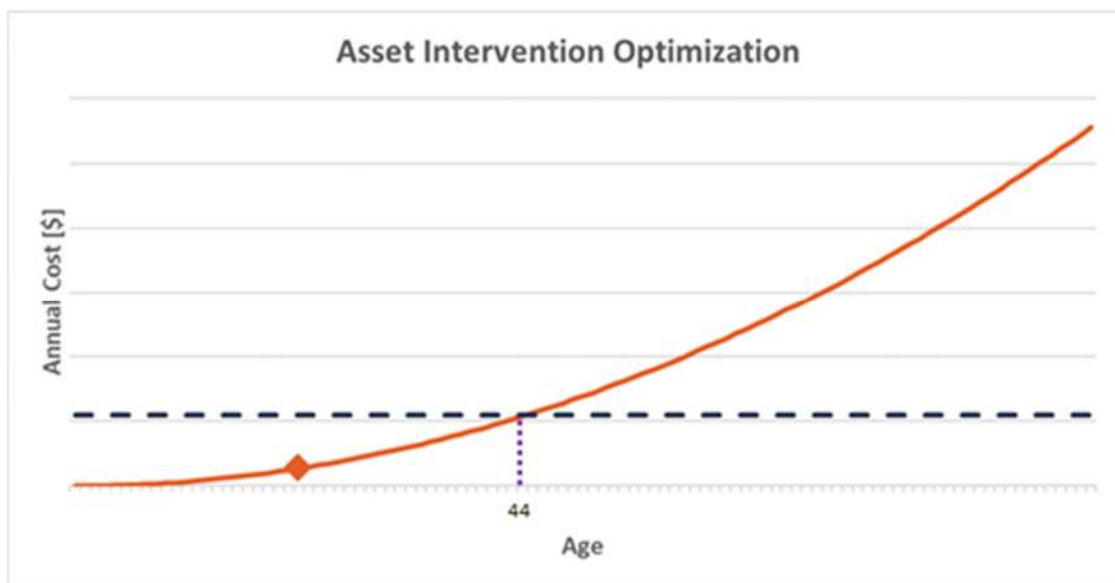
Figure 3-17 shows graphically how the optimization is performed, using an example of a station transformer. The horizontal, blue-dashed line is the levelled lifecycle cost of a new asset which is the overall cost of the asset divided by the number of years. The overall cost is usually the sum of capital, maintenance, risk and operating costs over the planned/designed lifespan of the asset. These vary by asset. The orange curve is the risk plus maintenance cost of the existing asset as it ages. This is known as the marginal cost. Risk is defined as the probability of failure, which increases as the asset ages, multiplied by the consequence cost of failure. As long as the marginal cost of the existing asset is lower than the levelled cost of the new one, it is cheaper to leave the existing asset in operation. When the curves intersect, the marginal cost of the existing asset is higher than the cost of a new one and the asset is at the end of its economic life. In the example below, the transformer is estimated for replacement approximately at age 44. Using this methodology, NBHDL determines how spending is optimized, prioritized and scheduled to align with budget envelopes in accordance with NBHDL's processes. The graph is not meant as a reference to actual data, but to illustrate the theory.

**Figure 3-17: Asset intervention optimization strategy (example shown for power transformer)**

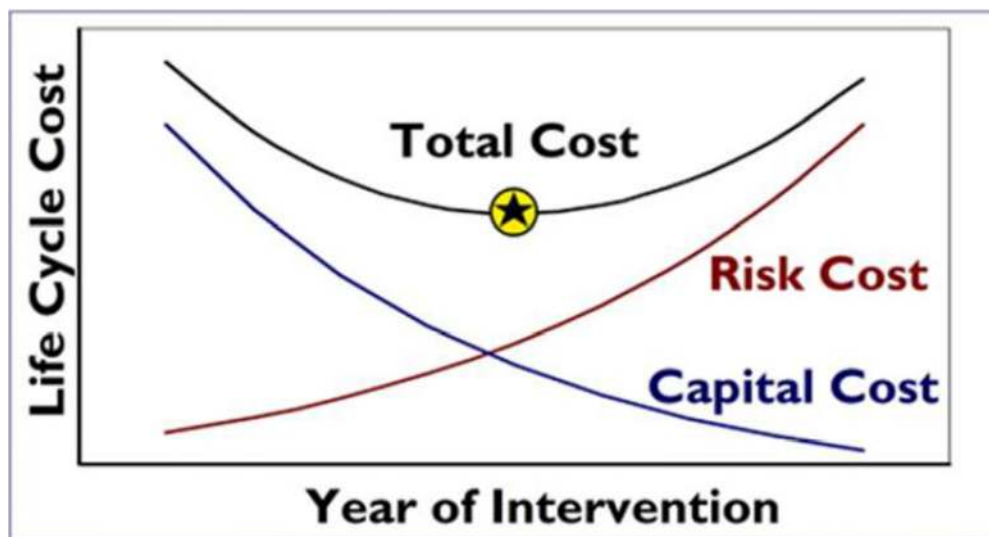
It is the systematic approach of inspections, condition and age assessment, data analysis and maintenance that allow NBHDL to identify and mitigate the risk of its assets and distribution system. NBHDL's risk-based strategy assumes that the optimal time to replace an asset is at the minimum total cost when considering both the asset capital cost and the risk of failure of the asset. For each asset, a risk cost is calculated and compared with the minimum total cost, and the asset is recommended for replacement when the costs are equivalent as is demonstrated in the following Figure 3-18.

*Figure 3-18: Risk-Based Decision Support System*

The risk costs are based on the consequence costs of failure and the probability of that failure. The consequence costs are built up from a combination of the asset replacement costs plus additional costs likely to be incurred due to emergency asset replacement requirements, potential collateral damage due to catastrophic failure and customer impact costs associated with an unplanned outage.

The current condition as per the asset condition assessment study modifies the demographic age of the asset to arrive at an “effective age”. The probability of failure is determined by plotting the “effective age” against the typical asset ageing characteristics for that asset. With the described assessment methodology prepared, NBHDL can prioritize its projects.

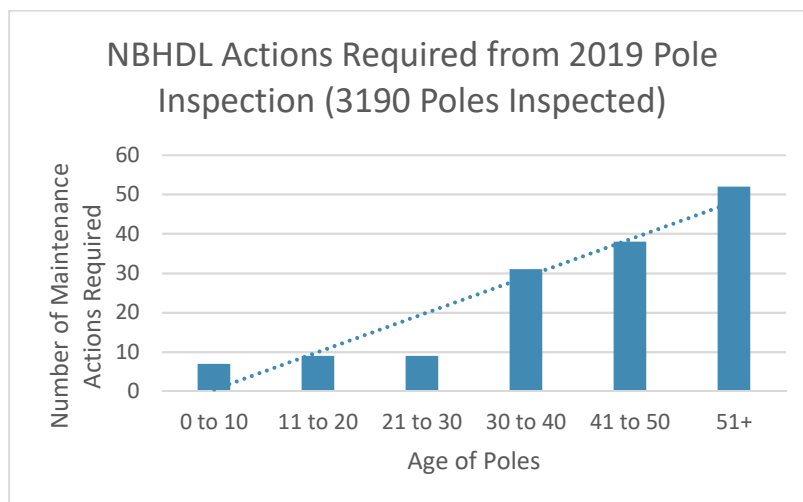
Through NBHDL’s pole inspections, performed under its maintenance program, issues are identified and assets with actions required are flagged for maintenance. NBHDL has observed that there is a correlation between the age of the asset and likelihood it would have an issue and a maintenance action will be required. In 2019, NBHDL inspected 3190 poles and 146 maintenance actions were generated, distributed over the pole age demographics shown in the figure below.

**Figure 4-2 : NBHDL Actions Required from 2019 Pole Inspections**

The information shows that the number of issues discovered trends upwards as the pole line assets age.
