# **EXHIBIT 2:**

# **RATE BASE**

# Distribution System Plan

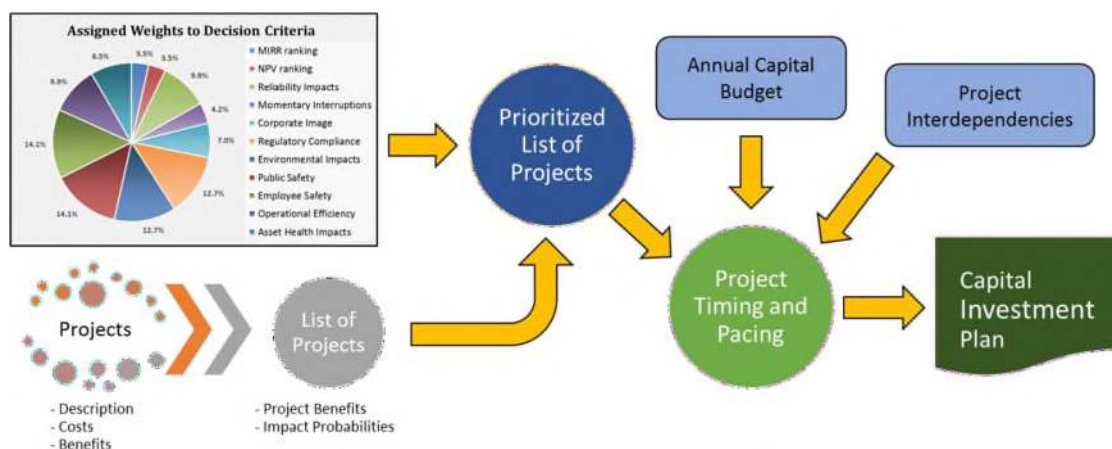
Figure 4-3 below illustrates NBHDL's optimized project prioritization methodology. As shown in the figure, once the list of prioritized projects has been made, additional inputs such as the annual capital budget, project interdependencies and project resources are considered to determine the appropriate project timing and pacing to construct the proposed capital investment plan.

**Figure 4-3: Project Prioritization Criteria and Weightings**

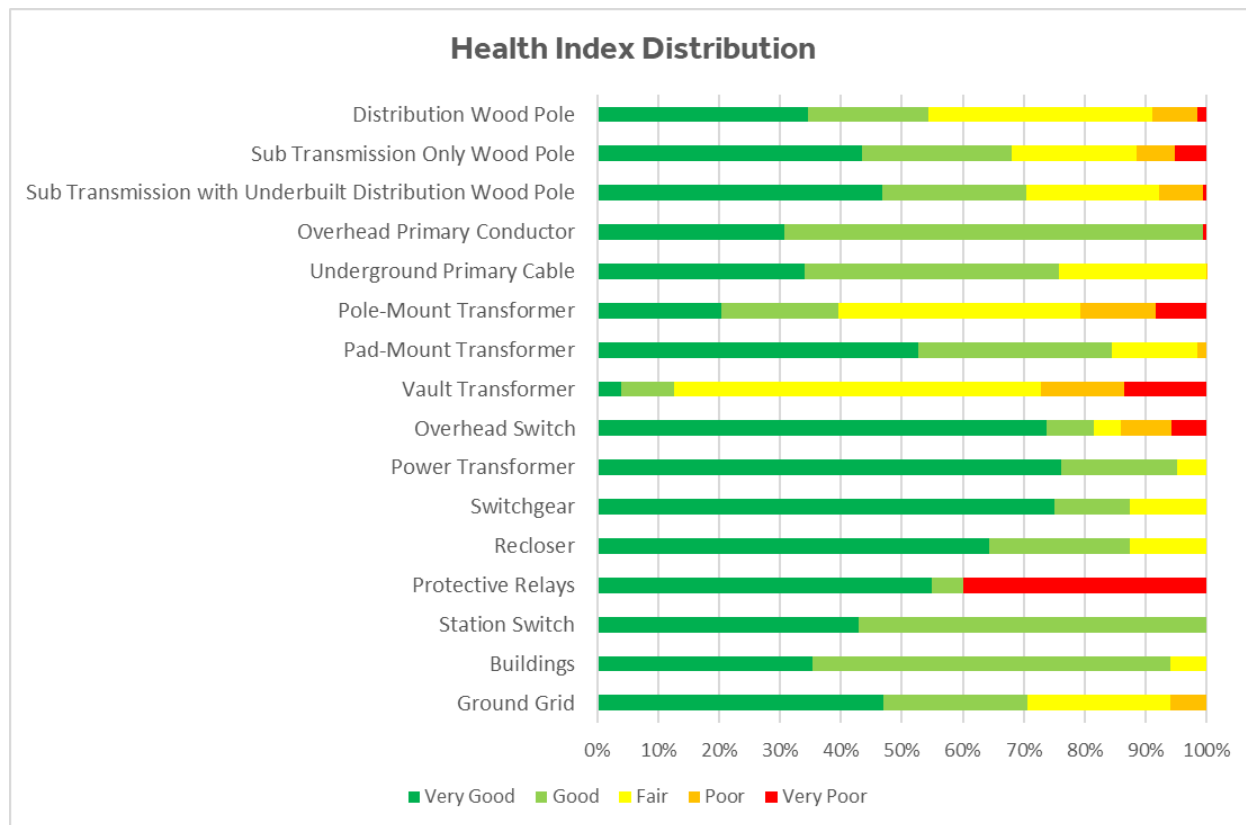
Using this scale, METSCO calculated the HI for every asset in the scope of the assessment using the applicable and available “condition parameters” – individual characteristics of the state of an asset’s components. Each condition parameter has its own sub-scale of assessment and a weighting contribution that represents the percentage in the overall HI made up by the particular parameter. METSCO’s findings for each asset class were developed using this methodology, as described in more detail in Section 3 and Section 4. The consolidated results of the Asset Condition Assessment are summarized in Figure 0-1.

**Figure 0-1: Health Index Results**

As the figure above indicates, the majority of NBHDL's distribution system is in Good or better condition, with several specific asset classes containing units found to be in Poor and Very Poor condition – most notably pole-mount transformers, vault transformers, overhead switches and station protective relays. Table 0-2 on the following page presents the numerical Health Index summary for each asset class. The distribution of Health Indices is based on the total population count of a given asset class. For each asset class, the following details are listed: total population, average Health Index, average Data Availability Index ("DAI"), and the Health Index distribution.

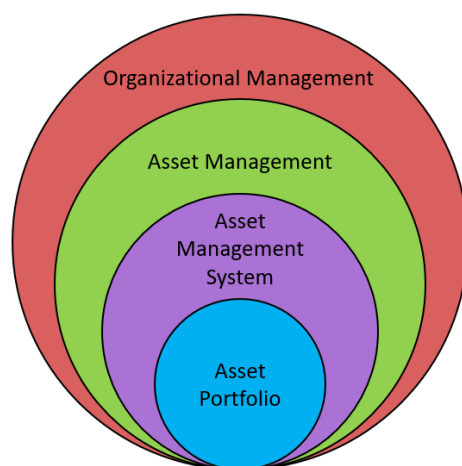
Figure 2-1: Relationship between key Asset Management terms<sup>1</sup>

Around the asset portfolio, the AM system operates and represents a set of interacting elements that establish the policy, objectives, and processes to achieve those objectives. The AM system is encompassed by the AM practices – coordinated activities of the organization to realize maximum value from its assets. Finally, the organizational management organizes and executes the underlying hierarchy.<sup>1</sup>

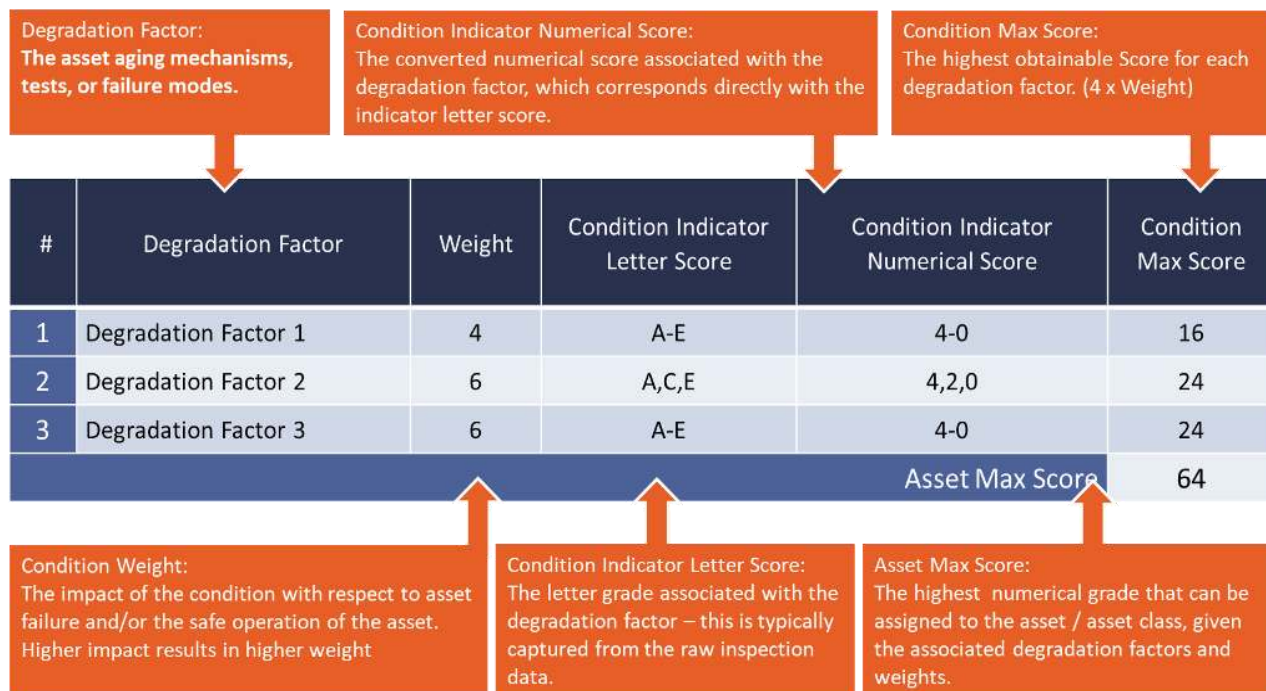
**Figure 3-1: Health Index Formulation Components**

To determine the overall Health Index for an asset, formulations are developed based on condition parameters that can be expected to contribute to the degradation and eventual failure of that asset. A weight is assigned to each condition parameter to indicate the amount of influence the condition has on the overall health of the asset. Figure 3-1 provides an example of a Health Index formulation table.

Condition parameters of the asset are characteristic properties that are used to derive the overall Health Index. Condition parameters are specific and uniquely graded to each asset class. Additionally, some condition parameters can be comprised of sub-condition parameters. This is particularly true for power transformers and the associated condition parameter "Oil Quality". The "Oil Quality" condition parameter can include multiple sub-conditions parameters like "Acid Number", "Interfacial Tension", "Dielectric Strength" and "Water Content". The "Oil Quality" condition parameter table is provided in Appendix B. In this case, the lowest sub-condition score is used as the score for the condition parameter.

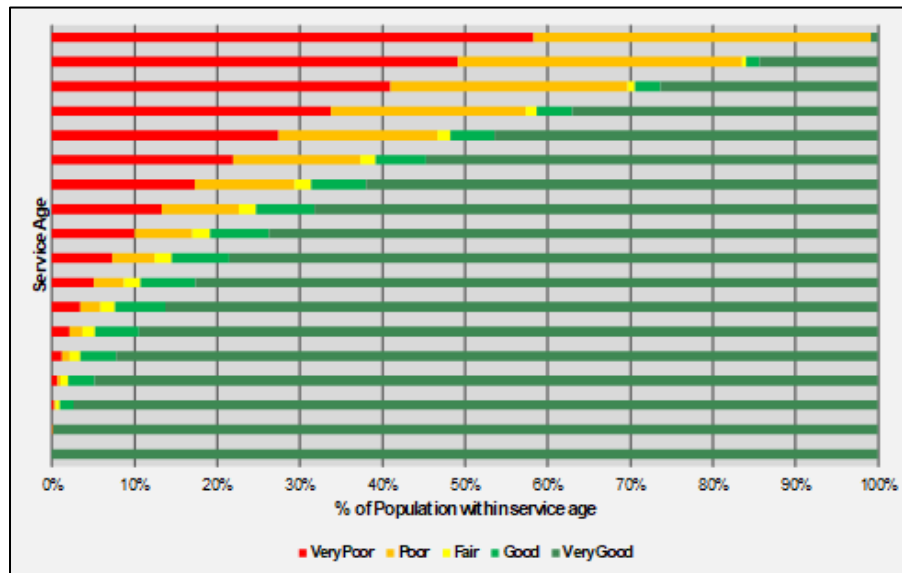
Figure 3-2: A Sample Asset Age vs. Condition Comparison Chart

Irrespective of the fact that METSCO used age data in calculating the Health Index for a particular asset class, an analysis that compares calculated asset condition with the applicable service age of units comprising the asset population is generally expected to follow the trend depicted in Figure 3-2 below. The figure shows a trend contrasting the age data with the calculated condition results. The trend can indicate to an asset manager that as age increases the condition increasingly becomes worse. However, this is not indicative of any clear action needed to be taken and is ultimately up to the corporation to manage asset health.

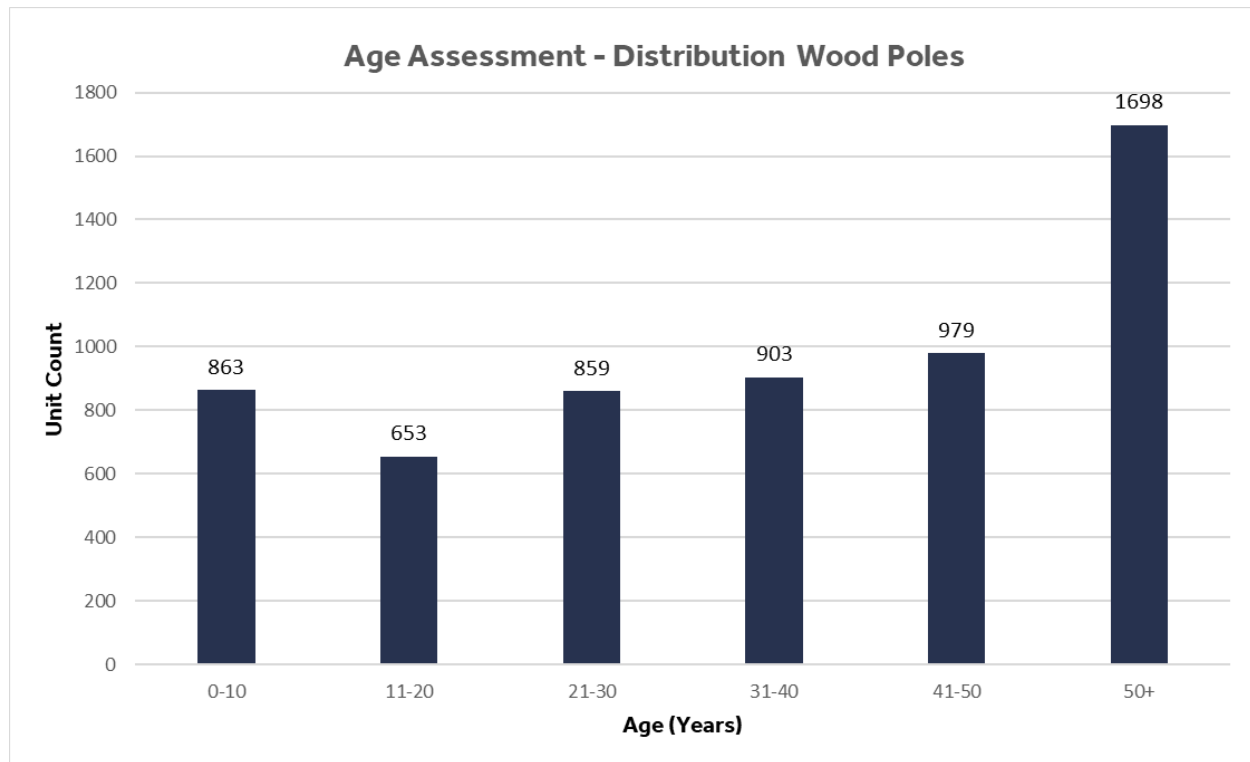
Figure 4-1: Distribution Wood Poles Age Demographic

NBHDL owns 10,384 wood poles within its service territory. Only 5,955 wood poles, which carry primary circuit, were considered in this assessment. The installation date is unknown for approximately 2% of the total in-service population. The assets with unknown installation dates were extrapolated by the average age of distribution wood poles on the same distribution feeder to show an approximate representation of the age distribution. The assumption for the service age of assets was used in the Health Index calculation and was confirmed with NBHDL. Figure 4-1 presents the age distribution for in-service distribution wood poles.

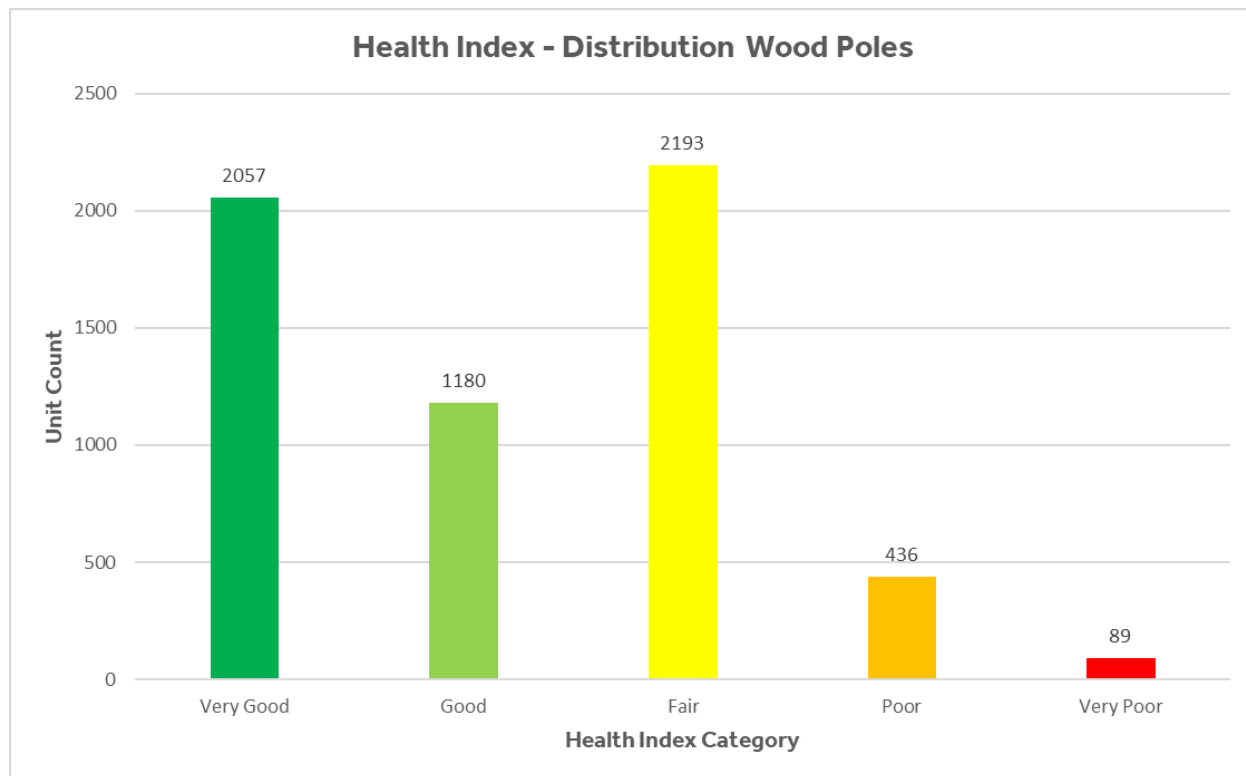
Figure 4-2: Distribution Wood Poles Health Index Demographic

NBHDL's pole maintenance and nameplate data were used to calculate the Health Index based on the criteria provided in Table 4-1. Poles are visually inspected annually, with all poles being visited every 3 years. Only the 2019 inspection record was used in the Health Index formulation. The 2019-inspected population shared a similar age distribution with the total population.

A valid Health Index was calculated for 31% of the distribution of wood poles. To complete the full analysis, the Health Index for the remaining 69% has been extrapolated based on the Health Index distribution with a valid Health Index score within each age group, at an interval of 10-years, according to the principle of representation by population in the 2019 inspection record. The overall Health Index distribution for the distribution wood poles is presented in Figure 4-2. Over half of the total population are in Very Good or Good condition with one-third of the total population being in Fair condition. Less than 10% of the total population are in Poor or Very Poor condition. The average Health Index for the distribution wood pole population is 73%.

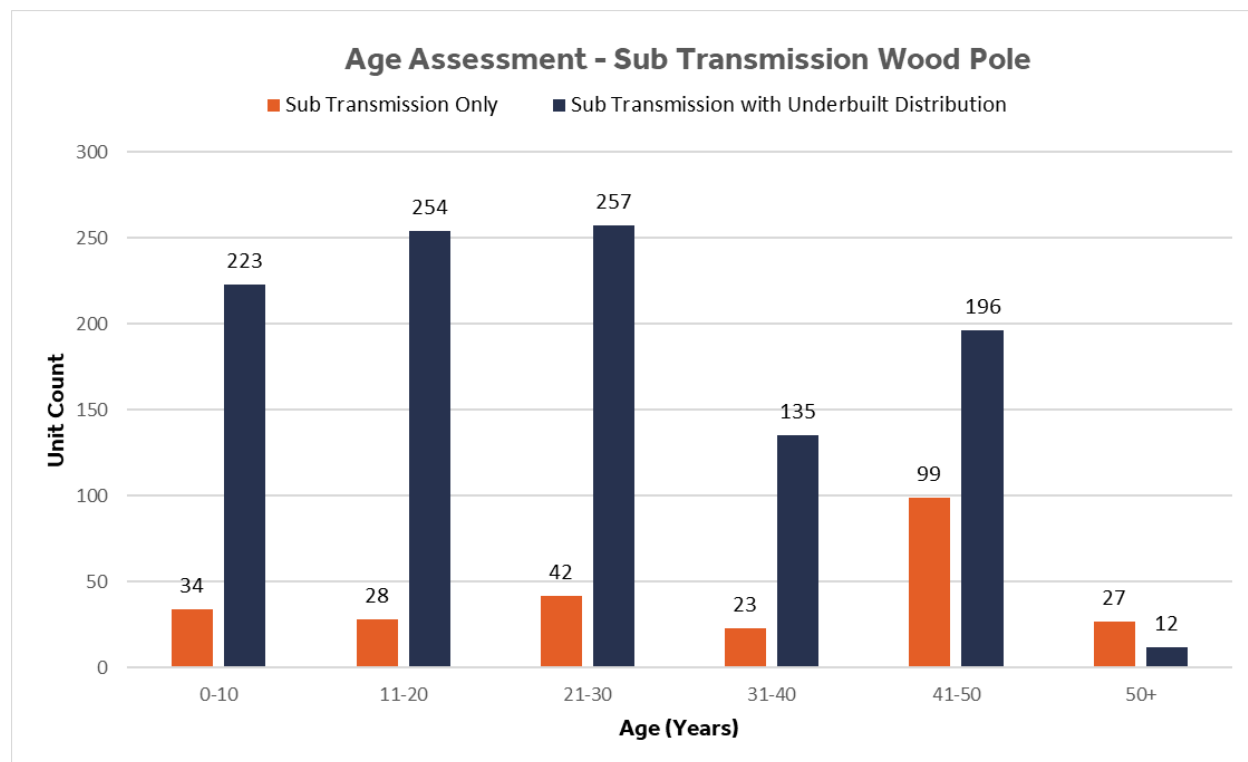
**Figure 4-3: Sub-Transmission Wood Poles Age Demographic**

NBHDL owns 253 sub-transmission only wood poles and 1,077 sub-transmission with underbuilt distribution ("underbuilt") wood poles within its service territory. The installation date is unknown for approximately 4% and 2% of the in-service poles, respectively. The assets with unknown installation dates were extrapolated by the average age of sub-transmission wood poles on the same feeder to show an approximate representation of the age distribution. The applied assumption for the service age of assets was used in the Health Index calculation and was confirmed with NBHDL. Figure 4-3 presents the age distribution for in-service sub-transmission wood poles.

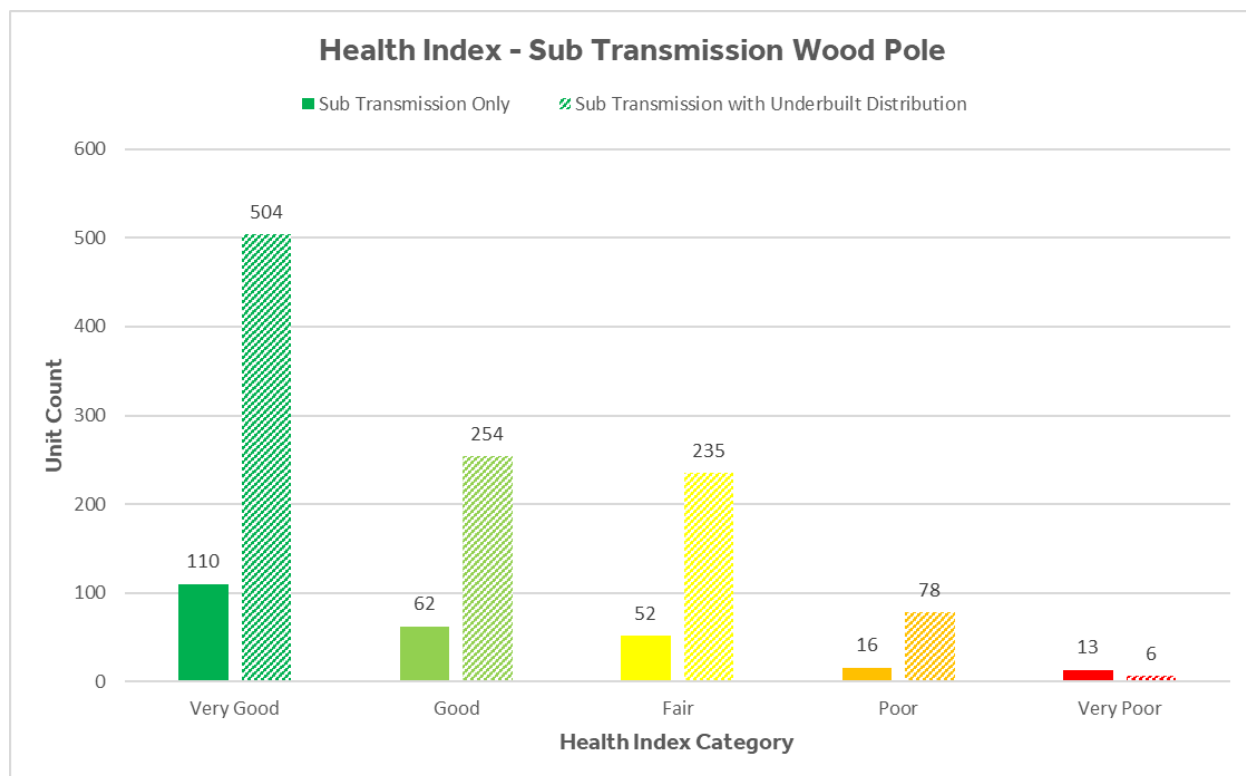
**Figure 4-4: Sub-Transmission Wood Poles Health Index Demographic**

NBHDL's pole maintenance and nameplate data were used to calculate the Health Index based on the criteria provided in Table 4-1. Poles are visually inspected annually, with all poles being visited every 3 years. Only the 2019 inspection record was used in the Health Index formulation. The 2019-inspected population shared a similar age distribution with the total population.

A valid Health Index was calculated for 41% and 43% of the sub-transmission and underbuilt wood poles. To complete the full analysis, the Health Index for the remaining 59% and 57% has been extrapolated based on the Health Index distribution with a valid Health Index score within each age group, at an interval of 10-years, according to the principle of representation by population in the 2019 inspection record. The overall Health Index

distribution for the wood poles is presented in Figure 4-3. Over half of the total population are in Very Good or Good condition with ~10% of the total population in Poor or Very Poor condition. The average Health Index for the sub-transmission and underbuilt wood pole population are 76% and 78%, respectively .

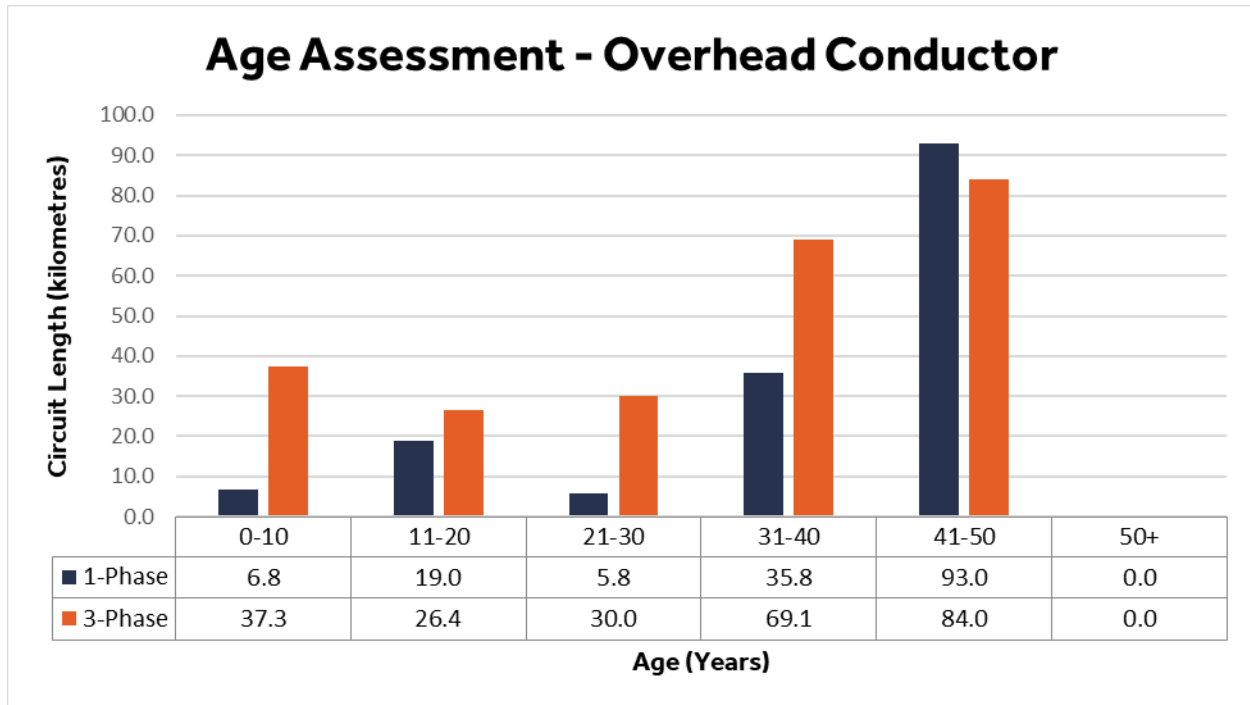
Figure 4-5 Overall Overhead Primary Conductor Age Demographic

NBHDL owns approximately 407 km of overhead primary conductor within its service territory. The installation date was unknown for approximately 67% of both 1-phase and 3-phase conductors and was extrapolated by the average age of distribution wood poles on the same distribution feeder to show an approximate representation of the age distribution. The figure presents the total length of overhead primary conductors for each age band. The applied assumption for the service age of assets was used in the Health Index calculation and was confirmed with NBHDL. Figure 4-5 presents the overall overhead primary conductor age demographics.

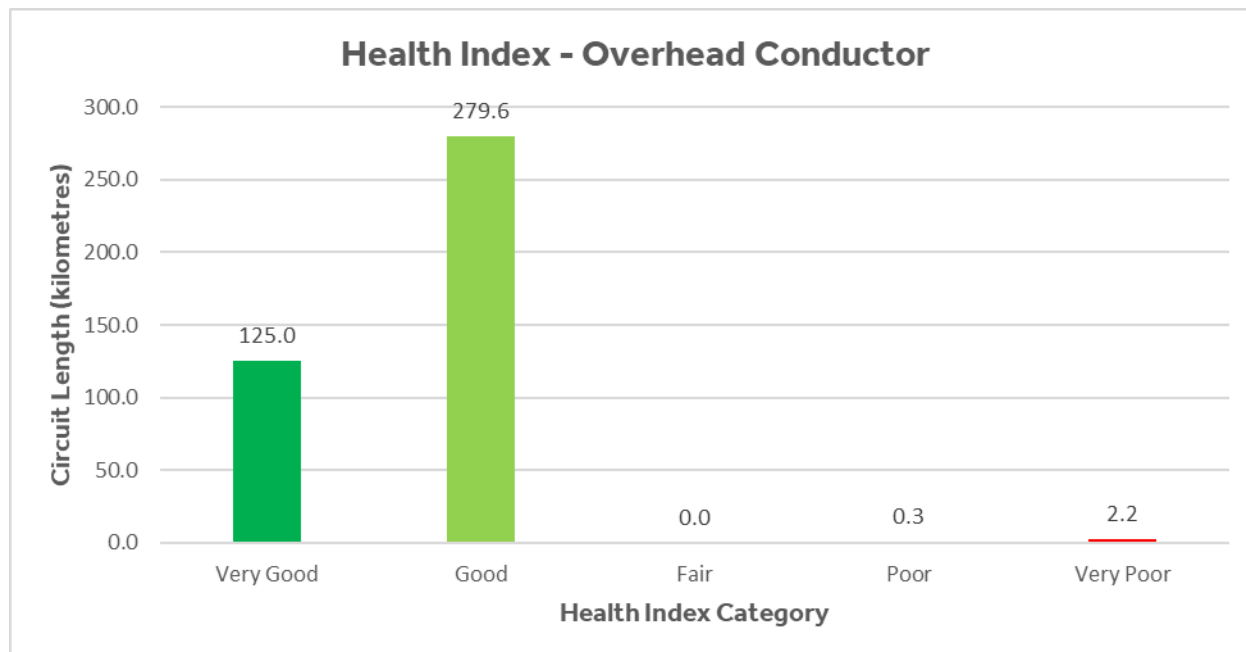
Figure 4-6: Overhead Primary Conductor Health Index Demographic

The overall Health Index for overhead primary conductors is illustrated in Figure 4-6. A valid Health Index was calculated for nearly 100% of the conductors, using the extrapolated age results. To complete the full analysis, the Health Index for the remaining has been extrapolated based on the Health Index distribution with a valid Health Index score within each age group, at an interval of 10-years. Most of the primary conductors are in Very Good and Good condition with less than 1% in Poor and Very Poor condition. The average Health Index for overhead primary conductors is 81%.

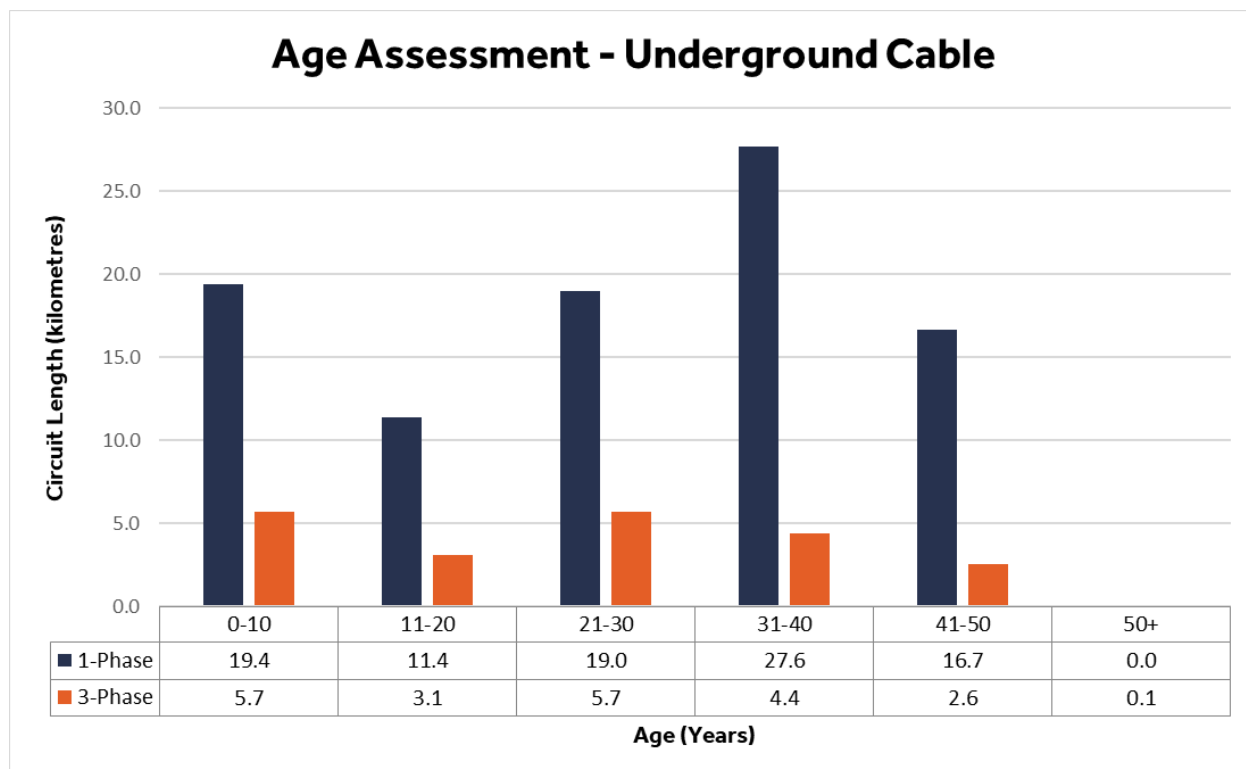
Figure 4-7: Overall Underground Primary Cable Age Demographic

NBHDL owns approximately 116 km of underground primary cable within its service territory. The installation date was unknown for approximately 2% of both 1-phase and 3-phase cables and was extrapolated by the average age of cables on the same distribution feeder to show an approximate representation of the age distribution. The figure presents the total length of underground primary cables for each age band. The applied assumption for the service age of assets was used in the Health Index calculation and was confirmed with NBHDL. Figure 4-7 presents the underground primary cable age demographic.

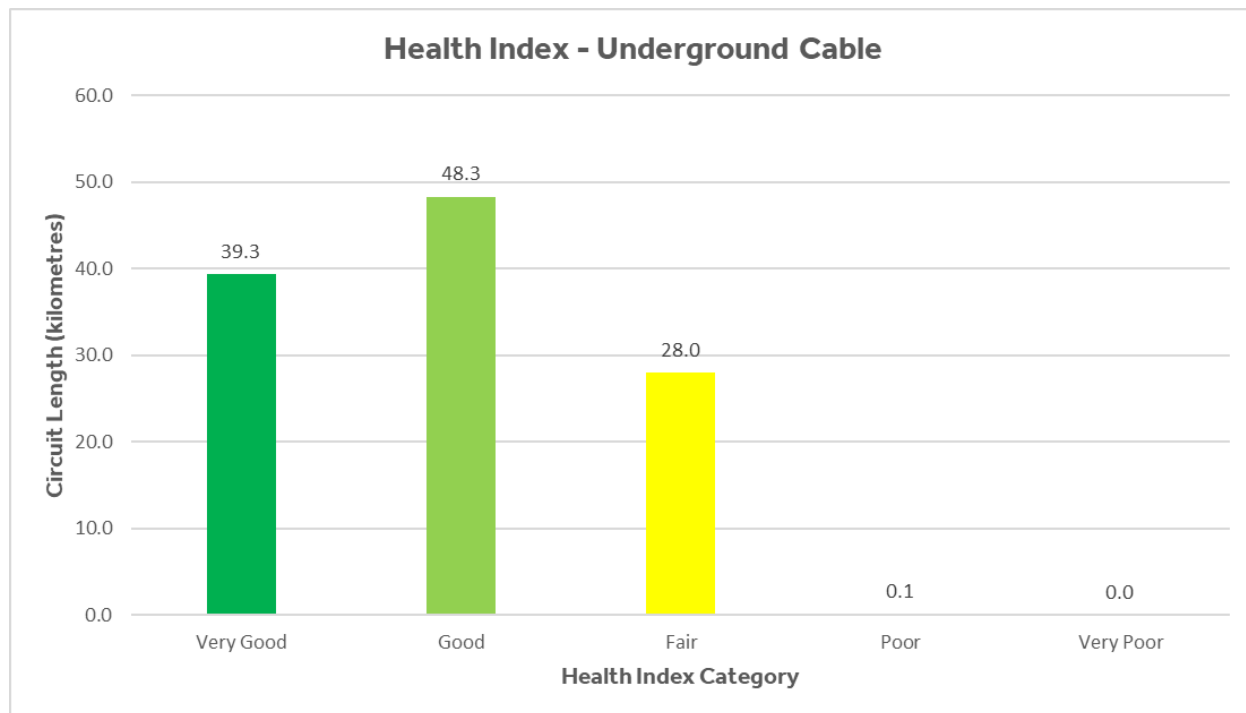
**Figure 4-8: Underground Primary Cable Health Index Demographic**

The overall Health Index for underground primary cable is illustrated in Figure 4-8. Most of the underground primary cables are in Very Good and Good condition with less than 1% being in Poor condition. The average Health Index for underground primary cables is 77%.

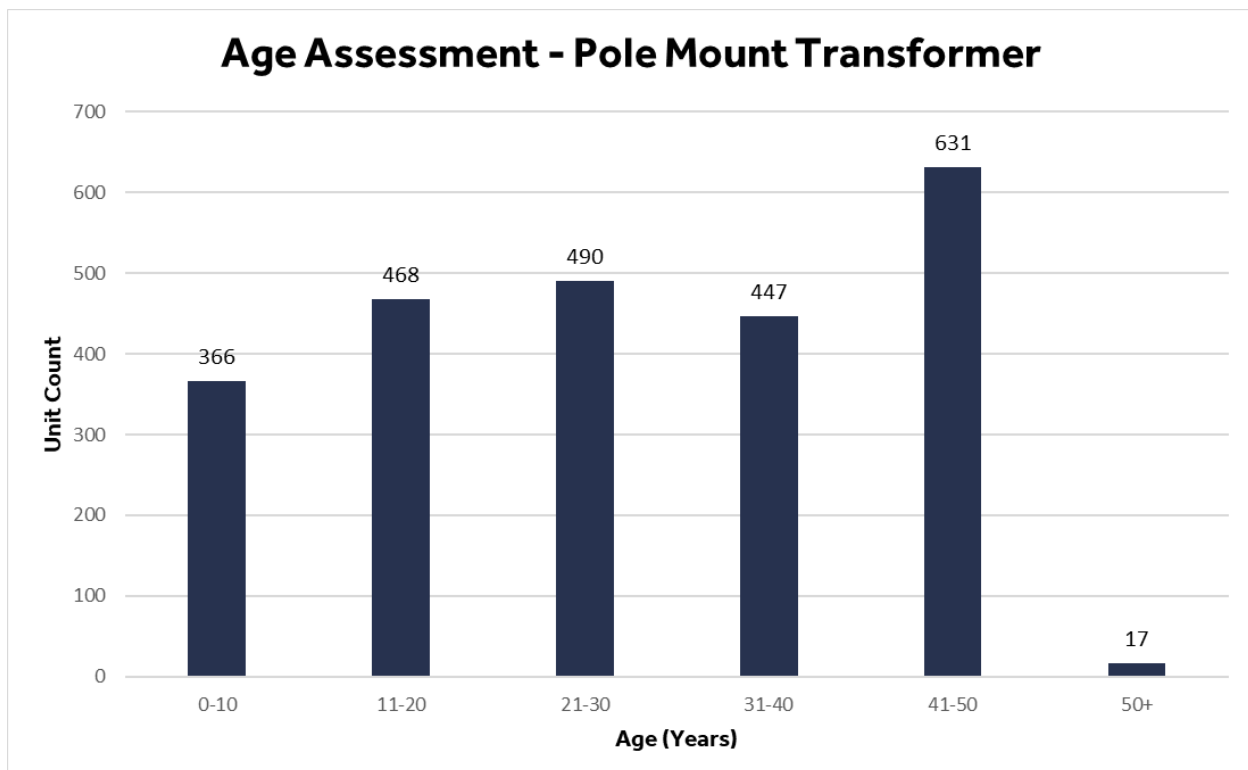
Figure 4-9: Pole-Mount Transformer Age Demographic

NBHDL owns 2,419 pole-mount transformers within its service territory. The installation date is unknown for 37% of the asset population. For unknown installation dates, the assumption made was to use the average age on the same feeder as the transformer age which resulted in 100% of assets having a known installation date. The applied assumption for the service age of assets was used in the Health Index calculation and was confirmed with NBHDL. Figure 4-9 presents the age distribution for pole-mount transformers.

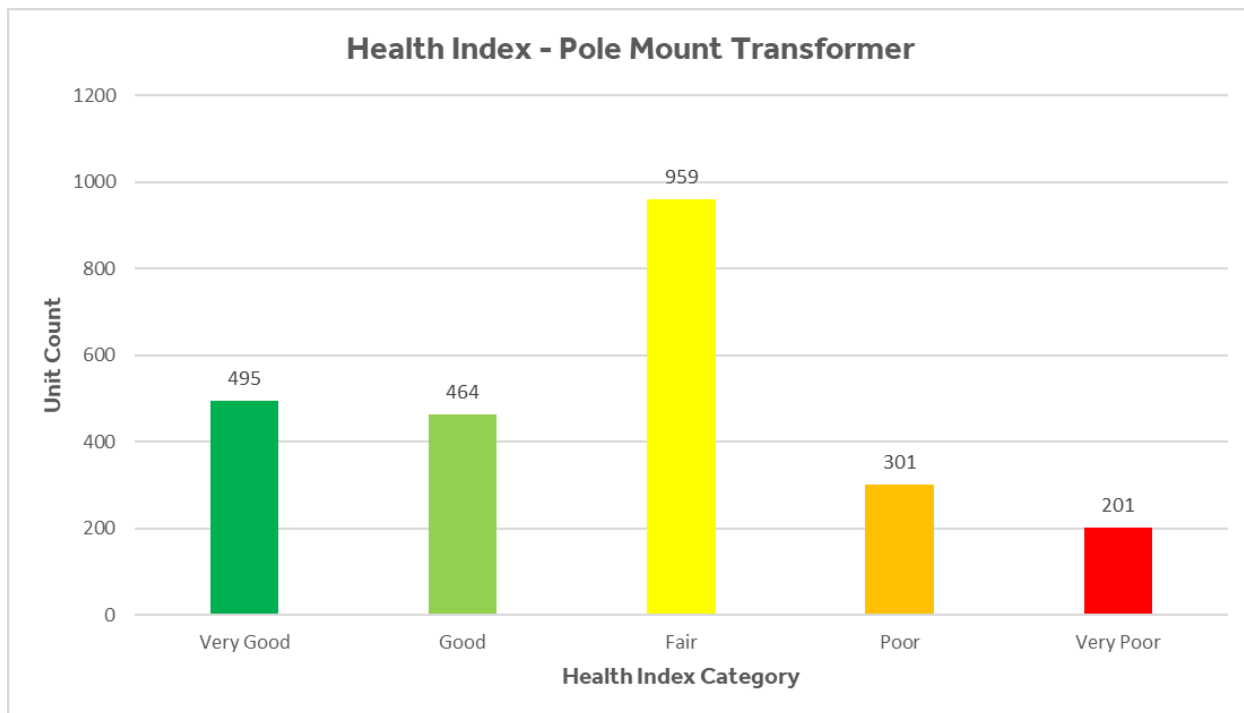
**Figure 4-10: Pole-Mount Transformers Health Index Demographic**

NBHDL's transformer nameplate information and operating loading data were used to calculate the Health Index based on the criteria provided in Table 4-8. A valid Health Index was calculated for 96% of the pole-mount transformers, using the extrapolated age results. To complete the full analysis, the Health Index for the remaining 4% has been extrapolated based on the Health Index distribution with a valid Health Index score within each age group, at an interval of 10-years. The overall Health Index distribution is presented in Figure 4-10 for the overhead transformer. The average Health Index of the overhead distribution transformers is 61%.

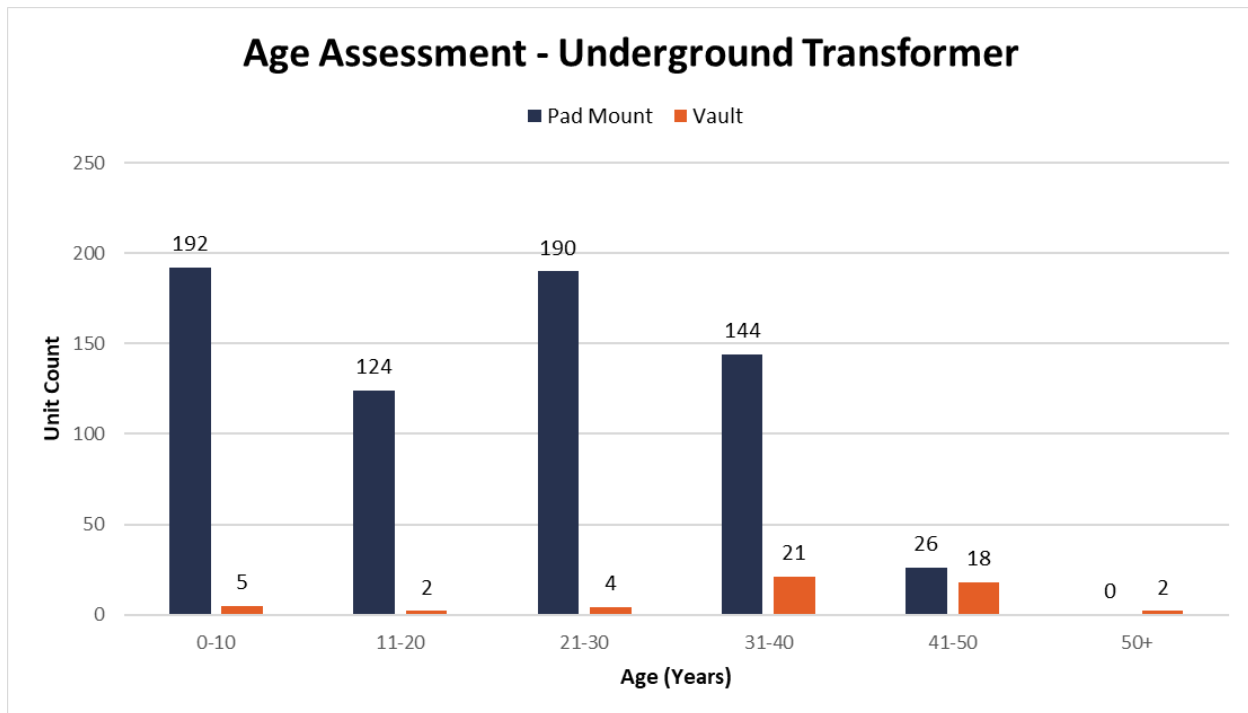
Figure 4-11: Distribution Transformers Age Demographic

NBHDL owns 676 pad mount transformers and 52 vault transformers within its service territory. Unknown installation dates account for approximately 18% of pad-mount transformers. For unknown installation dates, the assumption made was to use the average age of installed underground cables on the same feeder which resulted in 100% of assets having a known installation date. The applied assumption for the service age of assets was used in the Health Index calculation and was confirmed with NBHDL. Figure 4-11 presents the age distribution by transformer types.

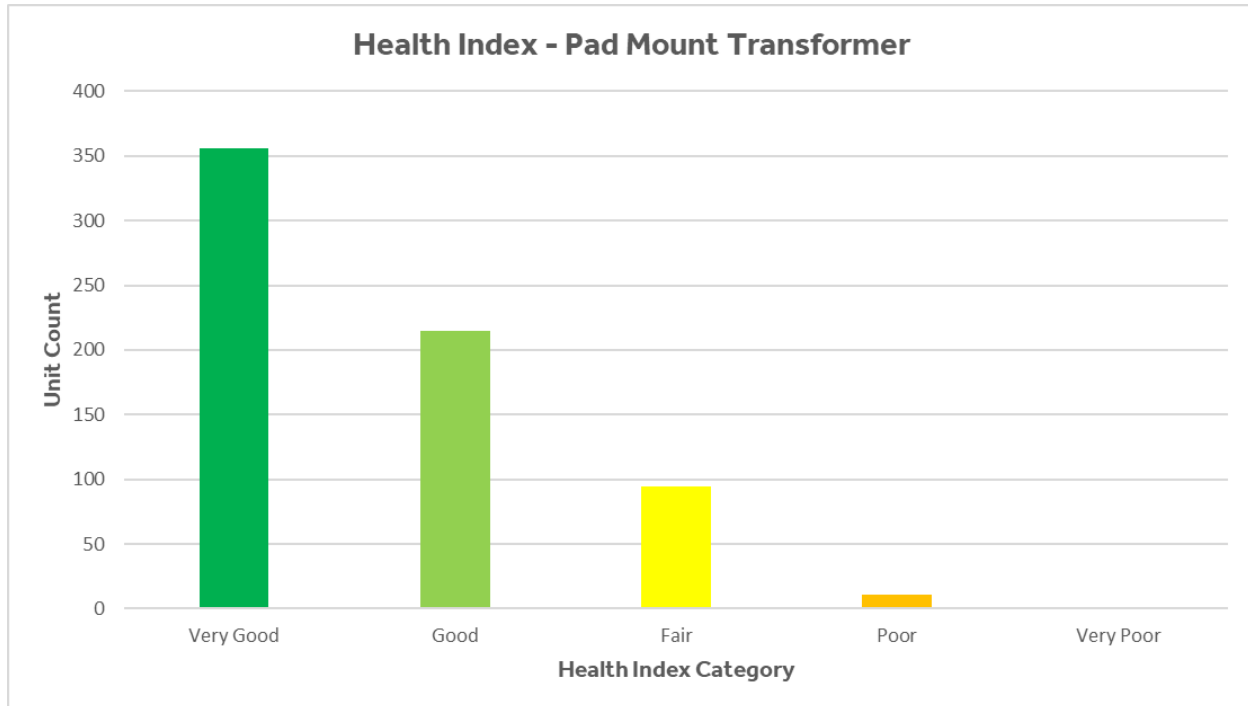
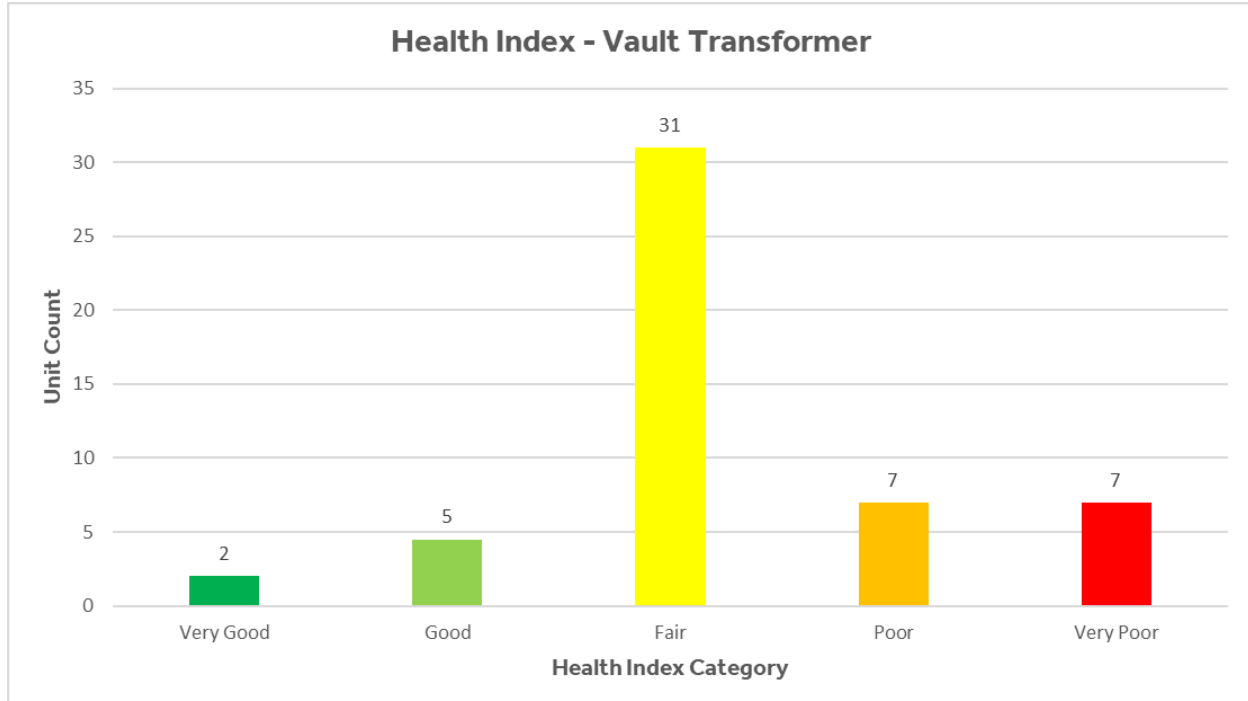
Figure 4-12: Pad-mount Transformers Health Index Demographic

Figure 4-13: Vault Transformers Health Index Demographic

Table 4-11. Approximately 3% of the underground distribution transformers within NBHDL's service territory have peak loading percentage greater than 100% which can pose operating restrictions and impact the condition of the assets. The overall Health Index distribution is presented in Figure 4-12 to Figure 4-13 for each transformer type. A valid Health Index was calculated for 79% and 96% of pad-mount and vault transformers, respectively. To complete the full analysis, the Health Index for the remaining has been extrapolated based on the Health Index distribution with a valid Health Index score within each age group, at an interval of 10-years. Most of the pad-mount transformers are in Very Good or Good condition. The average Health Index of the pad-mount and vault transformers are 83% and 52%, respectively.

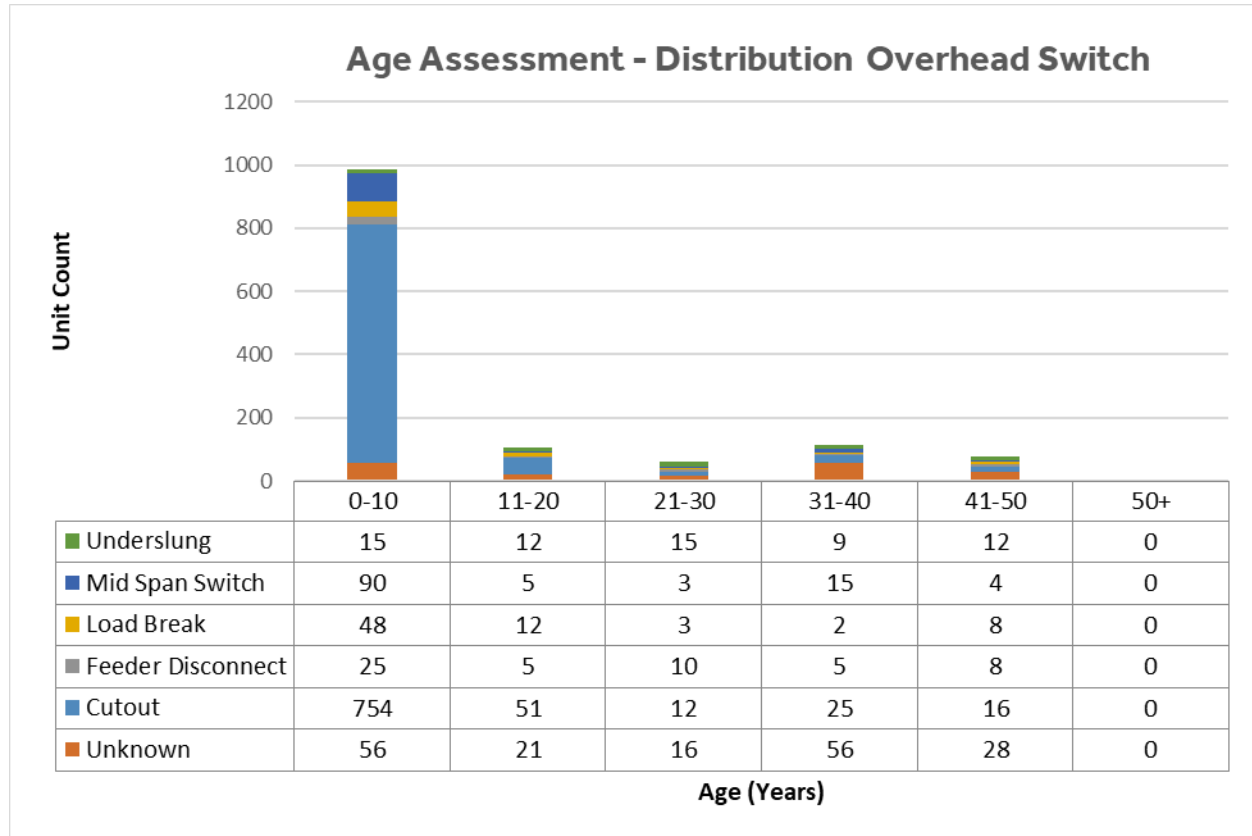
Figure 4-14: Distribution Overhead Switches Age Demographic

NBHDL owns 1,341 overhead switches within its service territory. For assets with unknown installation dates, the assumption made was to use the average distribution pole age on the same feeder as a proxy. This results in 82% of switches having a known installation date. The applied assumption for the service age of assets was used in the Health Index calculation and was confirmed with NBHDL. Figure 4-14 presents the age distribution for overhead switches to show an approximate representation of the age distribution.

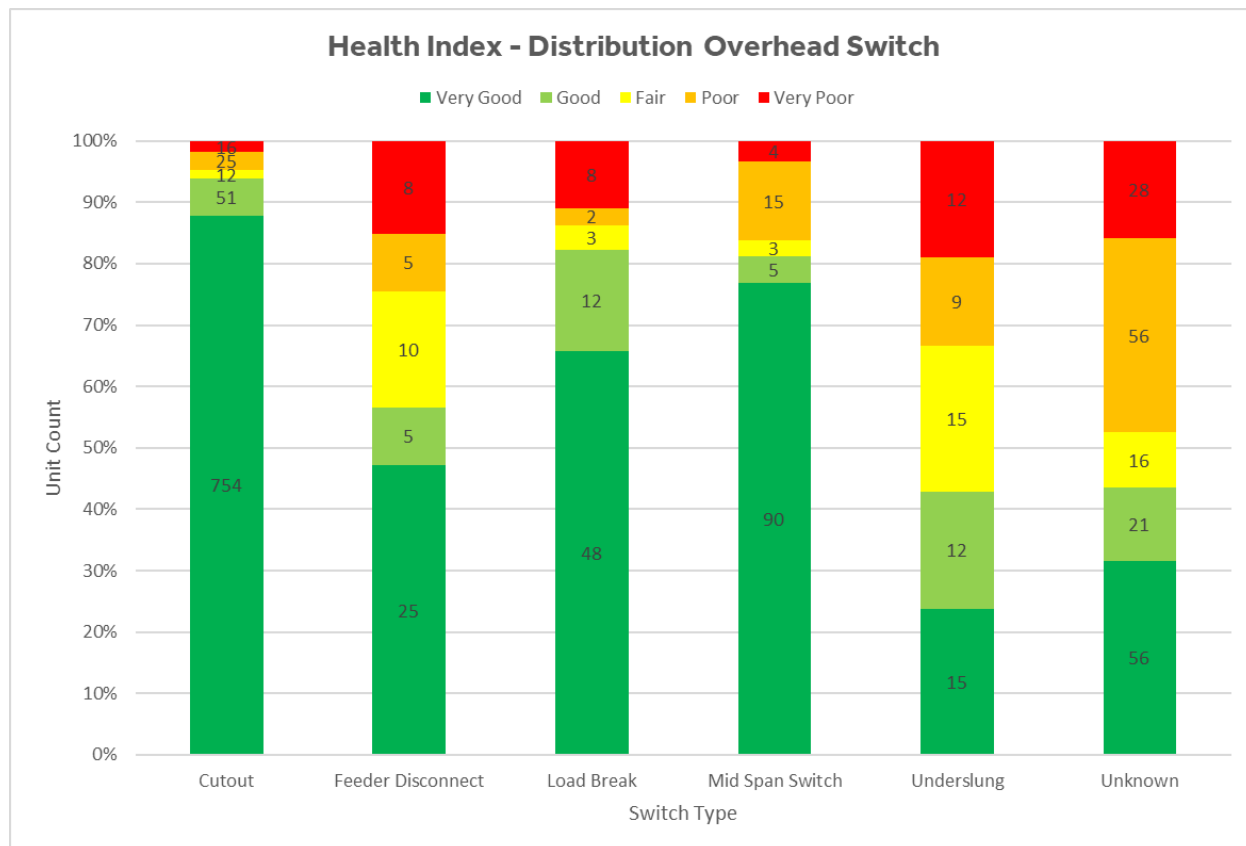
**Figure 4-15: Overhead Switches Health Index Demographic**

NBHDL's nameplate information was used to calculate the Health Index based on the criteria provided in Table 4-13. The overall Health Index distribution for the overhead switches is presented in Figure 4-15. More than 80% of the switches are in good or better conditions. The average Health Index of overhead switches is 85%.

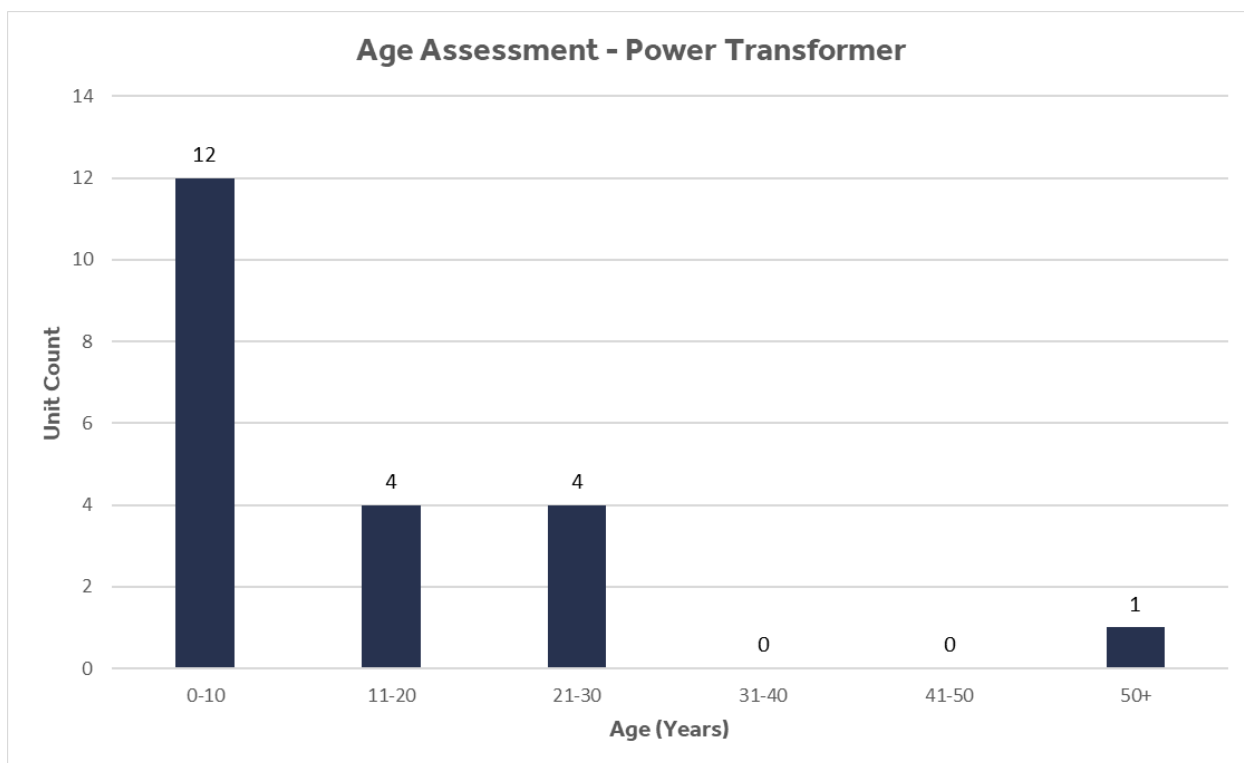
**Figure 4-16: Power Transformers Age Demographic**

NBHDL owns 21 oil type power transformers within its service territory. Age was known for all the power transformers in the system. Figure 4-16 presents the age profile of power transformers in-service.
