# **EXHIBIT 2:**

# **RATE BASE**

# Distribution System Plan

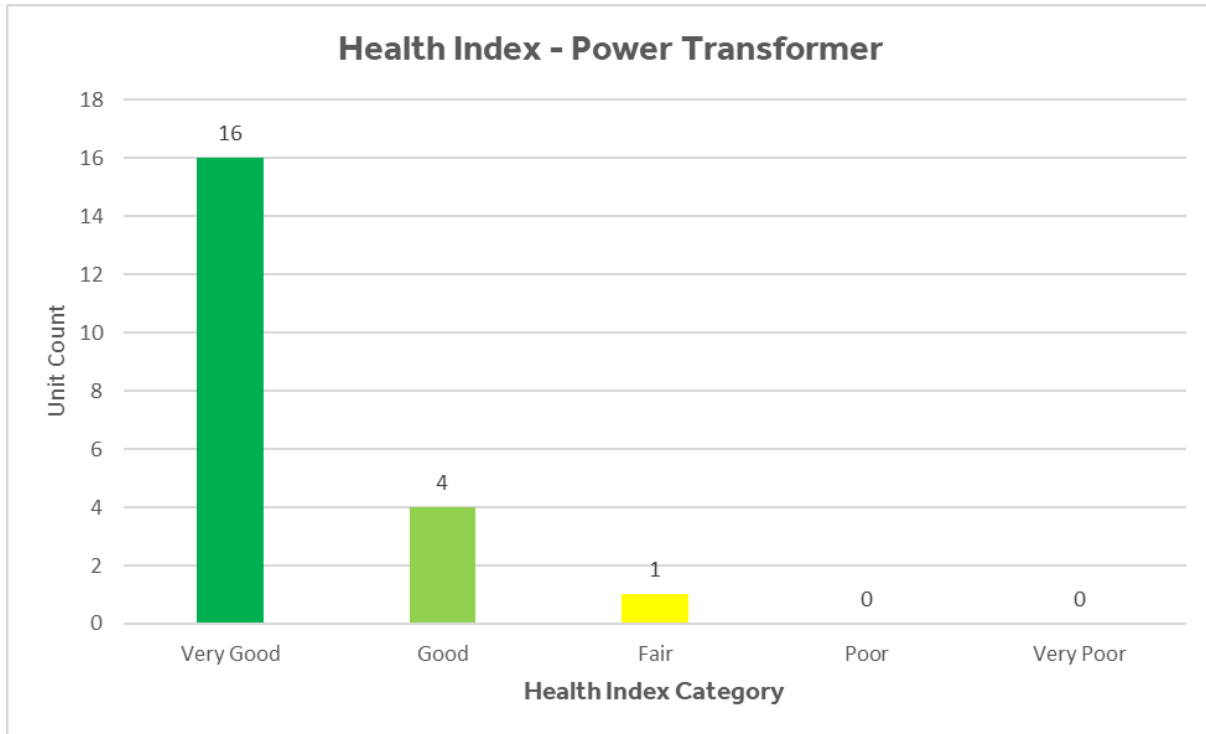
**Figure 4-17: Power Transformers Health Index Demographic**

NBHDL's power transformer inspections, test results and loading history were used to calculate the Health Index based on the criteria provided in Table 4-15. The Health Index distribution for in-service power transformers leveraged from the substation assessment<sup>3</sup> is presented in Figure 4-17. Most of the power transformers are in Very Good or Good condition with two power transformers in Fair condition. The average Health Index for power transformer is 88%.

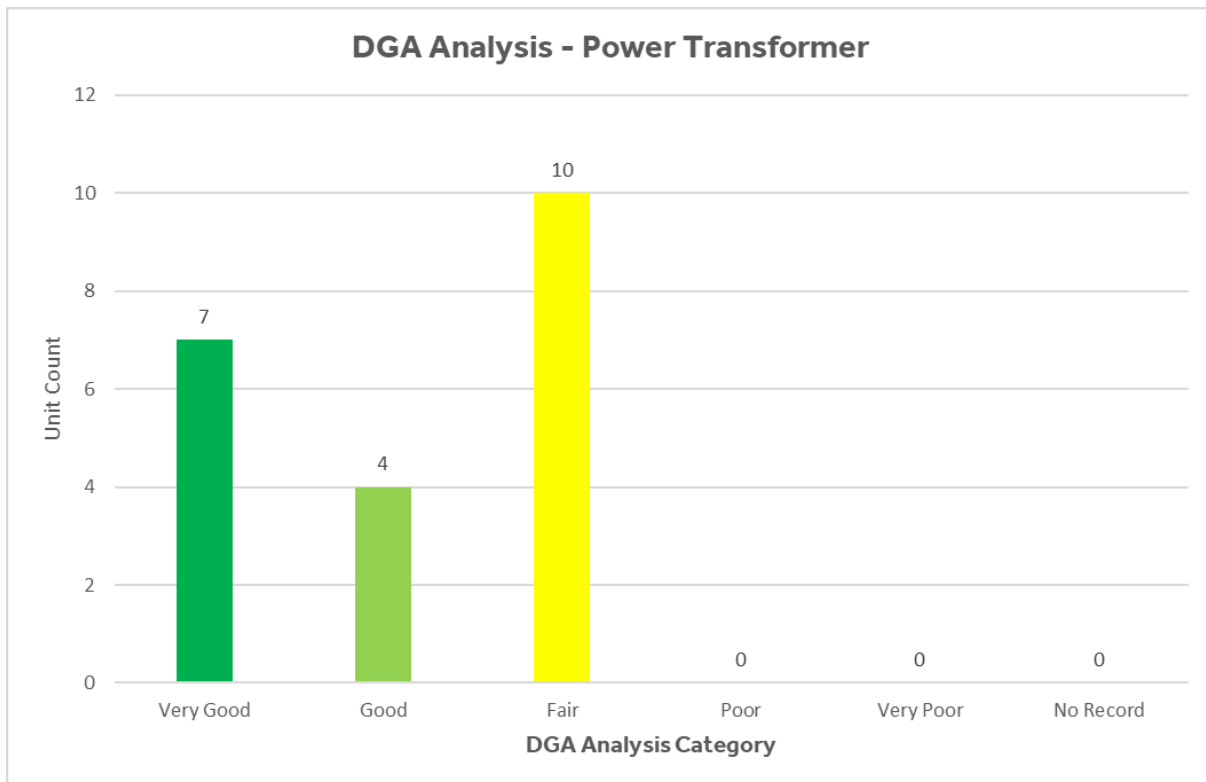
**Figure 4-18: Power Transformers DGA Analysis Results**

Figure 4-18 illustrates the DGA analysis results for the power transformers. DGA tests can be a leading indicator as to how the power transformer's internal condition is before experiencing unfavourable results. The figure is presented to show there are power transformers tested that may require intervention within a timely manner even though the overall Health Index is Very Good.

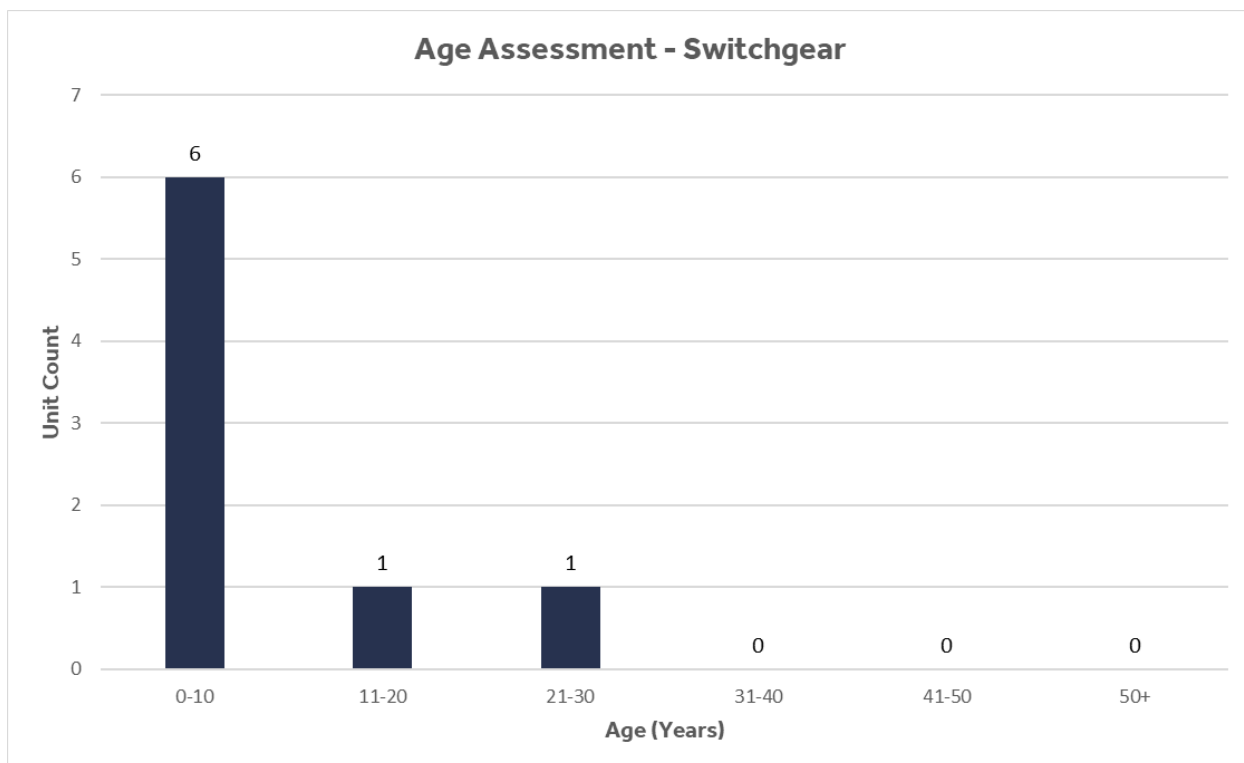
Figure 4-19: Switchgears Age Demographic

NBHDL owns 8 station switchgears within its service territory. Age was known for the total population of NBHDL's in-service station switchgears. Figure 4-19 presents the age profile of the primary switchgears.

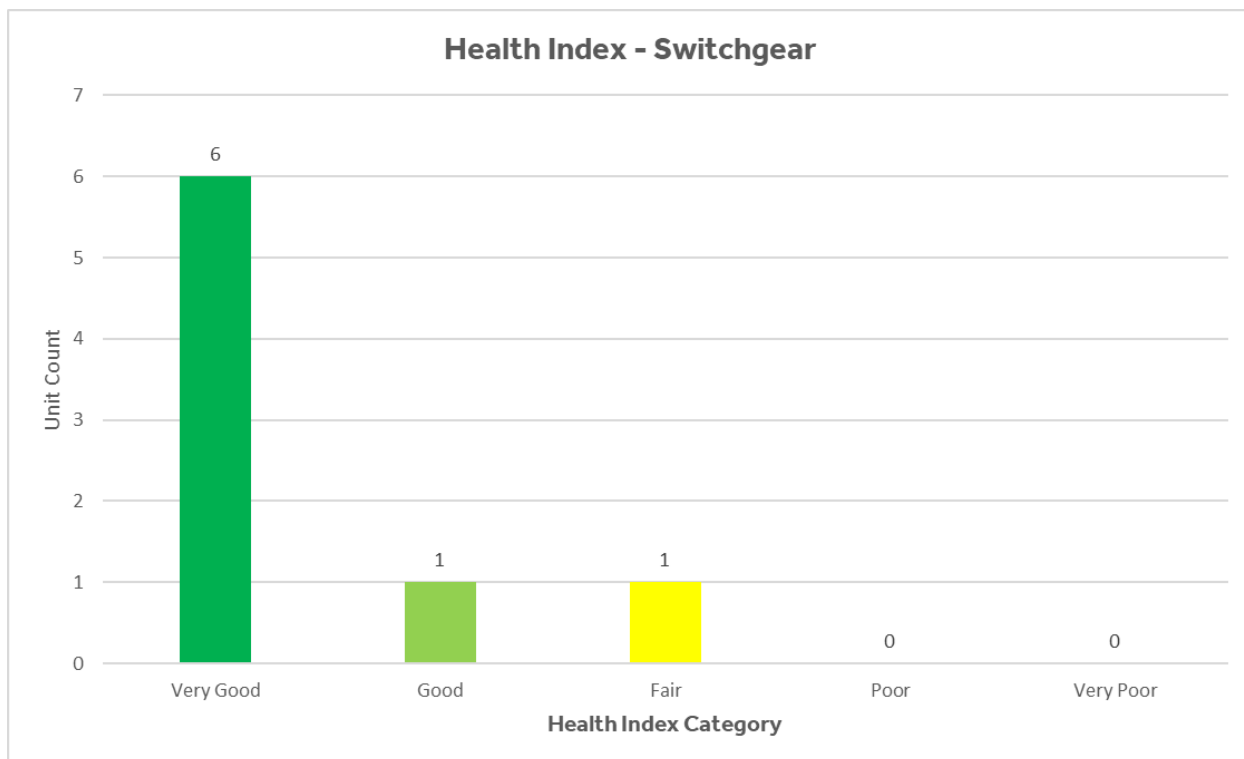
**Figure 4-20: Switchgears Health Index Demographic**

NBHDL's maintenance records and nameplate information were used to calculate the Health Index based on the criteria provided in Table 4-17. The overall Health Index distribution for the station switchgears leveraged from the substation assessment<sup>3</sup> is presented in Figure 4-20. Most of the asset class is in Very Good or Good condition, with one of the station switchgears in Fair condition. The average Health Index for station primary switchgear is 93%.

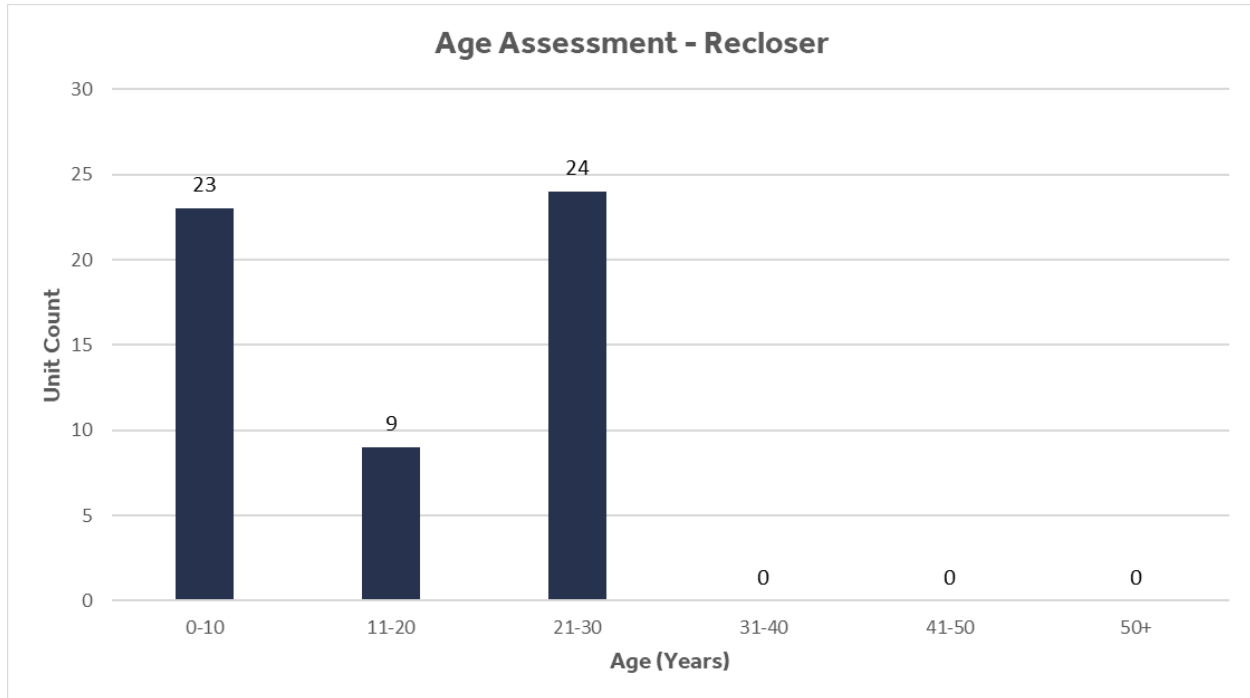
**Figure 4-21: Reclosers Age Demographic**

NBHDL owns 31 oil type and 25 vacuum type reclosers within its service territory. Age was known for all the reclosers in the system. Figure 4-21 presents the age distribution for reclosers.

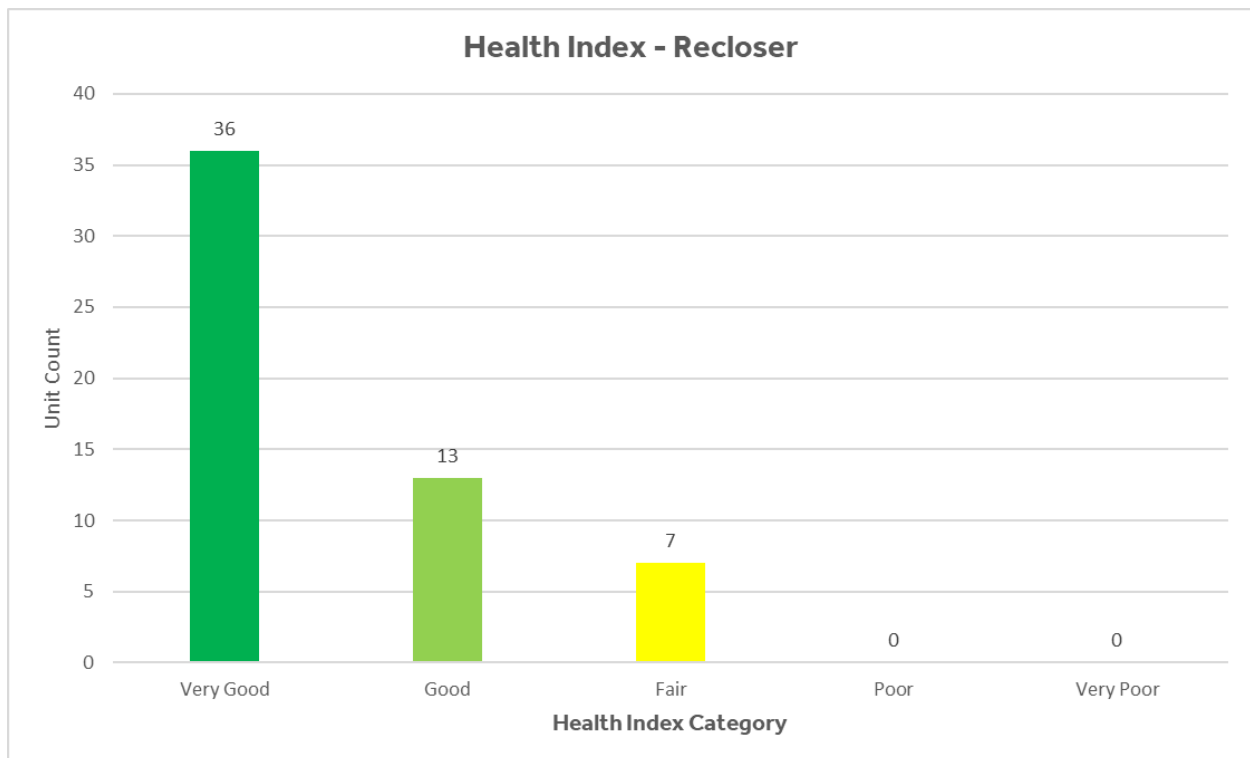
**Figure 4-22: Reclosers Health Index Demographic**

NBHDL maintenance records were used to calculate the Health Index based on the criteria provided in Table 4-19. The overall Health Index distribution for the reclosers leveraged from the substation assessment<sup>3</sup> is presented in Figure 4-22. The majority of the reclosers are in Very Good or Good condition, with ~13% in Fair condition. The average Health Index for reclosers is 91%.

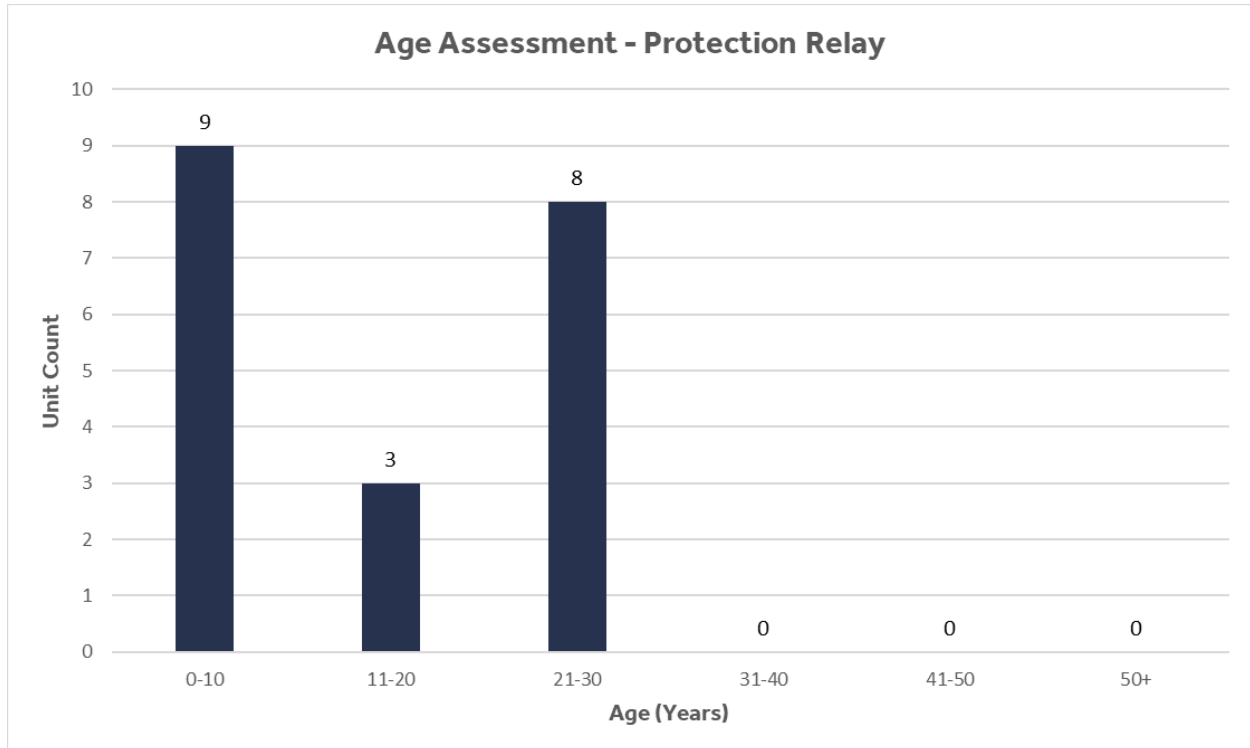
Figure 4-23: Protection Relays Age Demographic

NBHDL owns 20 protection relays. Age was known for all the relays in the system. Figure 4-23 presents the age demographics of the protection relays.

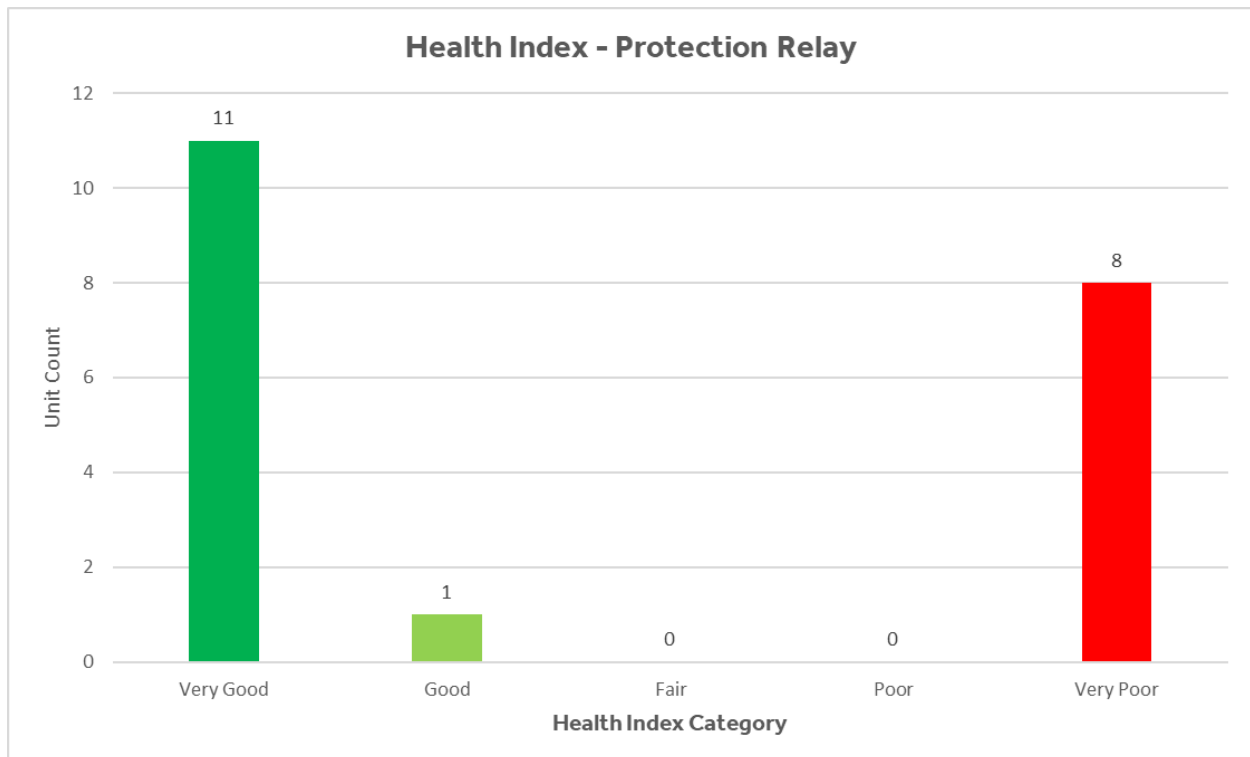
Figure 4-24: Protection Relays Health Index Demographic

NBHDL's most recent visual inspection results were used to calculate the Health Index based on the criteria provided in Table 4-21. The Health Index distribution for relays leveraged from the substation assessment<sup>3</sup> is presented in Figure 4-24. The population health is split with 40% of the relays in Very Poor condition. The average Health Index for protection relay is 68%.

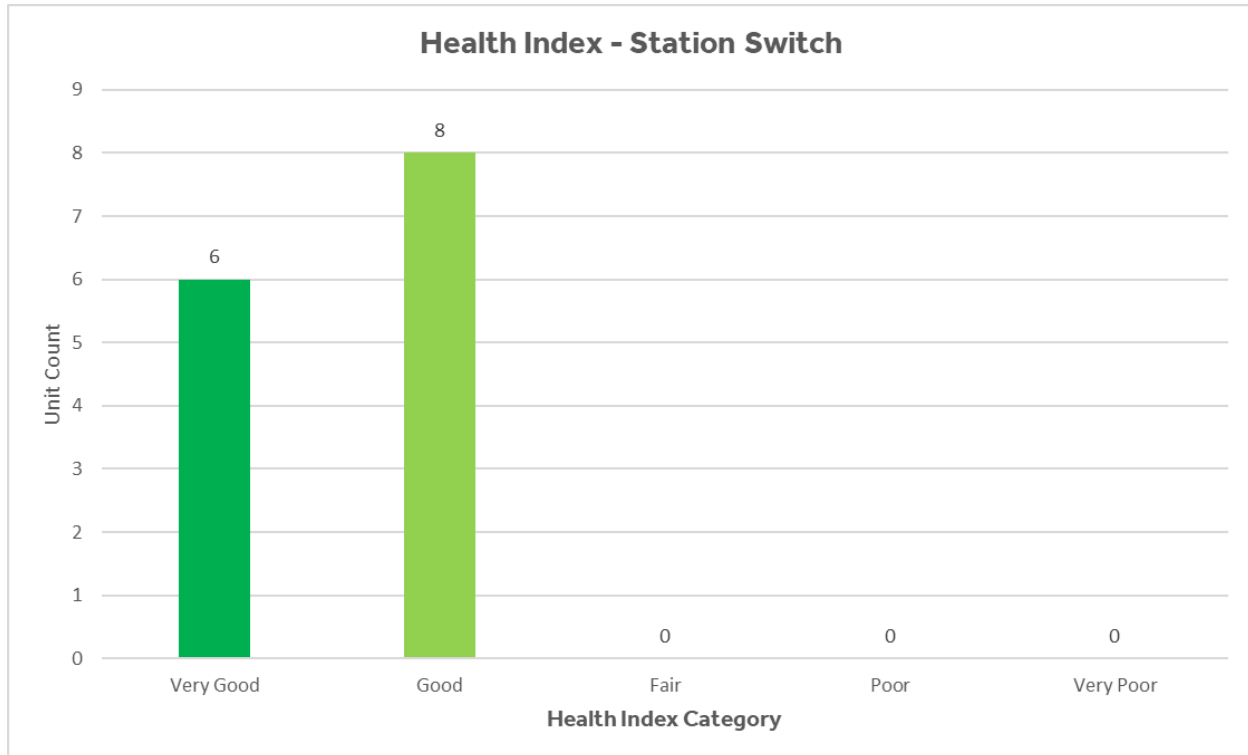
Figure 4-25: Station Overhead Switch Health Index Demographic

NBHDL owns 14 station overhead switches within its service territory. The Health Index for station overhead switches leveraged from the substation assessment<sup>3</sup> is illustrated in Figure 4-25. The entire population is in Very Good or Good condition. The average Health Index for station overhead switches is 87%.

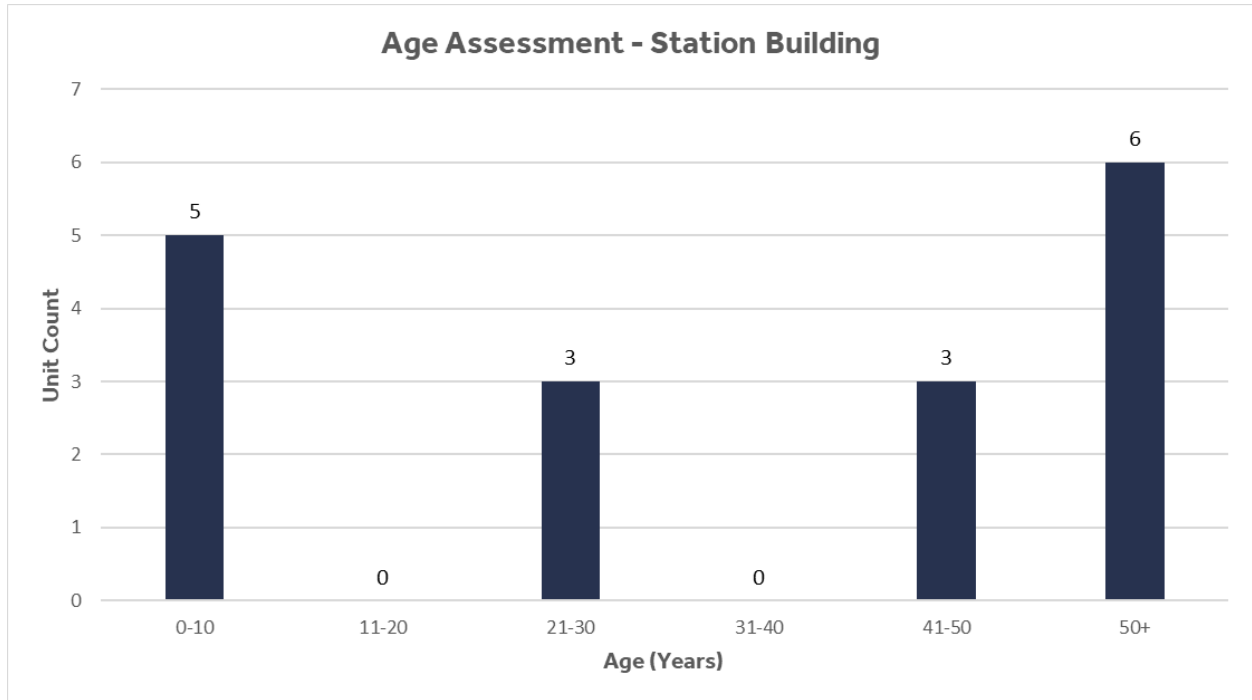
**Figure 4-26: Station Buildings Age Demographic**

NBHDL owns 17 station buildings within its service territory. An assumption is made to use the construction dates of the corresponding station to show an approximate representation of the age. Using the construction date does not mean the station was in-service with all units installed. Construction date results were not used as part of the Health Index calculation. Figure 4-26 presents the age distribution for buildings.

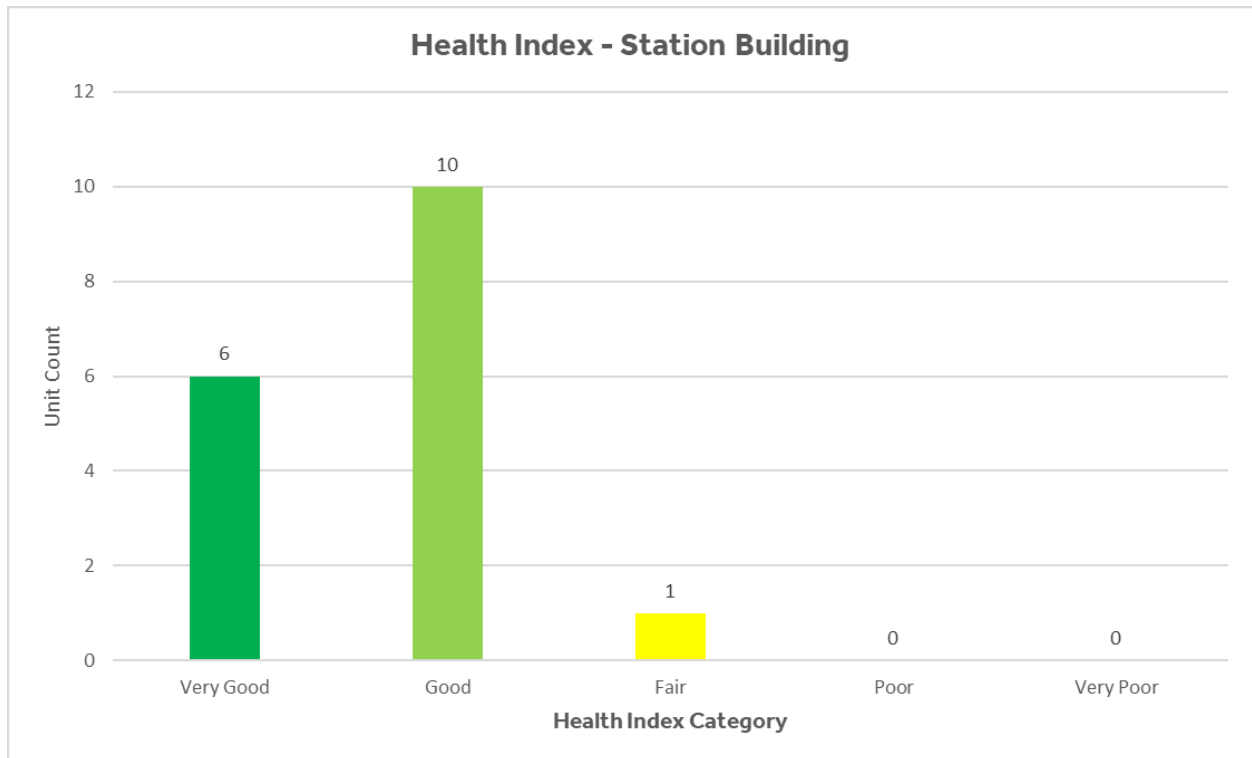
**Figure 4-27: Station Building Health Index Demographic**

NBHDL's most recent maintenance records were used to calculate the Health Index based on the criteria provided in Table 4-25. The Health Index values for station buildings were leveraged from the substation assessment<sup>3</sup> and are presented in Figure 4-27. The majority of the population is in Very Good or Good condition, whereas one unit is in Fair condition. The average Health Index for station buildings is 83%.

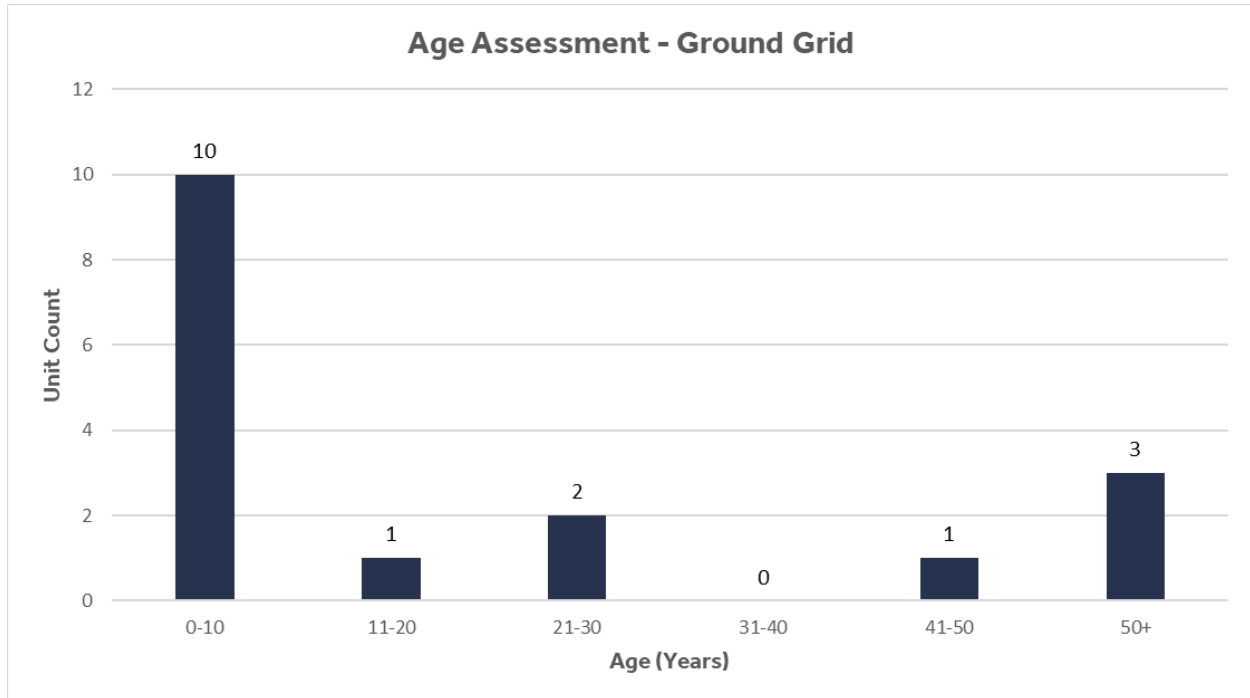
**Figure 4-28: Ground Grid Age Demographic**

NBHDL owns 17 stations within its service territory. The installation date is unknown for the total in-service population. An assumption is made to use the construction dates of the corresponding station to show an approximate representation of the age distribution. The extrapolated age results were not used as part of the Health Index calculation. Figure 4-28 presents the age distribution for ground grids.

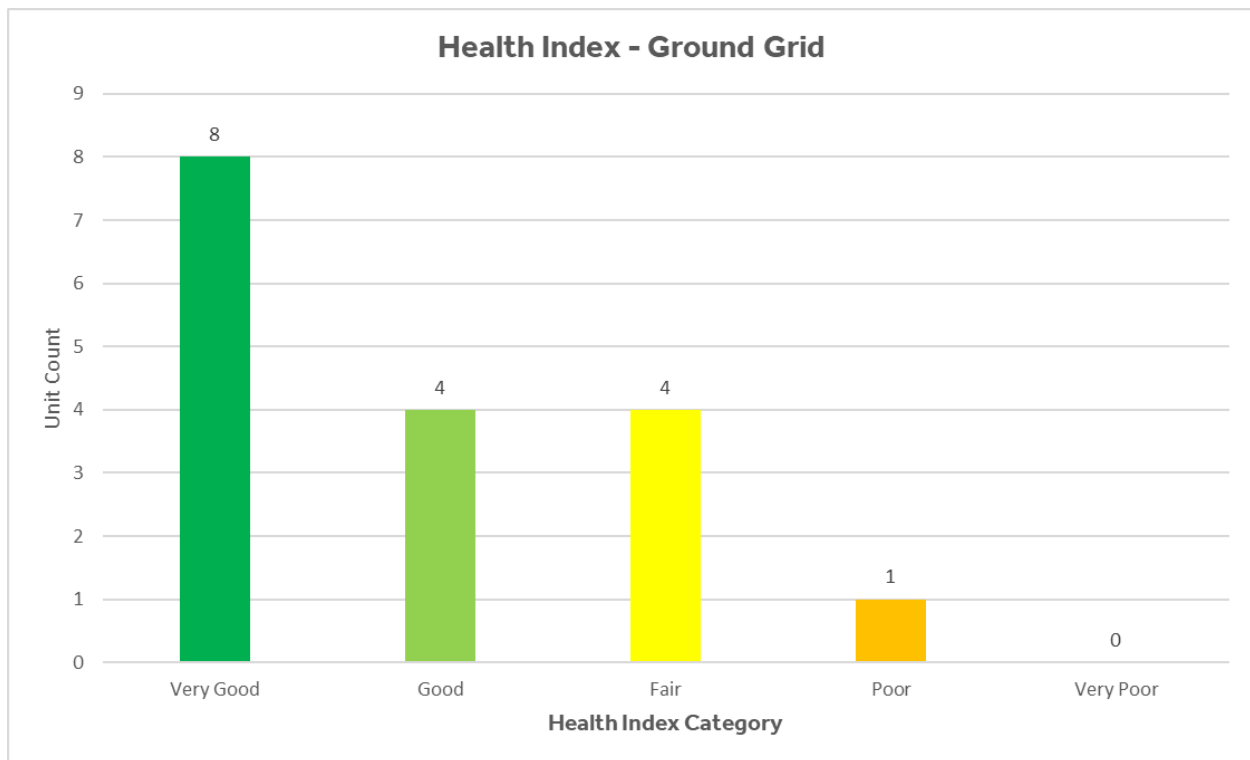
**Figure 4-29: Ground Grid Health Index Demographic**

NBHDL's most recent maintenance records were used to calculate the Health Index based on the criteria provided in Table 4-27. The Health Index values for ground grids were leveraged from the substation assessment<sup>4</sup> and are presented in Figure 4-29. The majority of the units are in Fair condition. The average Health Index for ground grids is 68%.

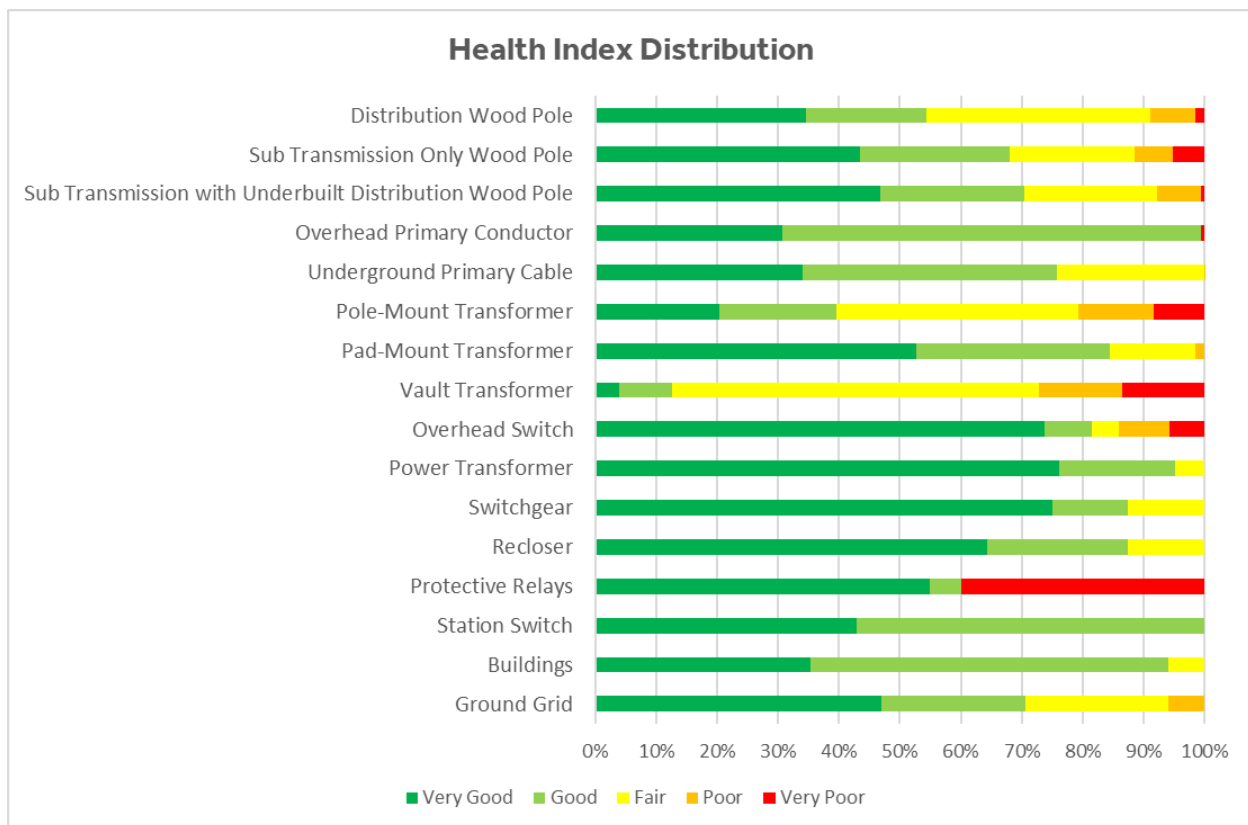
**Figure 6-1: Health Index Results**

As Figure 6-1 indicates, most assets across NBHDL asset classes analyzed are in Fair condition or better. This can indicate NBHDL has taken steps in the past to manage their asset health and performance for the benefit of its customers. As with every system, however, there are areas that require NBHDL's attention in the coming years where asset populations contain material portions of equipment in or approaching poor condition or worse.

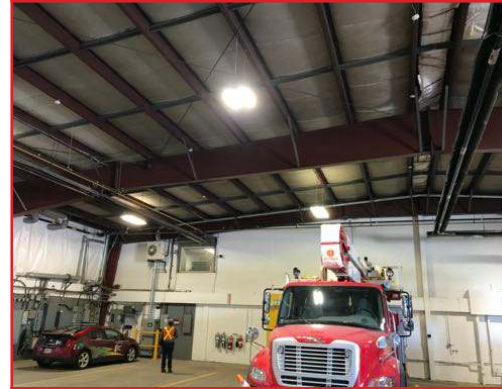
### Concrete Masonry - Original Building

A concrete masonry wall separates the eastern garage area from the western office space. No structural deficiencies were apparent. The 2013 BCR identified a crack in this wall but it was not observed during this inspection so it has either been repaired or is very minor in nature.

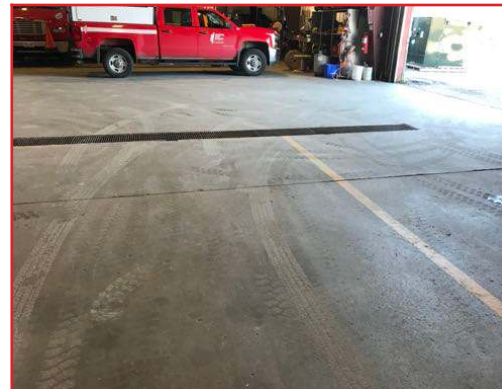
The concrete foundation is used as an unfinished floor for the vehicle storage area. Water runoff drains appear to have been integrated into the concrete slab as part of the original construction. No structural deficiencies were apparent.

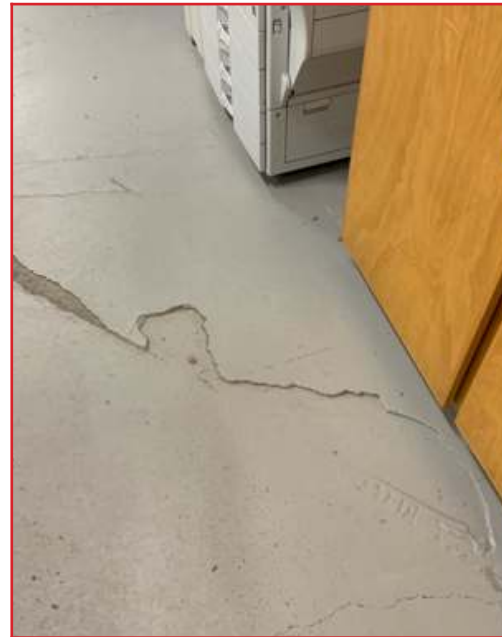
## Concrete Slab - Stores

The concrete foundation is used as a floor surface in the stores. The floor seems to have been re-levelled in the past and painted. The joints between the old and new cement were observed to have cracked and has even spalled in a few locations. Some cracked locations may be considered a tripping hazard.

A cost is included to repair the floor surface in the stores.

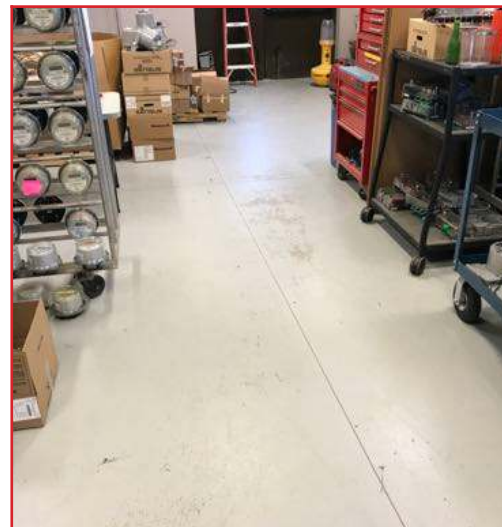
## Concrete Slab - Meter Shop

The concrete foundation is used as a floor surface in the meter shop. The floor appears to be in good condition.

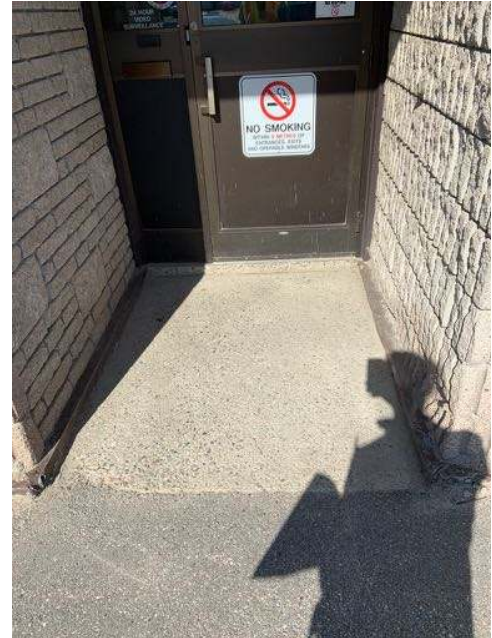
## Foundation Flashing - Addition on Southside

It appears that a base flashing has been applied over top of the protruding foundation wall in front of the split face block. While the intent of sill flashing is to shed water away from a wall the flashing has been applied in such a manner that it is horizontal from the wall. In some instances it slopes backwards to the wall. In addition the flashing has been damaged by vehicular wear and tear over time.

Repair base flashing. 45° slope over cant strip away from building.

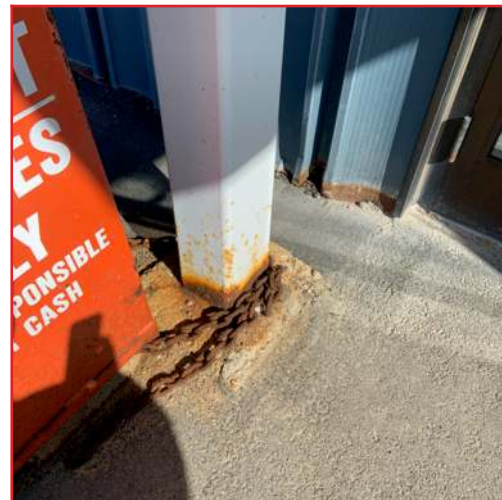
## Steel Columns & Footings - Visitor's Entrance

The small canopy above the visitor's entrance on the western side of the building is at least partially supported on two steel columns bearing on concrete footings. The bottom of the steel posts have begun to corrode noticeably. The top surface of the concrete footings were observed to have spalled along the edges.

A cost is included to refurbish the posts and install flashing to protect the footings.

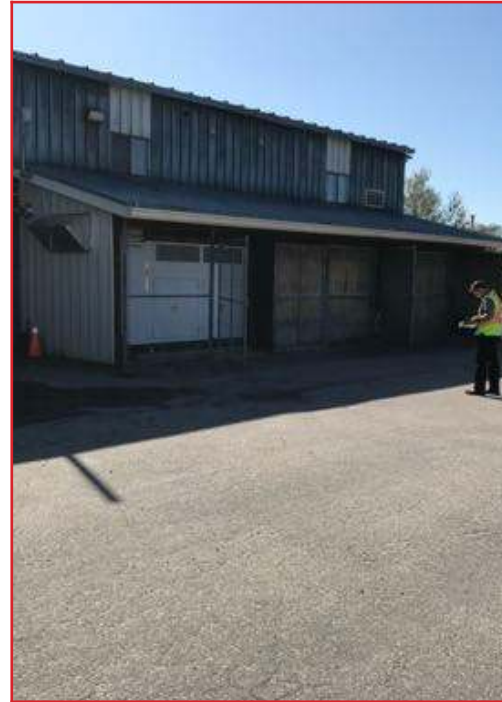
## Steel Structure - Rear Lean-to

There is a partially enclosed structure which is used to house the emergency generator, as well as store miscellaneous equipment on the north side of the building, which is attached to the original building. The structure appears to be of the prefabricated steel building type. Access to the interior of the space is restricted via locked chain-link fence gates. The steel frame appears unfinished and slightly corroded.

A cost is included for further inspection the Lean-To and replacement of its roof.

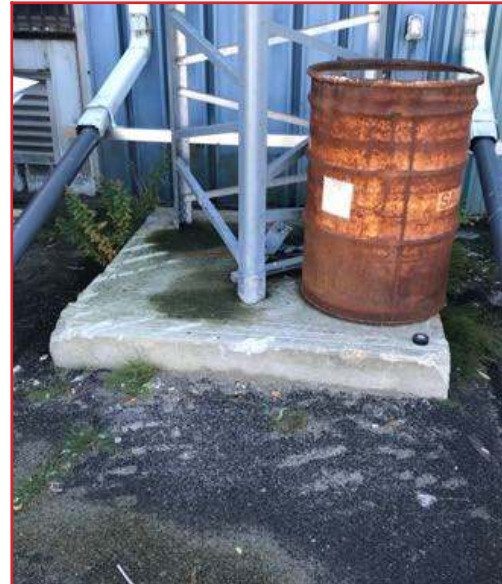
## Concrete Footing - Telecoms. Antenna

There is a small concrete footing used to anchor the telecommunications antenna at the rear of the building. The concrete appeared to be slightly deteriorated.

A cost is included to repair the concrete footing.

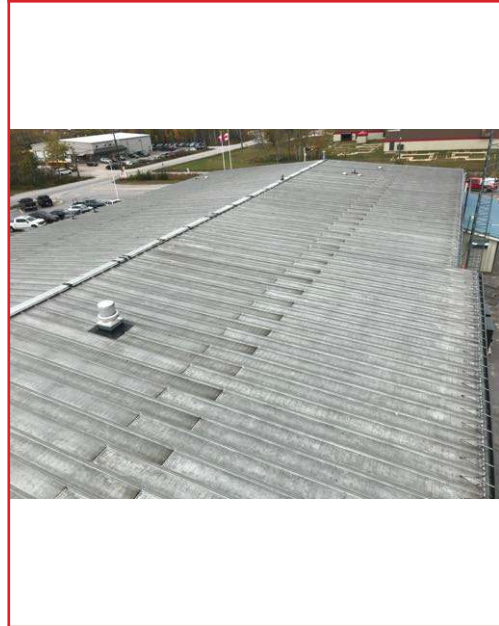
### Main Building Roof - Exterior

The main building roof (~ 18,000 ft<sup>2</sup>) is constructed of a 24 gauge (0.022" thick) metal roof which appears to be galvanized steel. The roof appears to be original to the building and is in generally good condition with a potential remaining life of 15 - 20 years. Fasteners and peak flashings have been sealed with caulking and this caulking is failing.

Fasteners under caulking have dried out or missing washers and should be replaced. Eavestroughs along the north and south sides appear to be in good condition although there are signs of rust on the underside of the eaves. A maintenance cost for this roof is included.

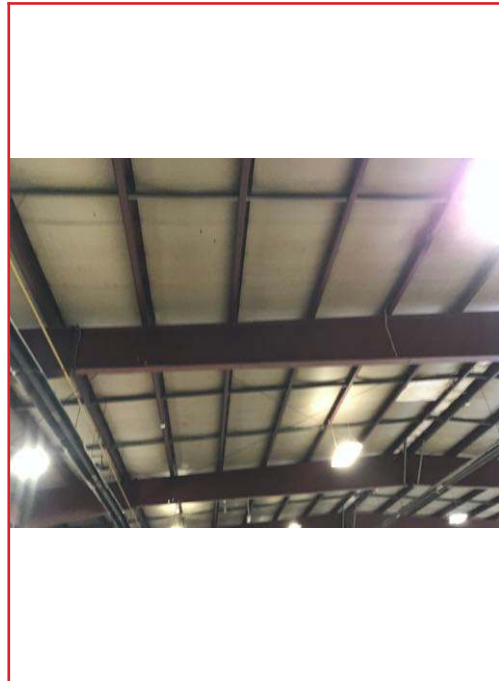
### Main Building Roof - Interior Insulation

The interior of the main building roof appears to be original to the building. Anecdotally, there does not appear to be an ongoing issue with routine roof leaking. Some evidence of water infiltration into roof insulation was noticed. See the attached roof thermography report for further information. Insulation appears to be 4" ± bag insulation with an estimated insulation value of <R8.

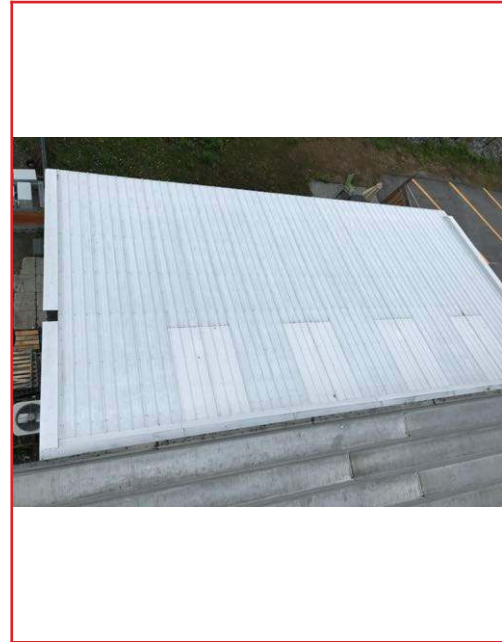
## Meter Shop Roof

The meter shop roof (~ 1,600 ft<sup>2</sup>) is constructed of what appears to be 26 gauge (0.018" thick) steel with an anodized finish and is in generally good condition. Some evidence of previous roof modifications or repairs exists. Neoprene washers are dried out or missing.

Fasteners should be replaced. An eave flashing appears to have slipped leaving an unprotected opening and this issue should be corrected forthwith.

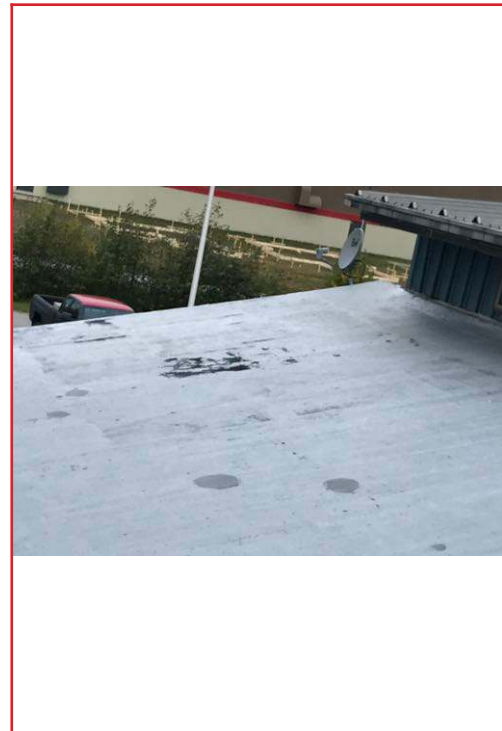
## Addition on Southside - Roof

The south office roof (~ 2,400 ft<sup>2</sup>) appears to be constructed of a non-typical modified bitumen material with a subsequent coating addition. The roof appears to have had relatively extensive patching and thermography indicates that there is water infiltration into the roofing system.

The south office roof should be replaced within the next five (5) years and a replacement cost is included. Further information can be found in the roof thermography report presented within appendices.

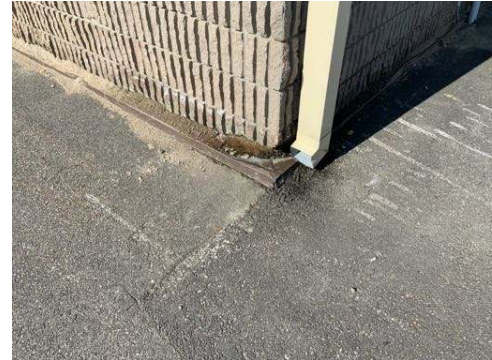
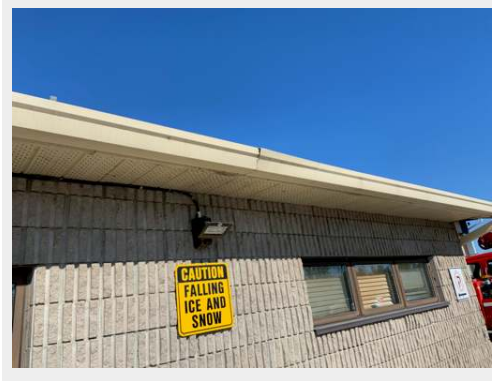
## Addition on Southside - Eaves Trough, Downspout and Soffit/Fascia

The eaves trough on the south-side of the building is damaged and the down spout discharges next to the split masonry wall causing erosion.

Repair eaves trough and review options to redirect downspout. Install snow retention chevrons to reduce risk of ongoing damage to eaves trough.

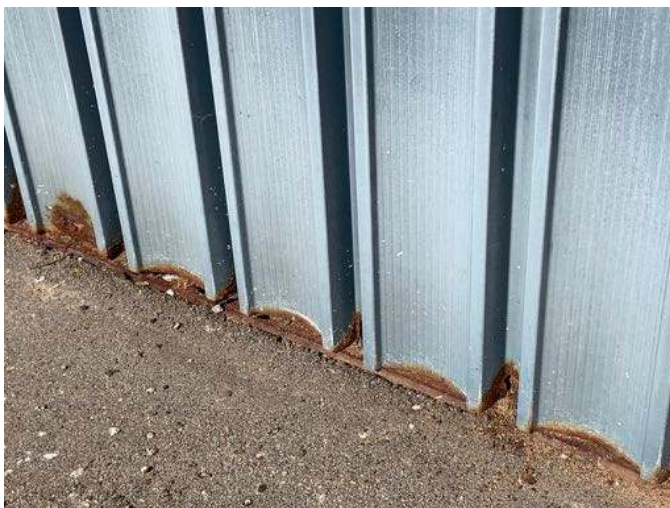
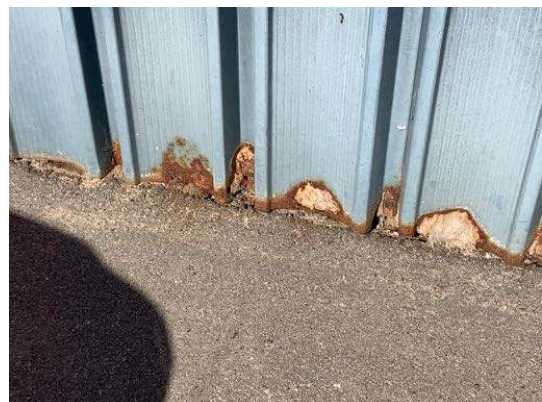
## Main Building - Metal Siding

The majority of the existing building including the additions is generally metal siding. The siding has somewhat faded in colour over time but is still intact. It appears in fair condition except for the condition at the base of the wall panels. The base drip flashing is directly at grade where asphalt abuts the building. Best practices usually dictates grade is 8 to 10" below base drip line. The as-built condition has led to major rusting and corrosion of the bottom of the metal panels. This condition exists over at least 45% to 50% of the exterior wall. As corrosion continues it will impact the integrity of the entire wall panel which rests on the foundation. As well, it will allow moisture to migrate through the wall at the base. Painting the walls will bring back colour but not arrest corrosion. More invasive work will be required. In several instances these panels have random holes which have been abandoned and left open. They require attention and patching. Unprotected corners at metal siding have also been damaged from vehicular or heavy object movement. In some instances damage is just visual, in others it has penetrated siding. At the main entrance, asphalt has been graded to ramp to door sill. In turn, it covers base sill metal flashing.

Repairs or replacement are required to ensure more severe long term damage does not continue. Asphalt perimeter parking lot could be altered to assist in protecting metal siding. (See 1.2 regarding French drain).

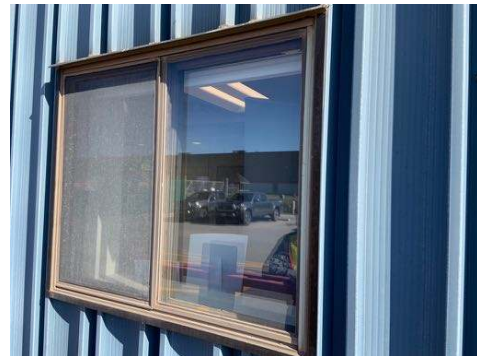
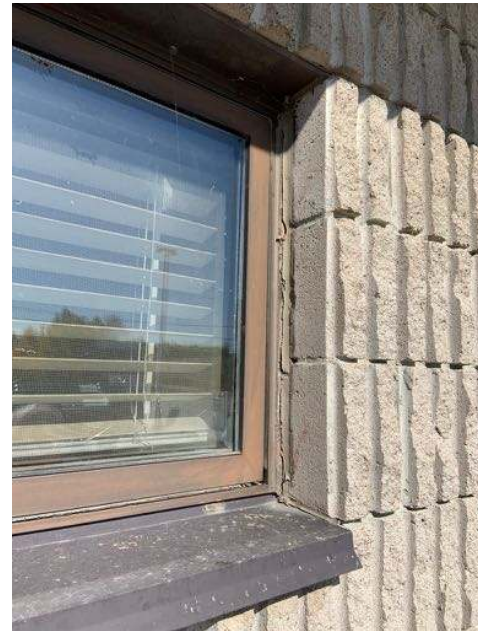
In general, the windows and personnel doors throughout the facility appear to be of original construction relative to the section of the building they are installed in. A thermographic inspection was completed of the exterior of the building and this can be found as an appendices to this report. This report identifies a variety of deficiencies that need to be addressed. The caulking around windows and doors and other building penetrations was found to be failing in a number of locations.

Consider replacement of windows based on their age and results of the thermographic inspection. Also ensure that the sealing elements on windows and doors receive routine maintenance. Review flashing on windows to ensure that it is sloped appropriately to shed water. Review and repair damaged caulking associated with all windows, doors and other wall penetrations.

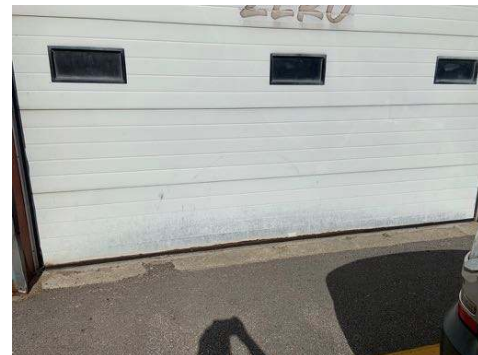
## Garage Doors

In 2014, two garage doors were replaced. The last Architectural Building Condition Assessment (2013) recommended all be replaced. The lifespan of the new overhead garage door with moderate usage is anticipated to be 20 years.

Replace doors as condition warrants. Service seals to improve energy performance.

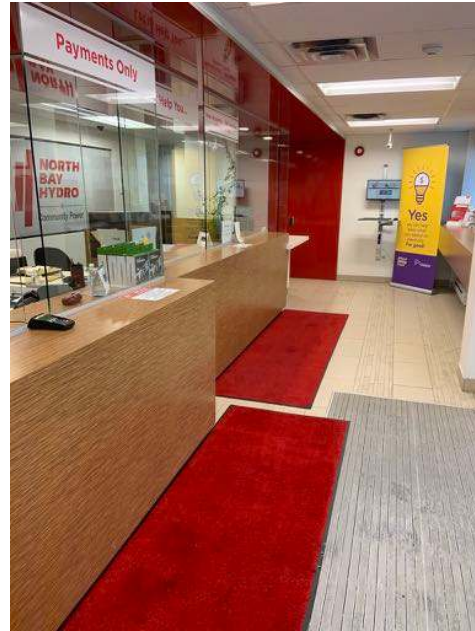
### Millwork

Millwork remains in generally reasonable condition having been replaced 10 to 11 years before. Original millwork with heavy usage would probably have a life span of another 4-5 years, light usage could extend life span. The millwork in the washroom areas including washroom accessories have been upgraded. These items are at the beginning of their life cycle and have another 15-18 years.

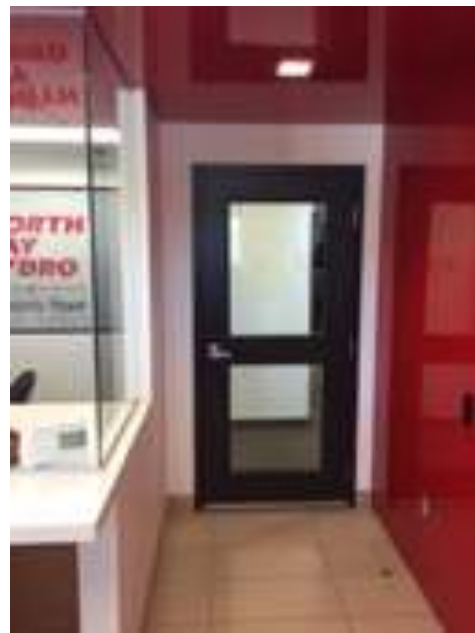
### Interior Doors - All Sections

Interior doors are mostly hollow metal construction on the ground floor and are in good shape. With proper care and maintenance, life expectancy is unlimited. The 2nd floor office area consists of hollow metal frames with hollow core wood doors, which have been recently installed and painted and should last beyond the replacement program.
