# **EXHIBIT 2:**

# **RATE BASE**

# Distribution System Plan

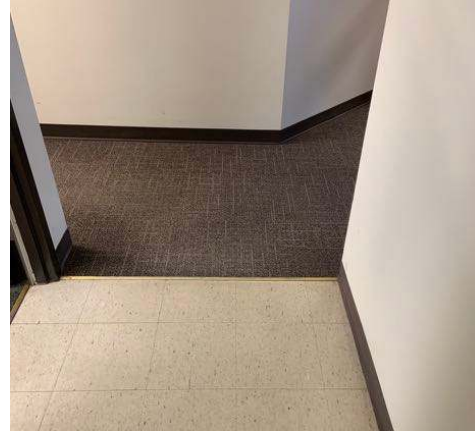
## Flooring - All Sections

1. Office Area 1st Floor - Carpet tile, select areas of vinyl tile and ceramic tile within the main entrance area.
2. Office area Upstairs – Carpet tile with select areas of vinyl tile.
3. Front Addition (South) – Vinyl tile with area of original ceramic tile.
4. The flooring in the change rooms and washroom areas have not been changed and upgraded. The existing tile flooring appears in reasonable condition.

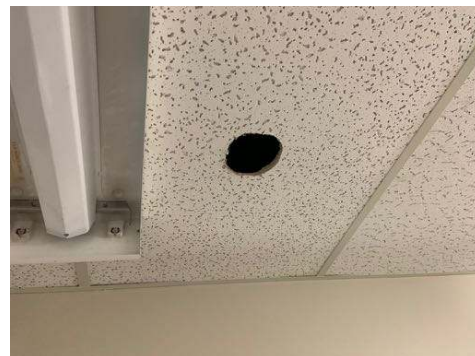
## Ceilings - Main Building (1st and 2nd Floor)

Within the offices there are minor areas of ceilings which are surfaced with gypsum board, including some bulkheads, vestibule ceilings and main entrance areas. The remainder of the office area is T-bar type ceiling. T-bar ceiling with proper building conditions will last indefinitely; the only reason for replacement would be damage from some event or aesthetic replacement.

It was observed level 100 T-bar ceiling is in good condition. The T-bar ceiling on level 200 exhibits some damage and water staining.

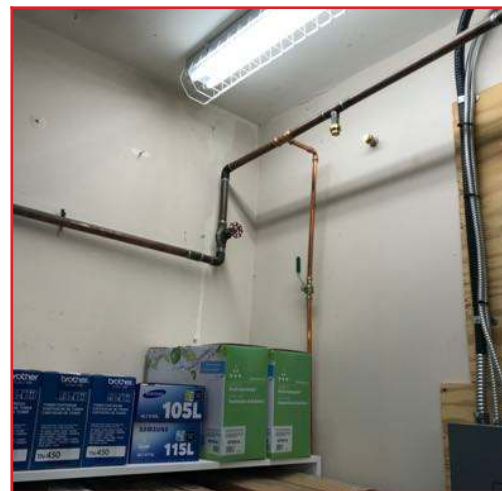
Based on the visible piping in the mechanical room, as well as those entering or exiting hot water heating tanks, the piping is typically of copper material. Hot water pipe typically requires more frequent maintenance than cold water pipes. Neither the cold or hot water piping appears to be insulated, and it is expected that the majority of the piping is of the same age as the building.

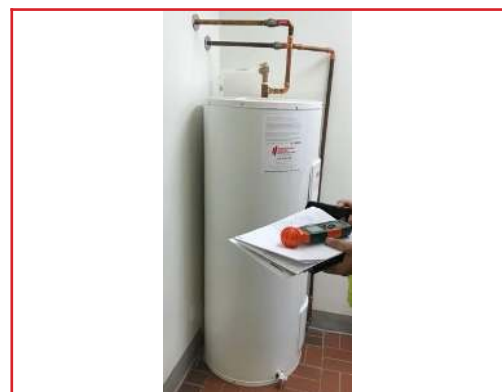
## Hot Water Tank - 1st Floor (Change Area)

There is a 74 gal<sub>us</sub> electric-powered hot water tank that serves the men's and women's washrooms in the change area addition. Model 172E-3F7M-CC, serial# A 9189195, 4500 W, 18.75 A, 240 VAC, 1-PH, 60 Hz. The tank appears to be in good condition and was installed in February 2019.

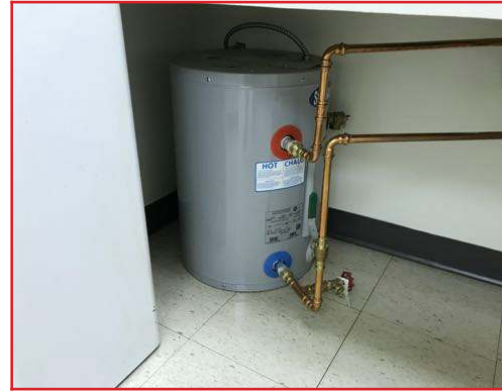
## Hot Water Tank - 1st Floor (Offices)

There is a 12 gal<sub>us</sub> electric-powered hot water tank that serves the office area washroom sinks. Model SS12SEB15, serial#1407J007170, 1500 W, 120 VAC. The tank appears to be in good condition and is roughly 5 years old.

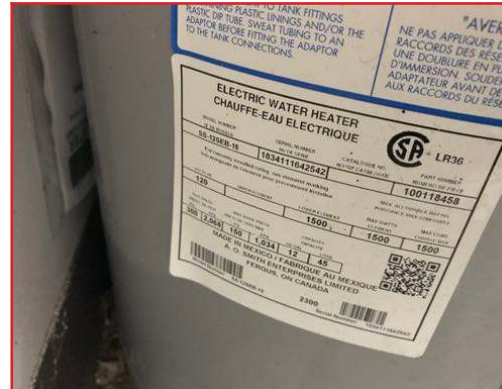
## Hot Water Tank - 2nd Floor (Offices)

There is a 12 gal<sub>us</sub> electric-powered hot water tank that serves the office area washroom sinks. Model SS-12SEB-15, serial#1834111642542, 1500 W, 120 VAC. The tank appears to be in good condition and is only approximately a year old.

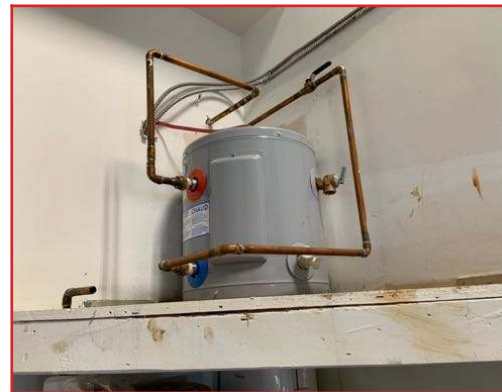
## Hot Water Tank - Stores

There is a 6 gal<sub>us</sub> electric-powered hot water tank that serves the stores area. Model SS06SEB015, serial#1544J007269, 1500 W, 120 VAC. The tank appears to be in good condition and is approximately four years old.

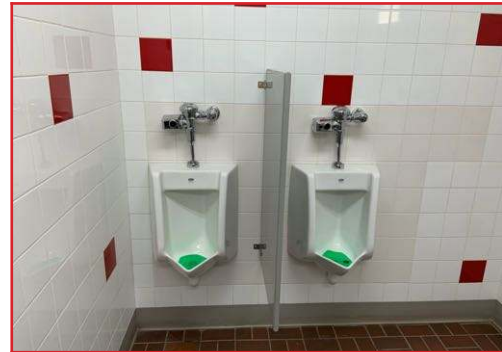
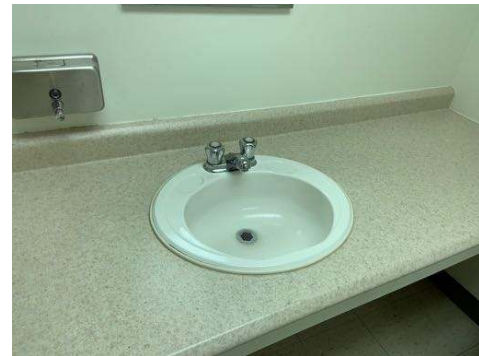
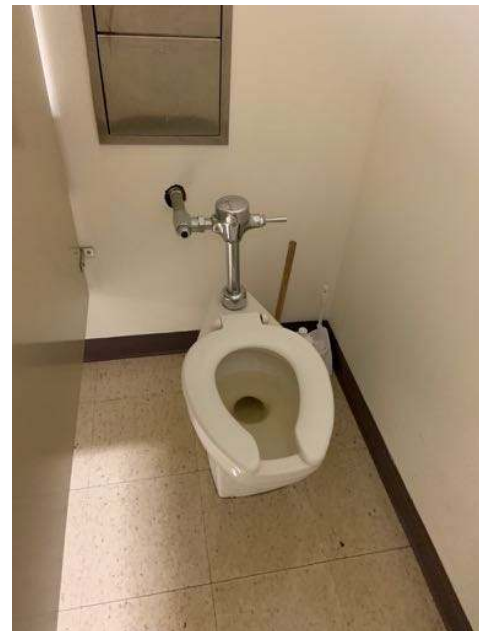
## 5.1.2 Plumbing Fixtures

Fixtures throughout the facility are of various ages but generally in good condition. Many of the fixtures have standard flow faucets/flush valves. Low flow fixtures should be considered when renovations are completed in the future as per the washrooms in the Addition on Southside.

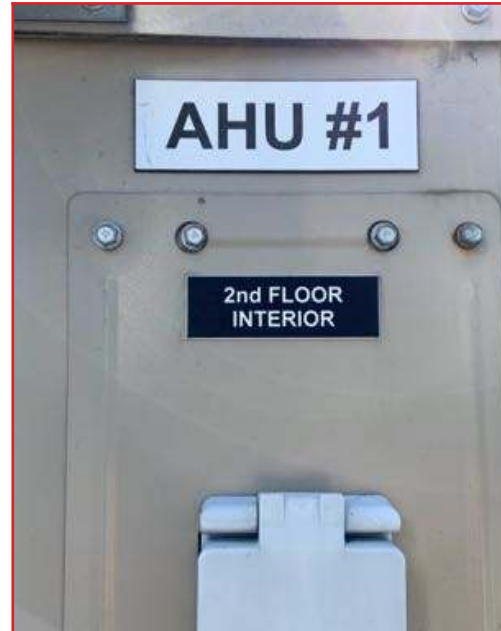
#### Air Handling Unit - #1

The second floor 'interior' area of the main building is climate controlled via a Lennox air handling unit, model LGH048S4TH2Y, serial# 5613L07130, gas-fired heating capacity 120 MBH at 80% efficiency, 49 MBH cooling capacity, SEER: 15, EER: 12.5. The unit is 6 years old and appears to be in good condition. The air intake screens were observed to be obstructed by dust and debris as well as slightly damaged and should be cleaned and repaired as part of routine maintenance.

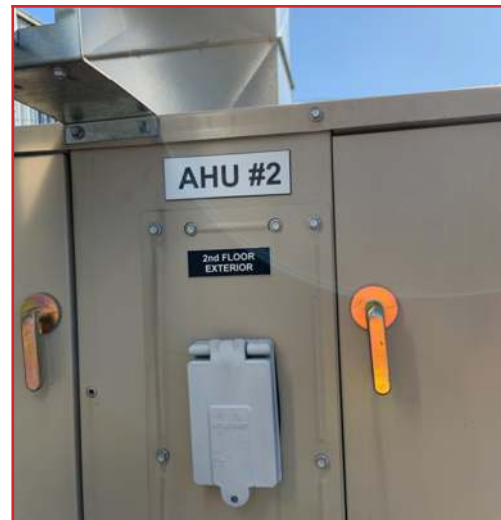
#### Air Handling Unit - #2

The second floor 'exterior' area of the main building is climate controlled via a Lennox air handling unit, model LGH036S4TU2Y, serial# 5613L07128, gas-fired heating capacity 84 MBH at 80% efficiency, 34.8 MBH cooling capacity, SEER: 15, EER: 11.6. The unit is 6 years old and appears to be in good condition. The air intake screens were observed to be obstructed by dust and debris as well as slightly damaged and should be cleaned and repaired as part of routine maintenance.

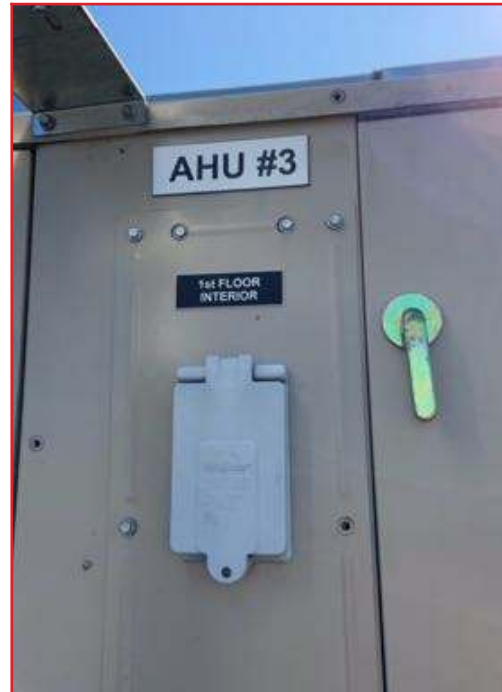
## Air Handling Unit - #3

The first floor 'interior' area of the main building is climate controlled via a Lennox air handling unit, model LGH060S4TH2Y, serial# 5613L07127, gas-fired heating capacity 120 MBH at 80% efficiency, 60 MBH cooling capacity, SEER: 15.5, EER: 12.5. The unit is 6 years old and appears to be in good condition. The CO2 levels in the area served by AHU#3 were observed to be in excess of 1000 ppm in a number of areas. The recommended maximum for CO2 is 800 ppm. The level had dropped to less than 600 ppm when the area was resurveyed a short time later.

Investigate system operation to confirm cause of elevated CO2 levels. A cost is included for the replacement of the AHU at the appropriate time.

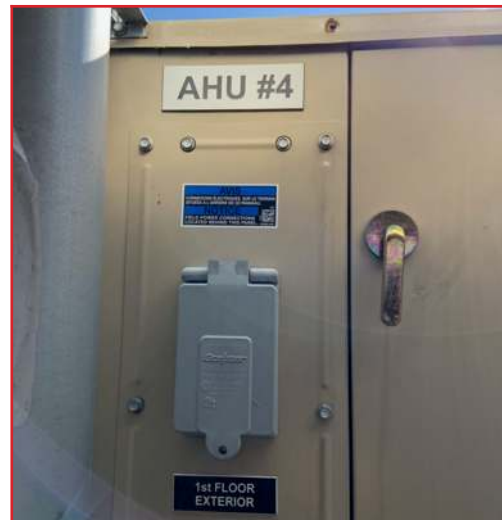
## Air Handling Unit - #4

The first floor 'exterior' area of the main building is climate controlled via a Lennox air handling unit, model LGH072H4BH2Y, serial# 5613L07129, gas-fired heating capacity 120 MBH at 80% efficiency, 60 MBH cooling capacity, EER: 12. The unit is 6 years old and appears to be in good condition. The air intake screens were observed to be obstructed by dust and debris as well as slightly damaged and should be cleaned and repaired as part of routine maintenance.

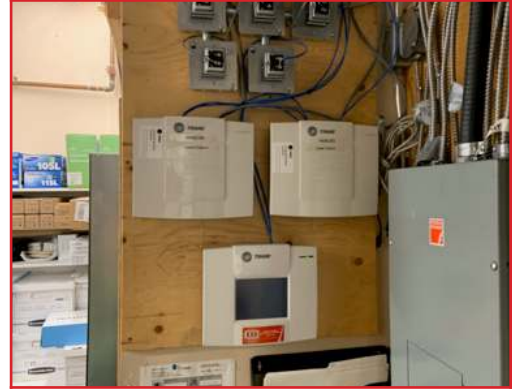
## HVAC Control Panels - Mechanical Room (AHU #3 & #4)

Control modules for AHU #3 and #4 are installed on the first floor in the mechanical room of the main building. Similar units for AHU #1 and AHU#2 are installed on the second floor. These units are 6 years old and appear to be in good condition.

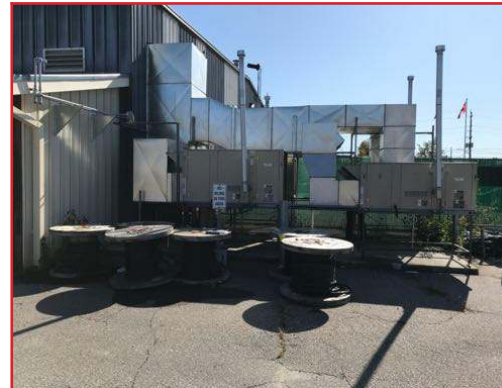
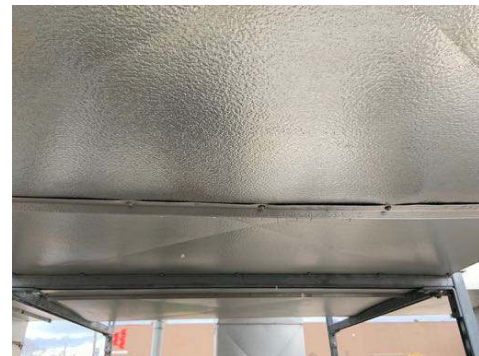
## Ducting - Main Building Exterior

Air handlers #1 through #4 are connected to the building using **insulated** rectangular galvanized steel ducting supported by pre-fabricated galvanized steel component frames. The exterior ducting assembly appears to be in generally good condition. Water was observed leaking from the duct work enclosure well after the last rain event so it appears the duct work is leaking and retaining water.

Investigate duct work to identify source of water ingress.

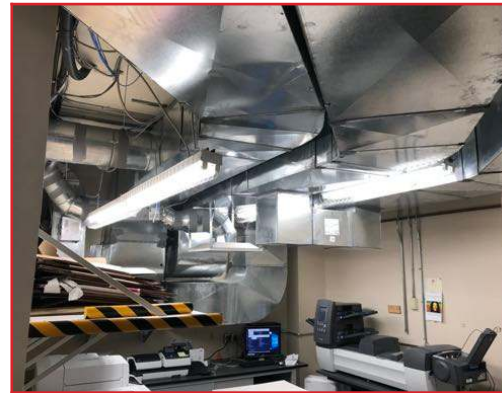
## Ducting - Main Building Interior

Air handlers #1 through #4 are ducted through the building using rectangular galvanized steel ducting through the ceiling space. The visible portion of the ducting appears to have been replaced 6 years ago at the same time that the AHUs were replaced in 2013. Duct work through major parts of the building was modified during the retrofit in 2013 so we are assuming any problem areas were rectified so the duct work is assumed to be in good condition.

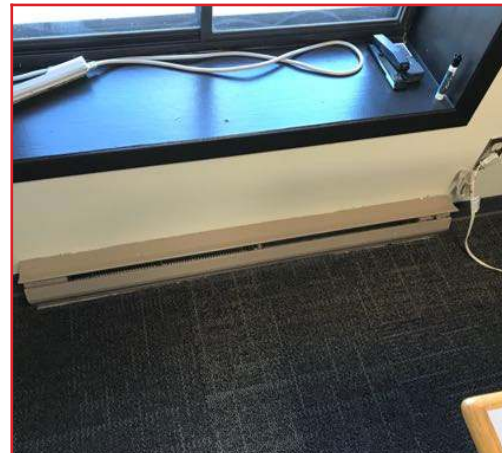
## Baseboard Heaters

Baseboard heaters are utilized in a number of areas throughout the building for supplementary heaters. A number of these are located below exterior windows in the offices and are coupled with the forced-air climate control system to avoid overlap between heating and cooling modes. The heaters appear to be generally in fair condition and the same age as the part of the building they are in.

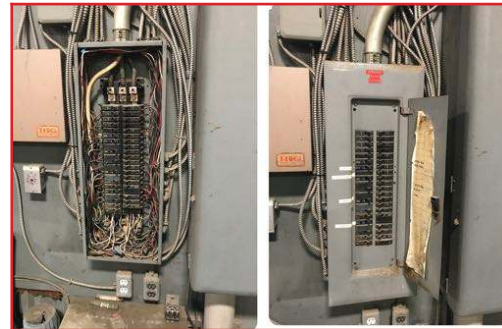
## Southside Addition Panel

This Commander brand distribution panel appears to be a 200 amp 3 phase panel with no available stabs. The breaker labelled 'Clothes Dryer Heating' was overloaded at the time of inspection and the overload condition should be addressed by a qualified electrician forthwith. The panel appears to be in fair condition loaded at 13/12/31 at time of testing.

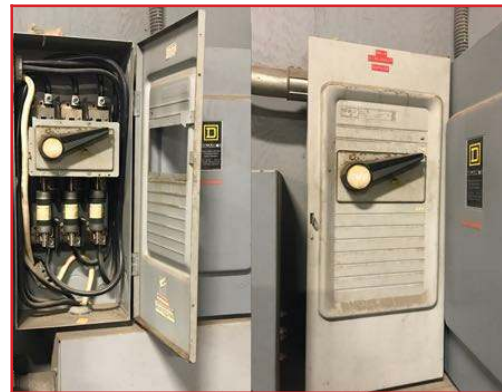
## Outside Storage Building Disconnect (Cold Storage)

This 200 Amp rated Square D disconnect is wired for single phase and is equipped with 125 Amp fuses. The disconnect appears to be in good condition.

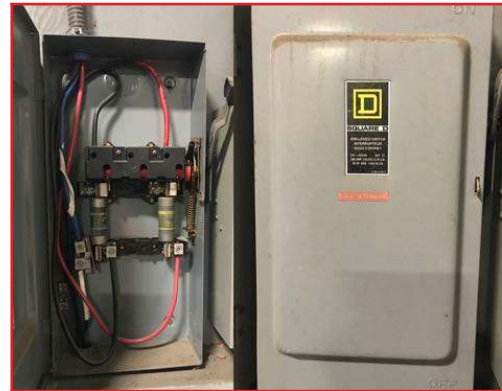
## Southside Addition Disconnect

This Federal Pioneer, 200 Amp rated disconnect employs 150 Amp fuses. A minor issue is suspected on the load side connection of the 'A' phase and should be investigated by a qualified professional. The disconnect appears to be in fair condition.

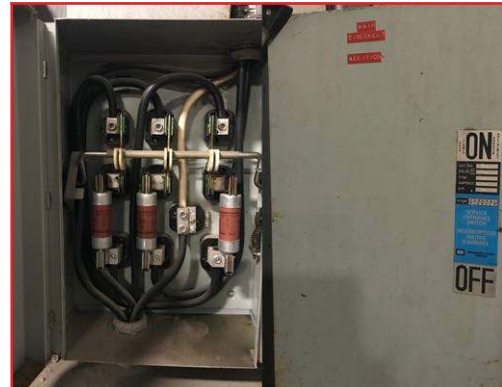
## Main Building (Substation Workshop) Disconnect

This Federal Pioneer Switchmatic disconnect is 100 Amp rated and utilizes 100 Amp fuses. The disconnect is prone to dirt and moisture ingress due to an open punch out on the top of the panel. The panel appears to be in fair condition.

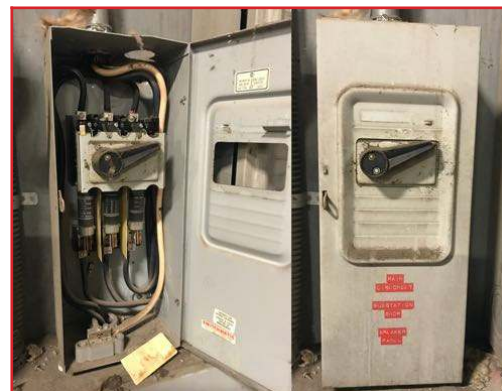
## Main Building (Boardroom) Disconnect

This Federal Pioneer Switchmatic disconnect is rated for 200 Amps and utilizes 200 Amp fuses. A minor issue is suspected on the load side connection of the 'B' phase and should be investigated by a qualified professional. The panel appears to be in fair condition.

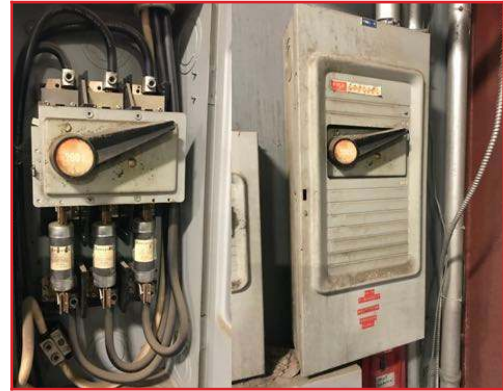
## Main Building Mezzanine Disconnect Splitter Panel

This 200 Amp rated Federal Pioneer Amalgamated Electric disconnect utilizes a 150 Amp fuses for the 'A' and 'B' phase, and a 200 Amp fuse for the 'C' phase. The panel appears to be in fair condition.

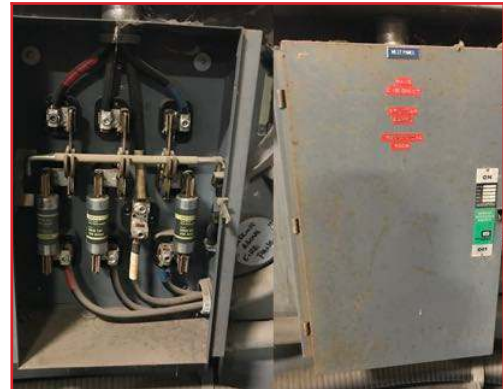
## Main Building (Stores) Disconnect

This 200 Amp rated Federal Pioneer Amalgamated Electric Products disconnect 200 amp fuses. Although the switch was in the closed position, knives were barely engaged; this condition should be corrected immediately to prevent the risk of excessive heating. The disconnect appears to be in poor condition and must be repaired or replaced forthwith.

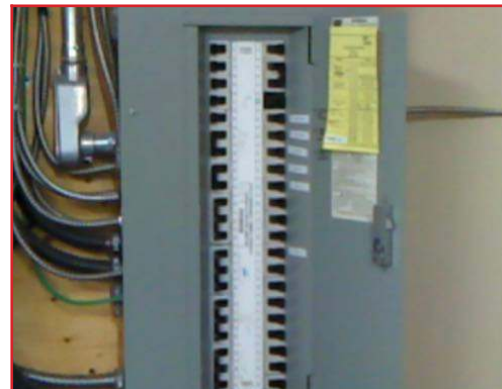
## Main Building (Printer Room) Distribution Panel

The Federal Pioneer panel is rated for 225 Amps. Breaker #2 was observed to be overloaded with 18 amps at time of testing, and should be inspected by a qualified professional. The panel appears to be in otherwise good condition.

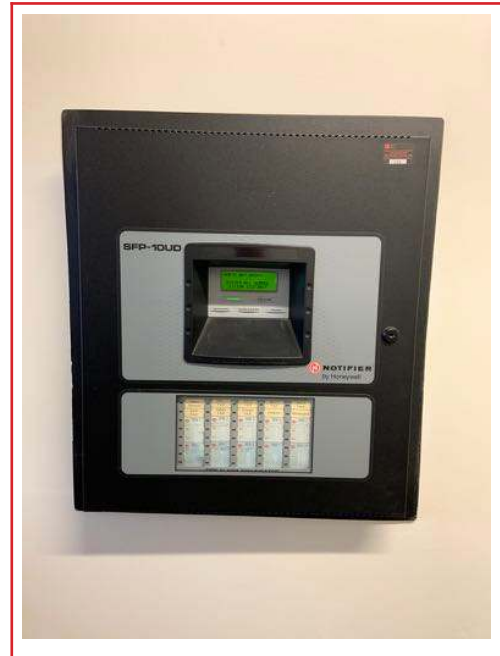
The existing fire alarm control panel is a Honeywell Notifier series Model SFP-10UD, located in the Southside Addition entrance vestibule. The system is a ten zone conventional fire panel system that is in generally good condition however the age of the system could not be determined. These systems can be maintained until parts are no longer available or a new system is required due to capacity requirements.

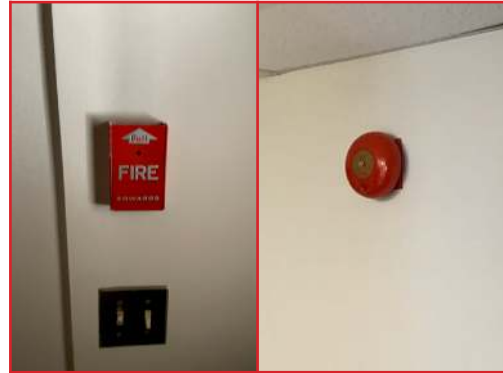
## Fire Alarm Bells & Pull Stations - Across the Facility

Pull stations and alarm bells across the facility appear to range in age and condition relative to the part of the building in which they are installed. These devices are critical life safety elements and as such are tested on a routine basis. With this in mind these devices would only be updated upon failure or when they can no longer be serviced as spare parts are not available.

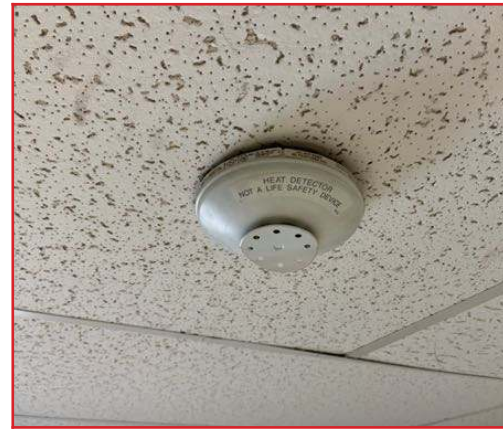
## Heat Detectors - Across the Facility

The heat detectors across the facility appear to range in age and condition relative to the part of the building in which they are installed. A majority of the heat detectors on the main level of the office space appear to have been upgraded during the renovations in 2011. These devices are critical life safety elements and as such are tested on a routine basis. With this in mind these devices would only be updated upon failure or when they can no longer be serviced or spare parts are not available.

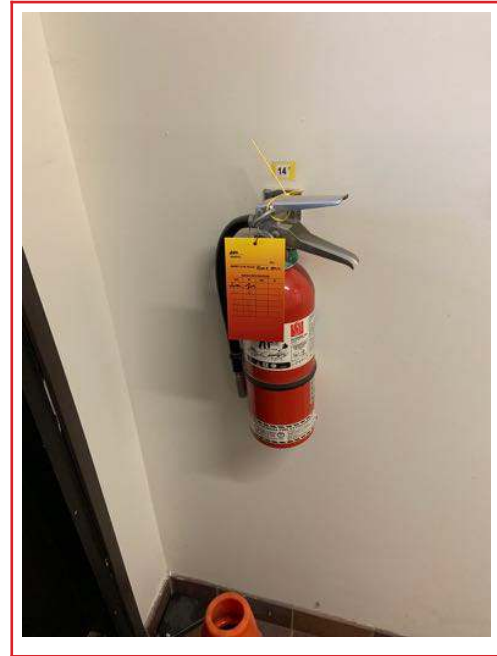
## Fire Extinguishers - Across the Facility

There are numerous fire extinguishers distributed across the facility. These extinguishers are well maintained and from the inspection tags checked on a monthly basis.

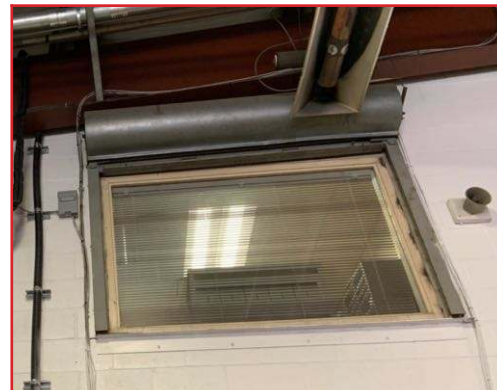
## Fire Shutter - Vehicle Storage

There is a fire shutter installed on the only window between the main building second-floor offices and the vehicle storage area. The shutter is designed to provide a fire-retarding barrier at the opening in the event of a fire in the vehicle storage area. The shutter appears to be in fair condition. This unit should be tested as part of the routine maintenance of the fire alarm system.

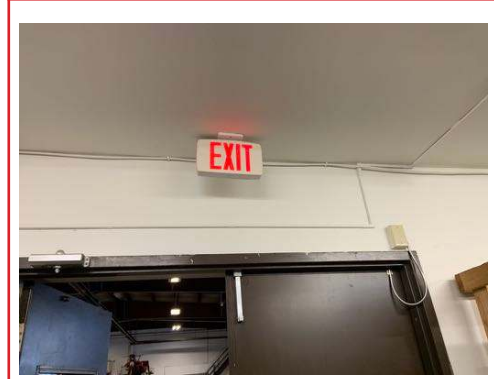
### Exit Signs - Throughout Facility

There are a variety of exit signs throughout the campus. These signs are in fair condition.

It is recommended that all older non-LED type exit signs be upgraded to new to reduce maintenance cost and down time but this will also reduce energy consumption.

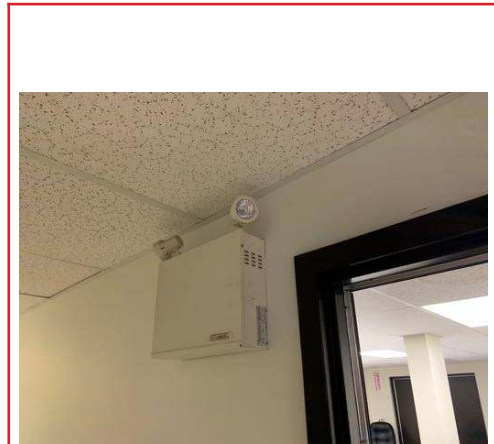
### Emergency Lighting - Throughout Facility

There is a variety of emergency lighting configurations throughout the campus. These lights are in fair to good condition.

We recommend that a review of emergency lighting systems be completed to ensure that proper coverage is maintained/achieved throughout the facility. It is recommended that all emergency lighting battery packs be tested annually to determine which units require maintenance/replacement.

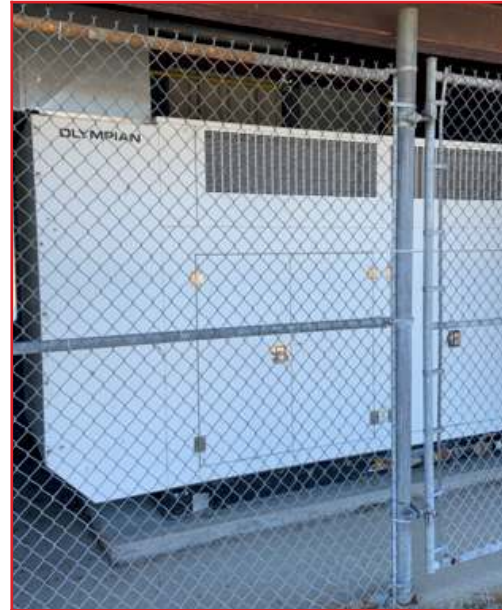
## Emergency Power - Natural Gas Generator

There is a natural gas powered emergency generator located in a lean-to at the rear of the main building: Olympian, model G150LG2, serial# \*GXC03179, production date 08/19/14, 150 kW capacity, 188 kVA, 0.80 power factor. The generator is powered by a 231 hp natural gas engine: Generac, EGNXB06.82C3, production date 08/19/14. The system is 5 years old and appears to be in good condition. A maintenance plan is reportedly in place and carried out by the supplier of the generator.

A cost is included for the replacement of the generator.

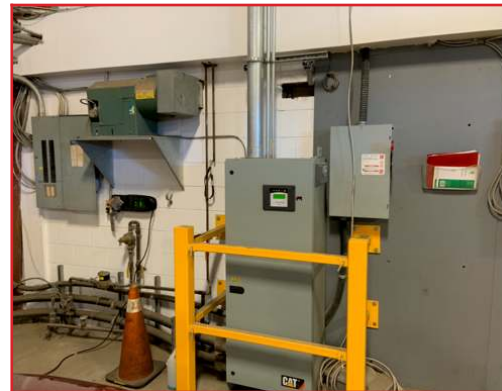
## Emergency Power - Switch Gear

The emergency power generator is connected to the electrical distribution of the building via a switchgear located in the vehicle storage area. The switchgear appears to be in good condition.

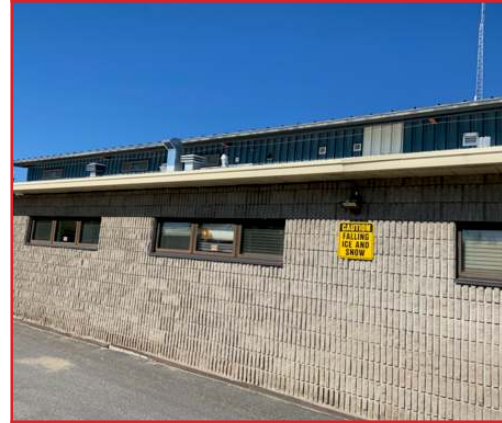
There is a fall-arrest lifeline installed on the south side of the building above the linemen and lunch room addition, presumably to facilitate maintenance on the lower roof. The condition of the system is unknown.

The system should be reviewed to ensure that it meets the requirements for fall-arrest anchors as per applicable working at heights standards and regulations.

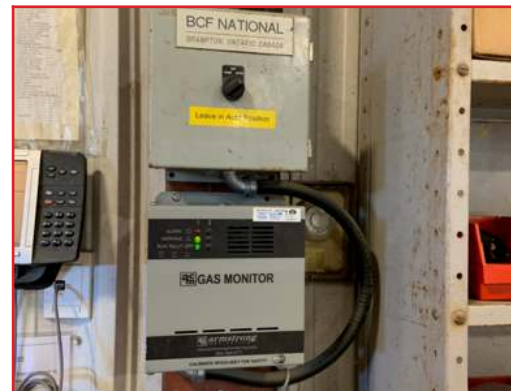
### C02/N2 Detector - Main Building (Vehicle Storage)

The C02/N2 detector located in the vehicle storage area has been upgraded since the last BCA was completed in 2013.

Ensure maintenance is completed as per manufactures recommendations.

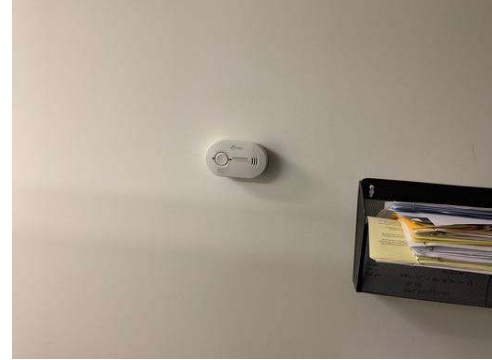
## C02 Detector - Various Locations

There are C02 detectors located in various locations throughout the Southside Addition and the Office areas on the first and second floor. These units are in good condition but given they are battery powered they should be tested annually and the batteries replaced twice a year. Kidde the manufacturer of the units currently installed has noted a 10 year useful life for this model. A label should be added to the unit to note when the battery was last changed.

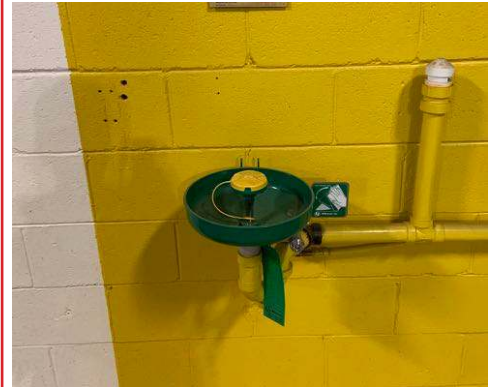
## Eye Wash Station - Main Building (Vehicle Storage)

There is an eyewash station located next to the fire extinguishers in the vehicle storage area. The eyewash station is connected to a cold water line rather than a tempered water line, which does not meet the requirements of applicable safety standards.

A cost is included to install piping to tempered water line. These units should be inspected annually and operated on a routine basis to ensure they provide the required volume and temperature of water and to ensure they are free of contaminants.

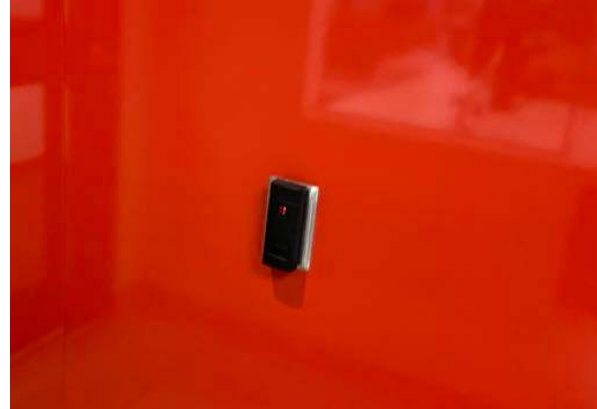
### Access Control - Campus Wide

Access control is provided primarily via a key card system that appears to be in good condition. These systems are typically run until failure. Since these systems are computer based they can become obsolete as manufactures no longer support a certain product line.

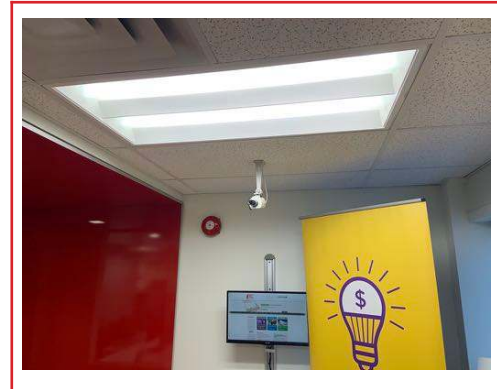
### CCTV - Campus Wide

The property is monitored by numerous CCTV camera's around the property and also within the building in key locations. These camera's are recorded on a digital recording system. The entire system appears to be in good condition. These systems are typically run until failure. Since these systems are computer based they can become obsolete as manufactures no longer support a certain product line.

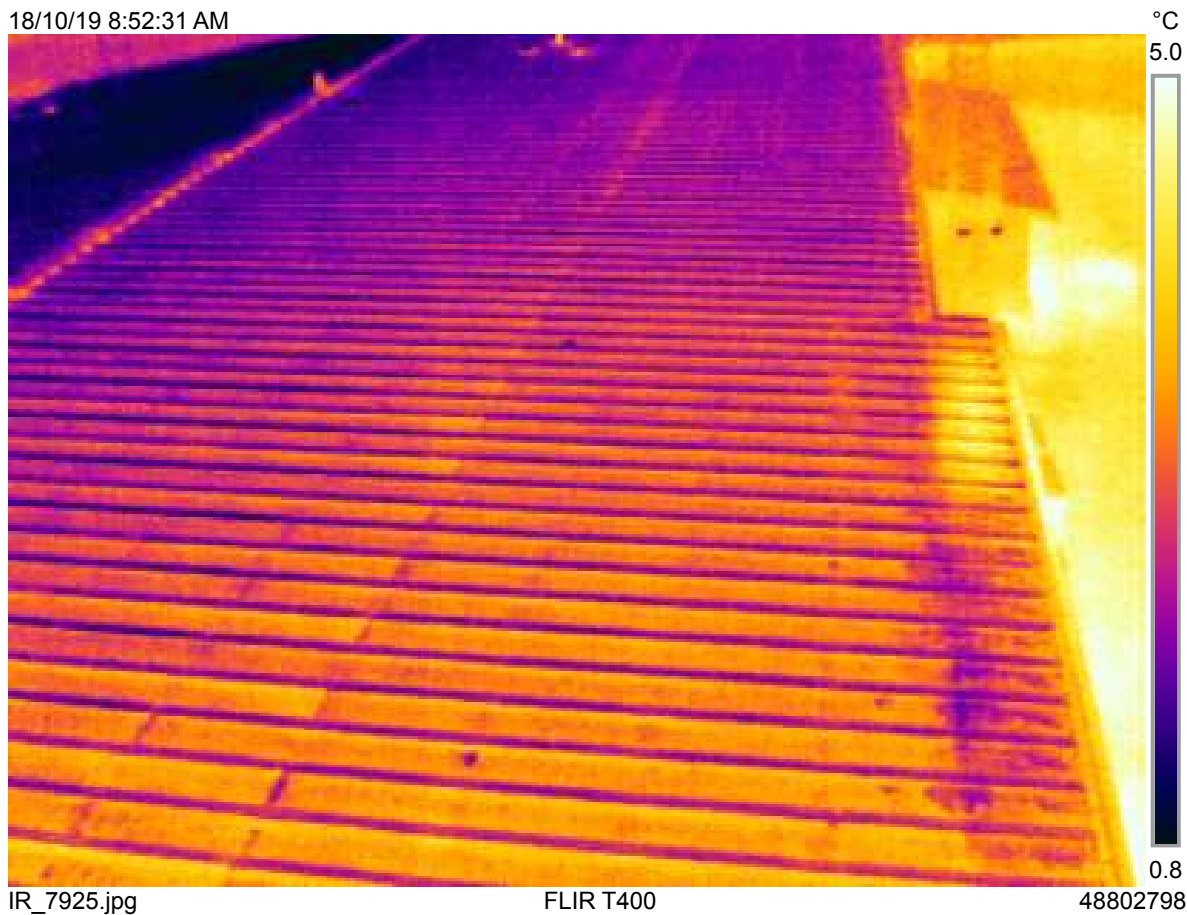
East end roof showing peak vent and various vents. No significant issues noted

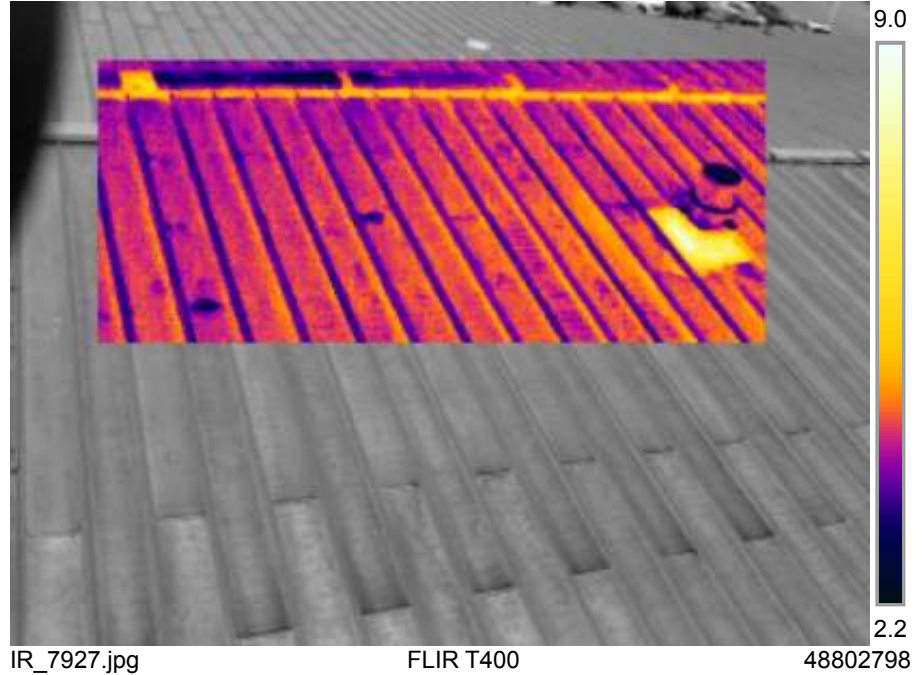
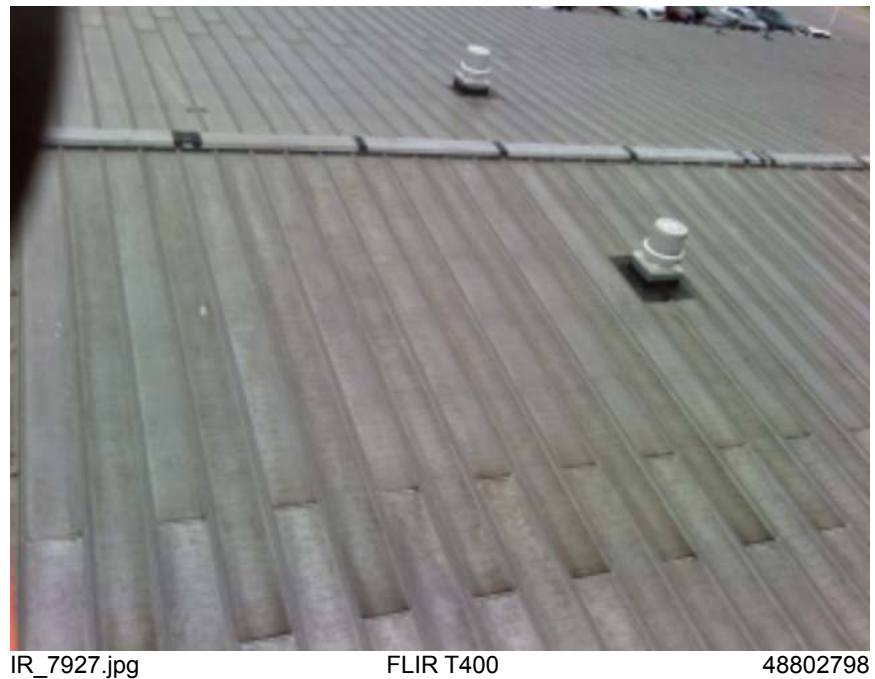
Connection between shop and stores roof. Notice significant heat leakage from vertical connection. Warm circles may be ceiling lights in stores or similar heat source. Overall roof shows no major anomalies.

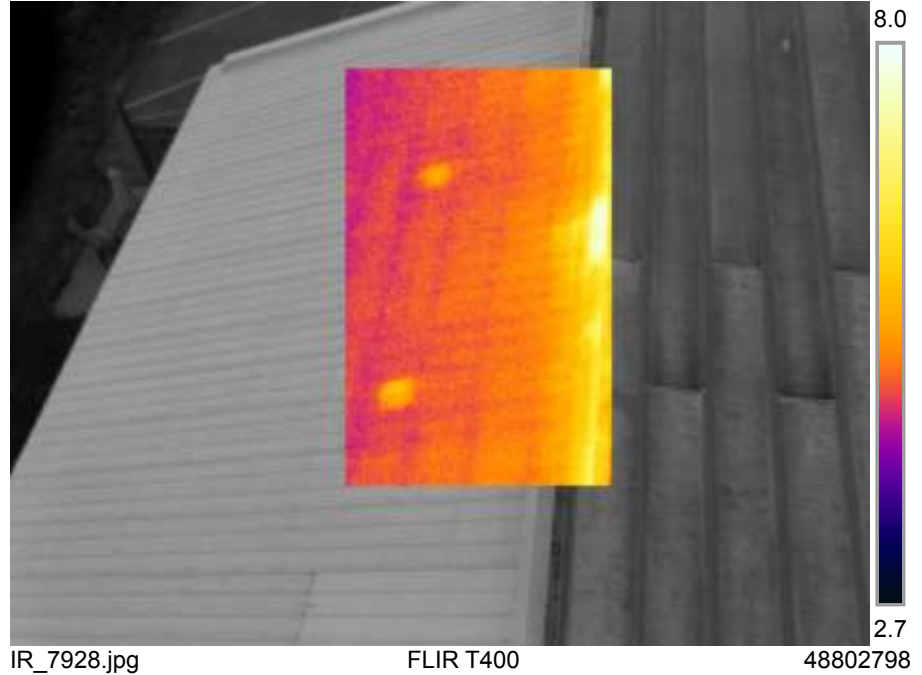
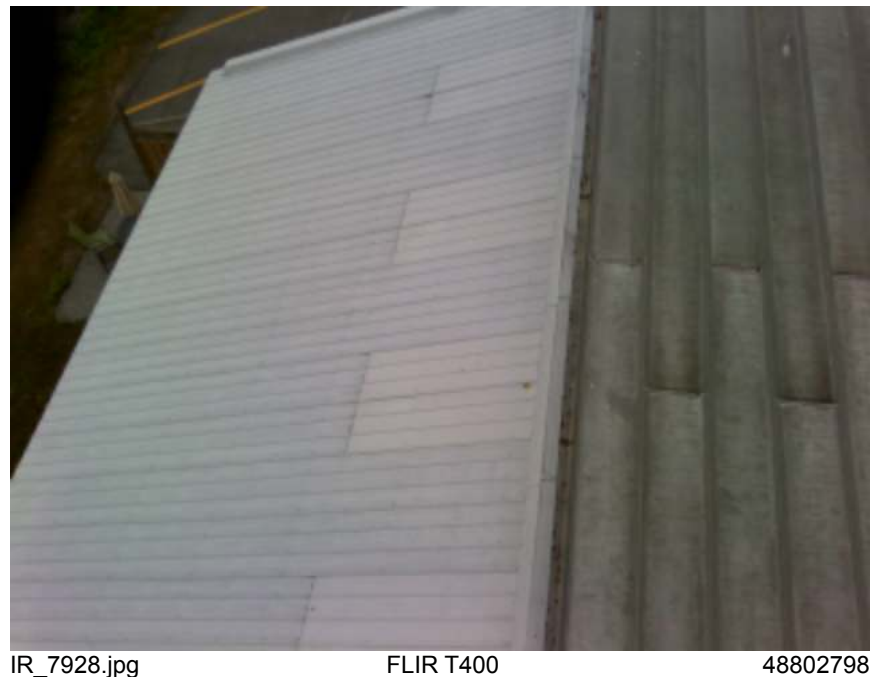
South facing shop roof showing normal patterns at vents and fasteners. Heat tracing is likely not turned on but only appears warm due to emissivity characteristics. No significant fault noticed.

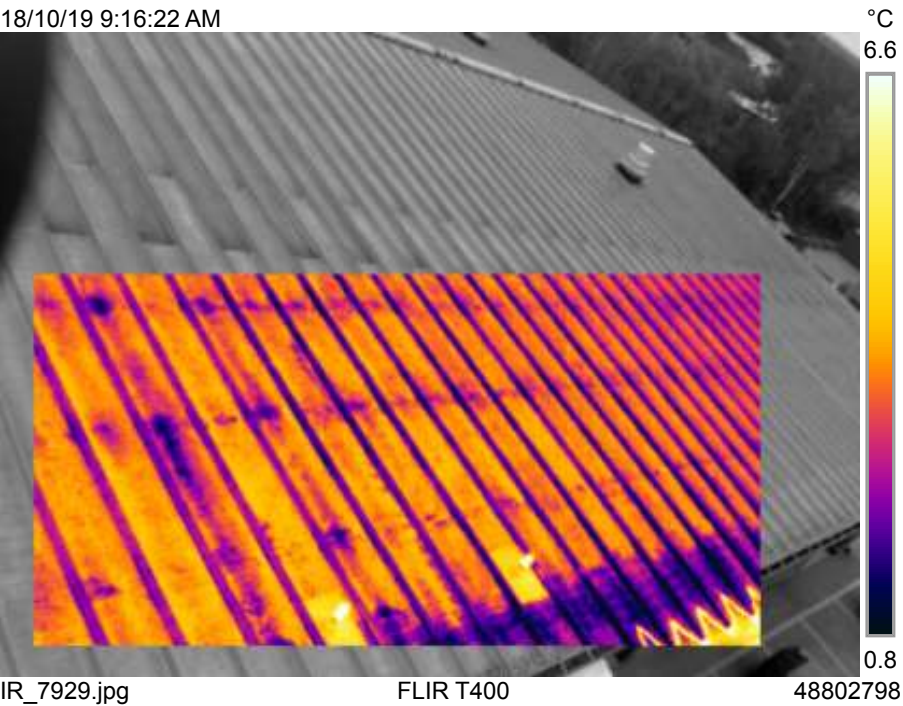
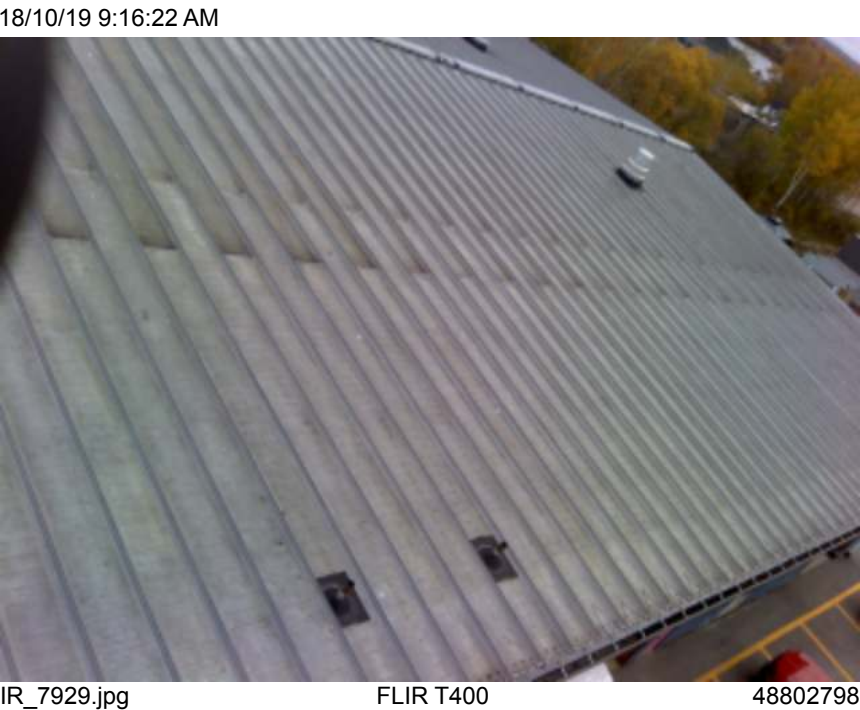
Notice the warm "runs" from some of the patched areas down the slope of the roof indicating less insulation potentially due to moisture affected insulation. Also notice warmer surface along lower edge of building which could indicate more moisture accumulation at bottom of slope.

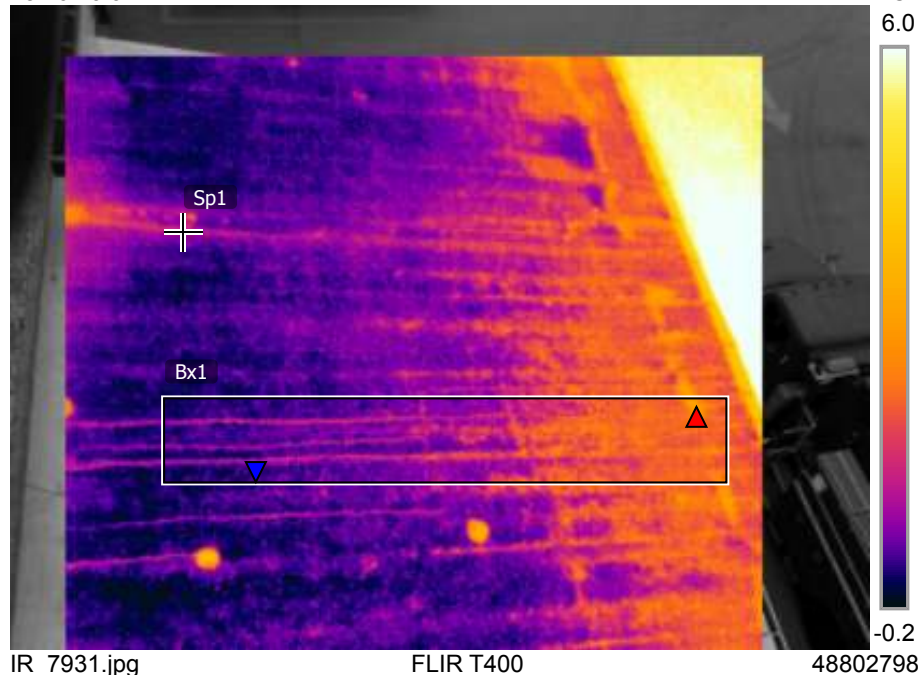
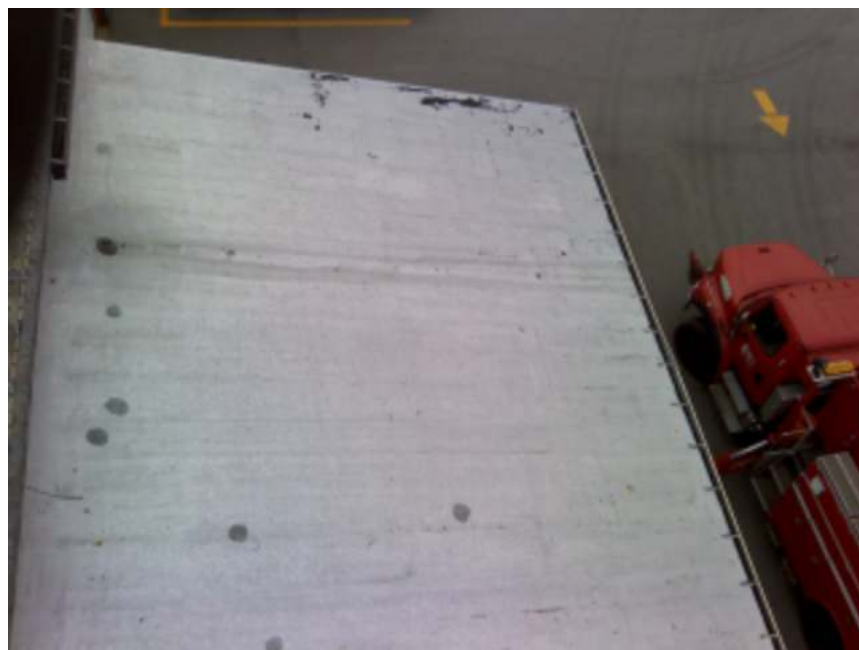
Lower south facing office roof indicating potential moisture infiltration into roof membrane.

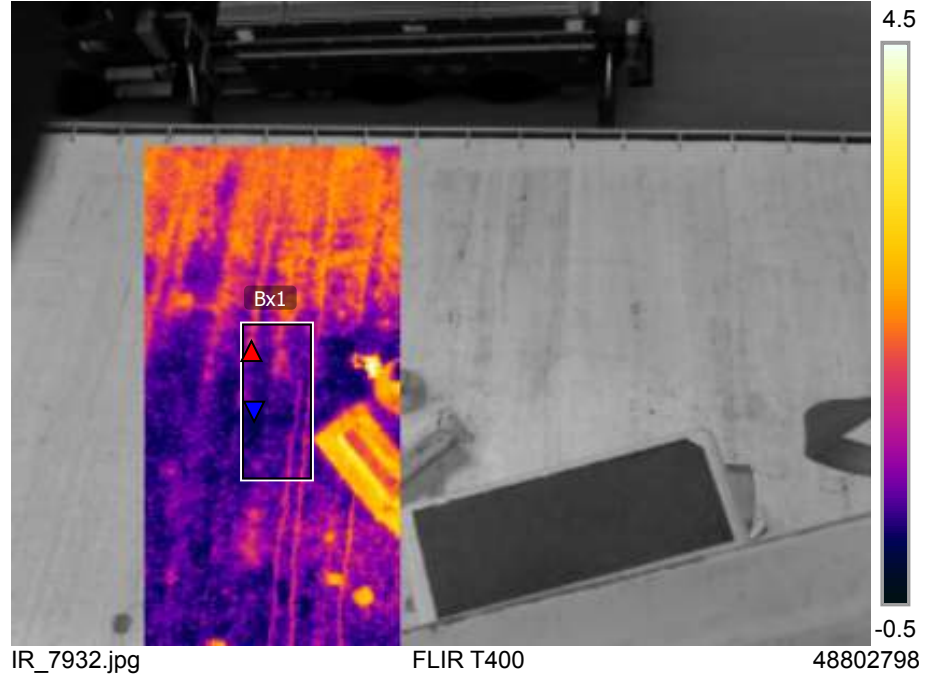
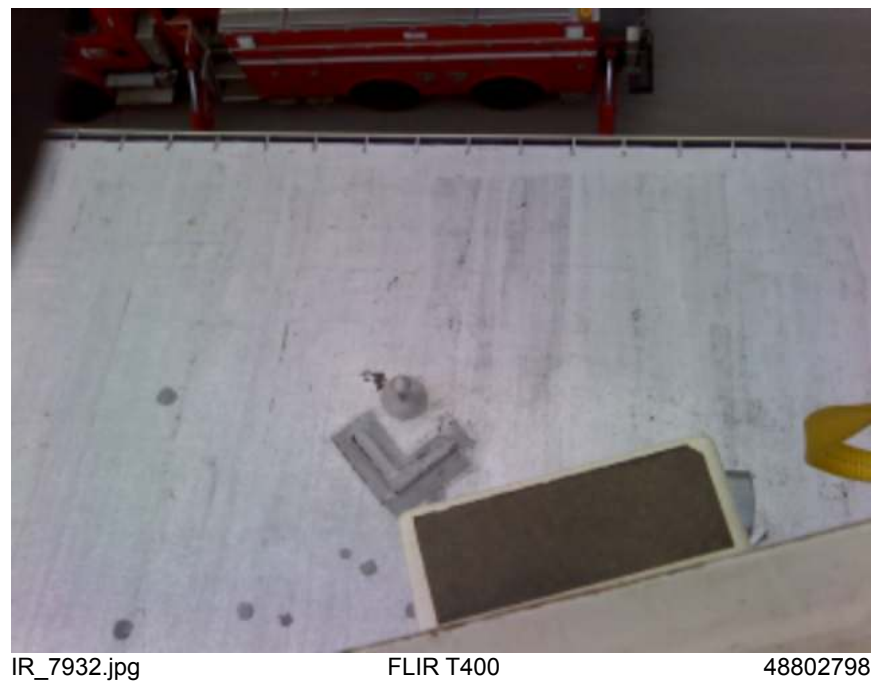
Internal thermal image of shop roof showing suspicious cold area in insulation. Should be investigated further for potential water infiltration onto insulation.

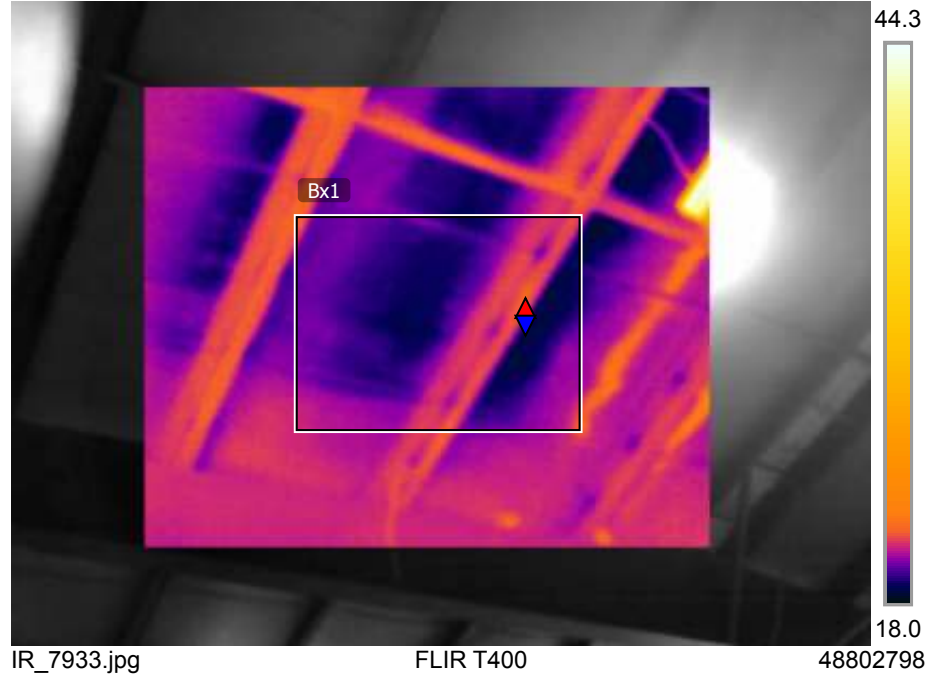
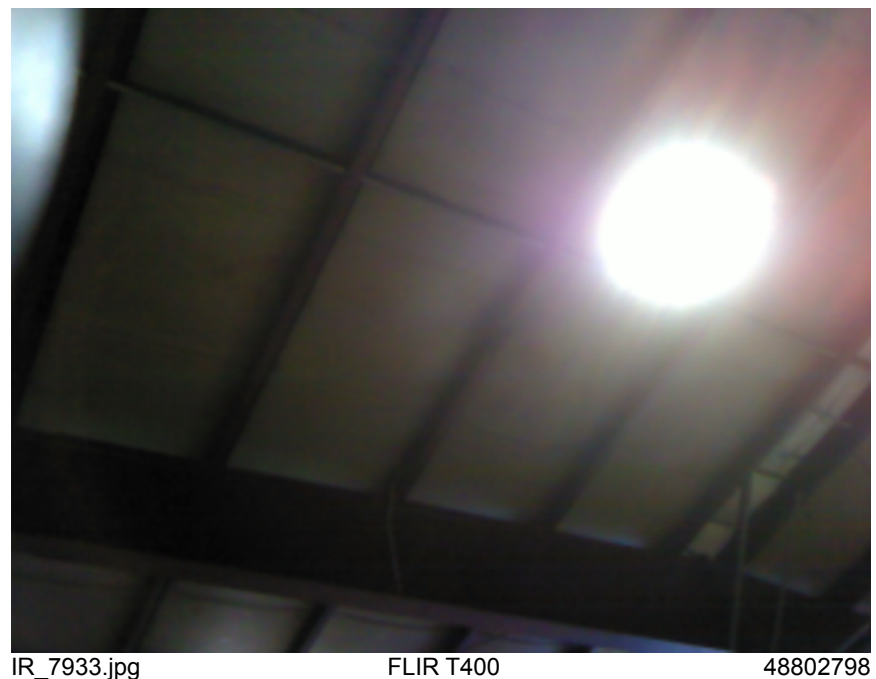
Additional image of potential insulatin damage in shop ceiling
