# **EXHIBIT 2:**

# **RATE BASE**

# Distribution System Plan

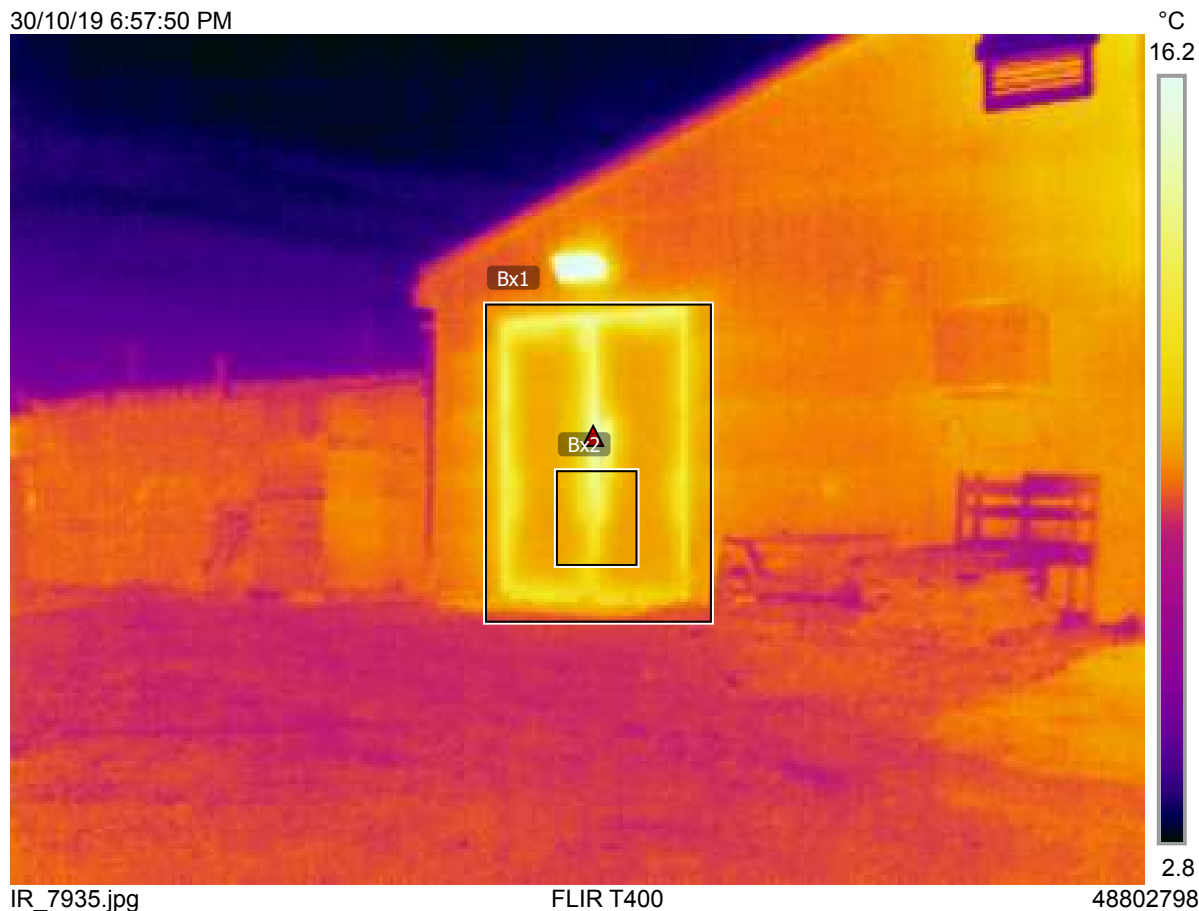
Bx2 Better than average insulation value.

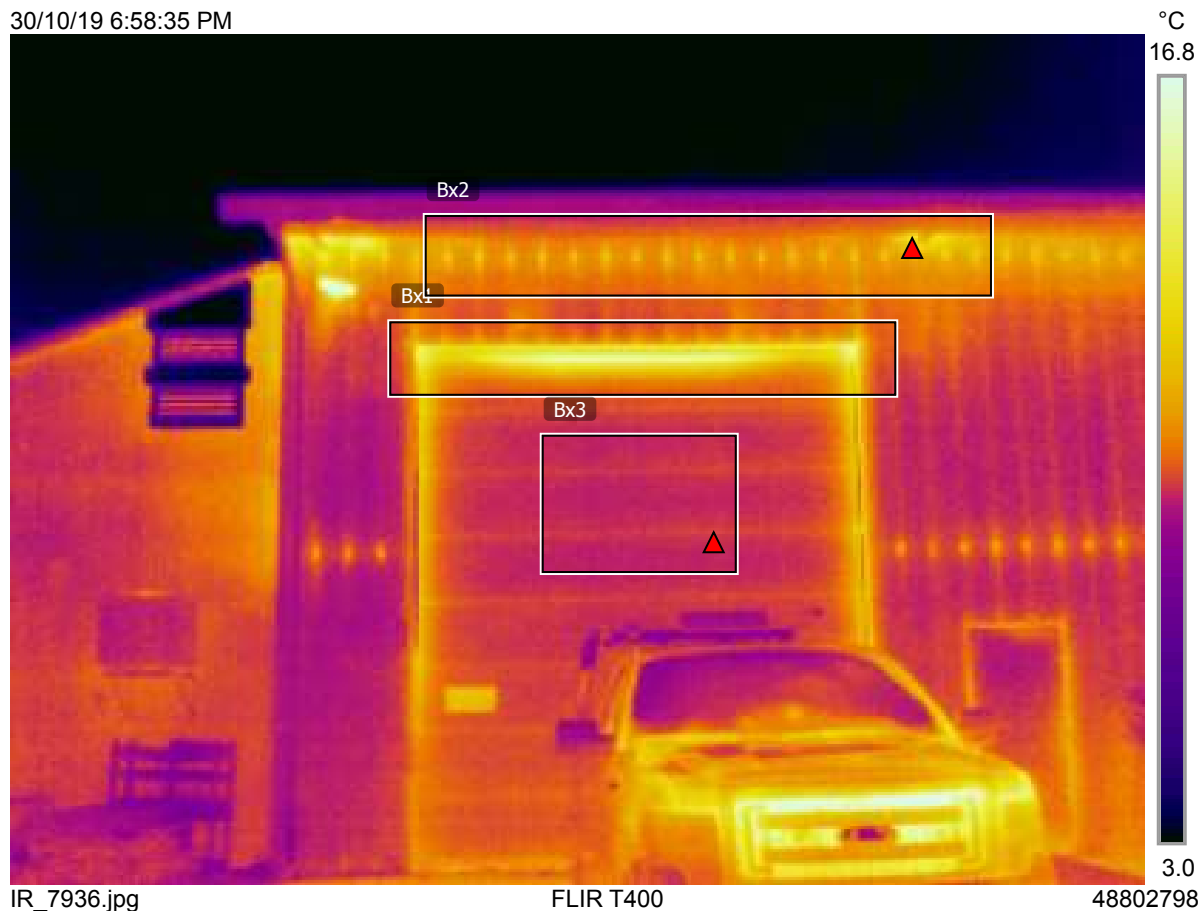
Bx1 & Bx3 Warehouse door leakage is deemed average.  
Garage door appears well insulated with an average exterior temperature of 9.5 degC versus a 7 degree ambient background.  
Apparent hot spot on left hand side under eaves is security camera.  
Bx2 Thermal bridging under eave and at connection points for exterior sheeting/heating.

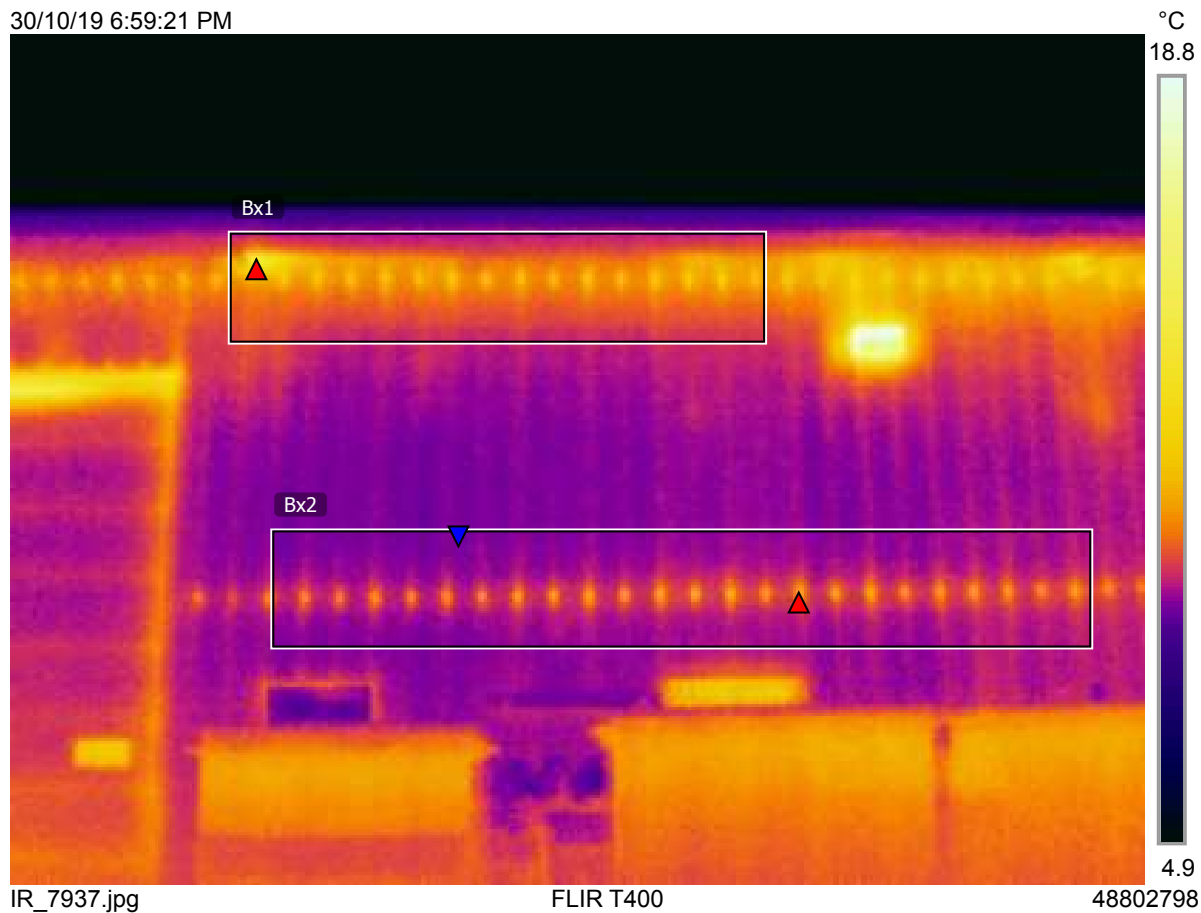
North Side  
Bx1 further examples of thermal bridging just below building eve.  
Bx2 thermal bridging where exterior sheeting attaches to building structure.  
Hot spot on right is exterior light.

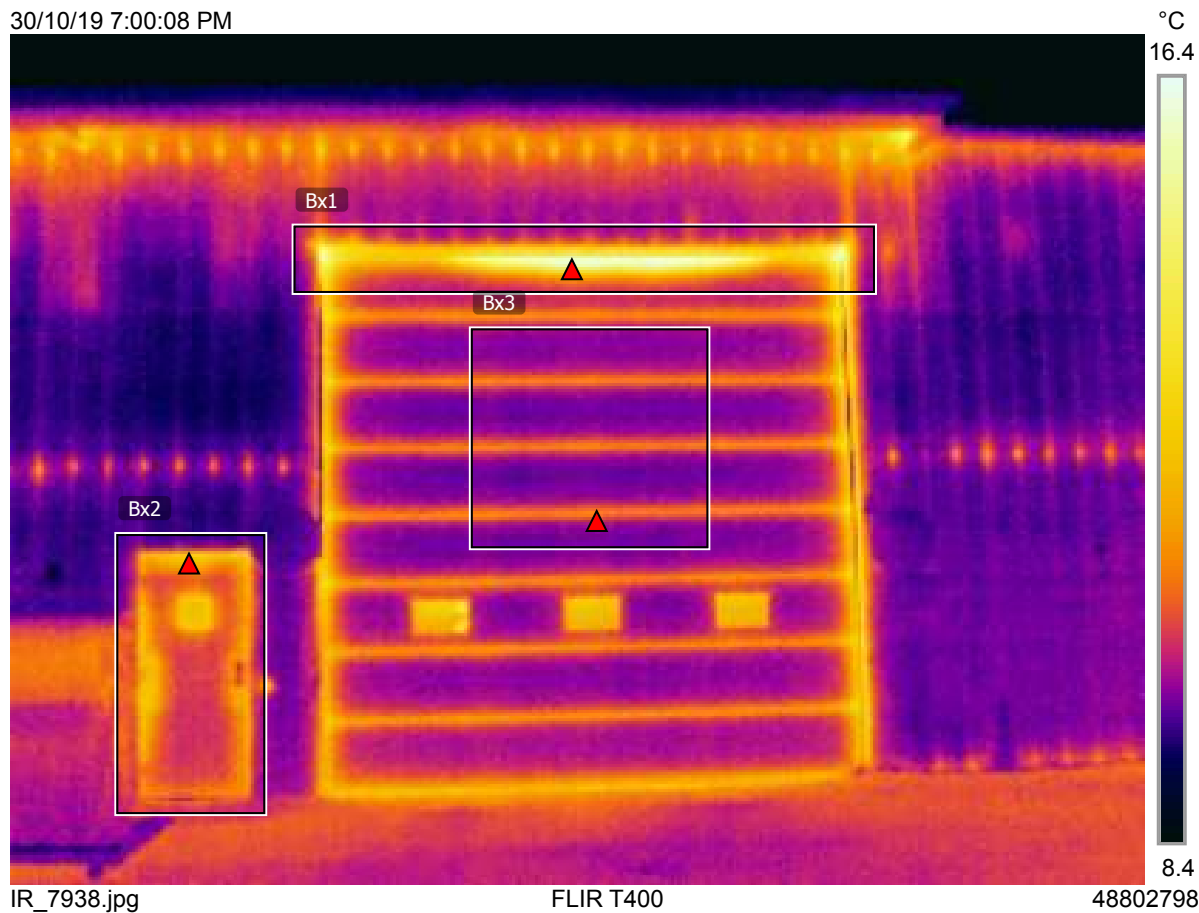
North Side  
Bx1 & Bx3 Warehouse door leakage is slightly worse than average. Garage door average temp is 11C which is comparable to previous door, thermal bridging between panels.  
Bx2 Average leakage at perimeter of door. Door appears reasonably insulated, average exterior temperature of 11.0C versus a 7C ambient.

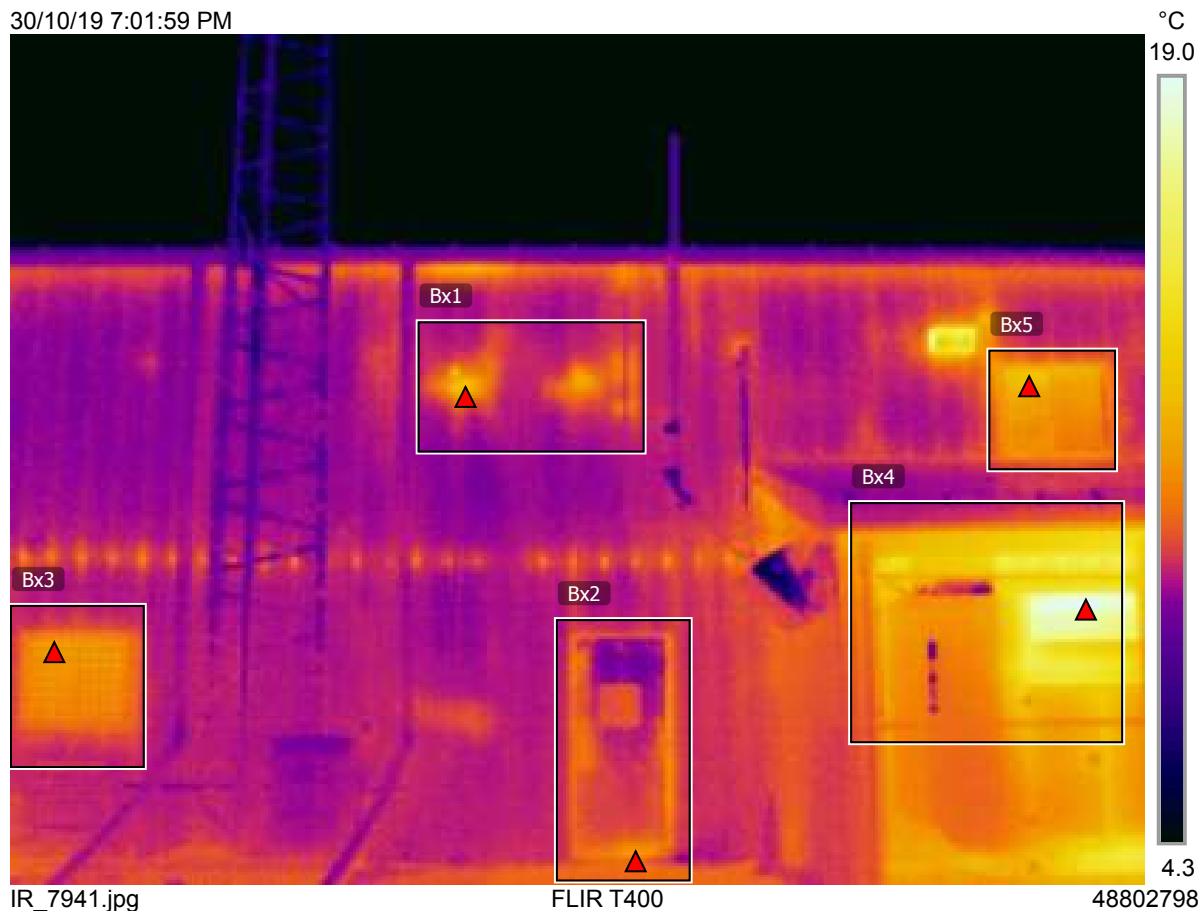
Bx5 Window, some leakage at perimeter but still performing reasonably well with an average temperature of 11.5C. 5C.

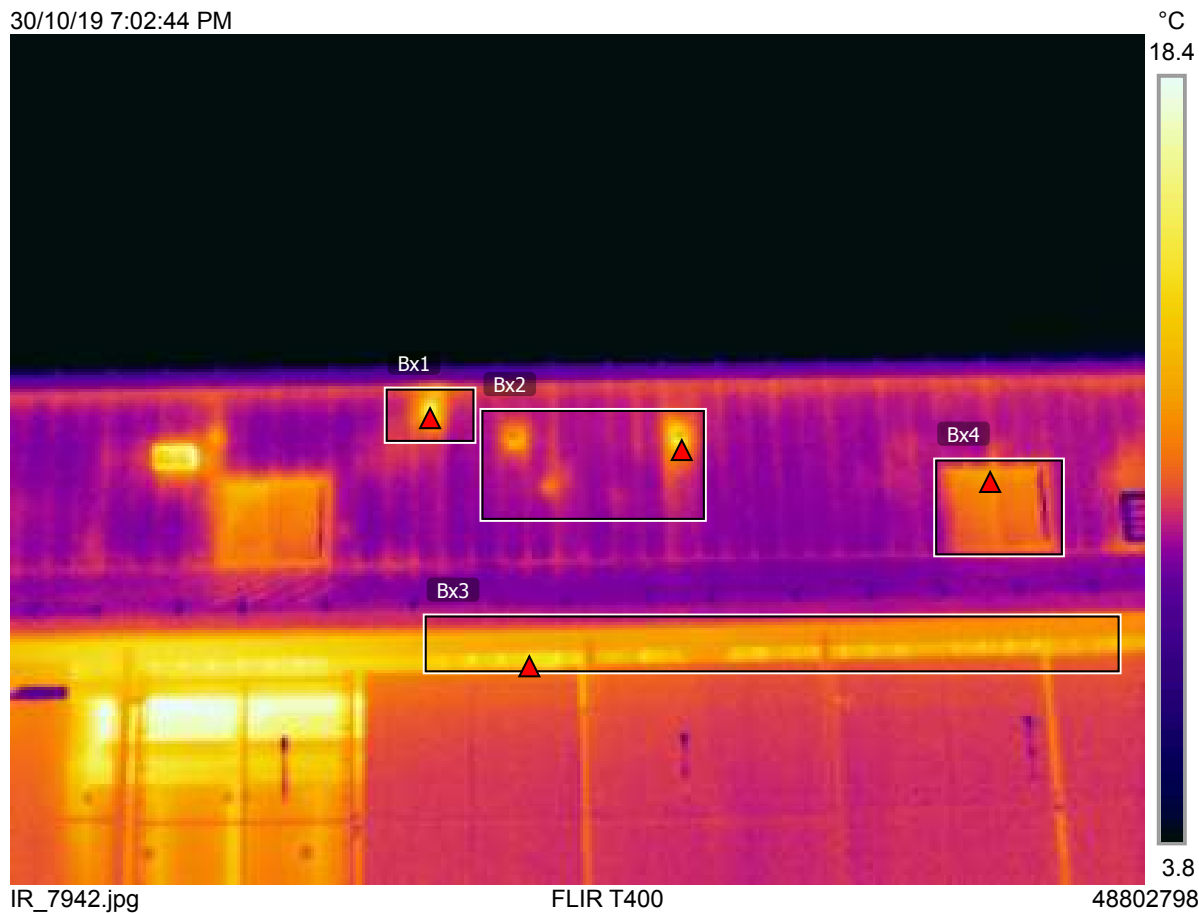
North Side  
 Bx1 Building exhaust.  
 Bx2 Two building exhausts.  
 Bx3 Warm in generator shed.  
 Bx4 Below average leakage and better than average insulation.

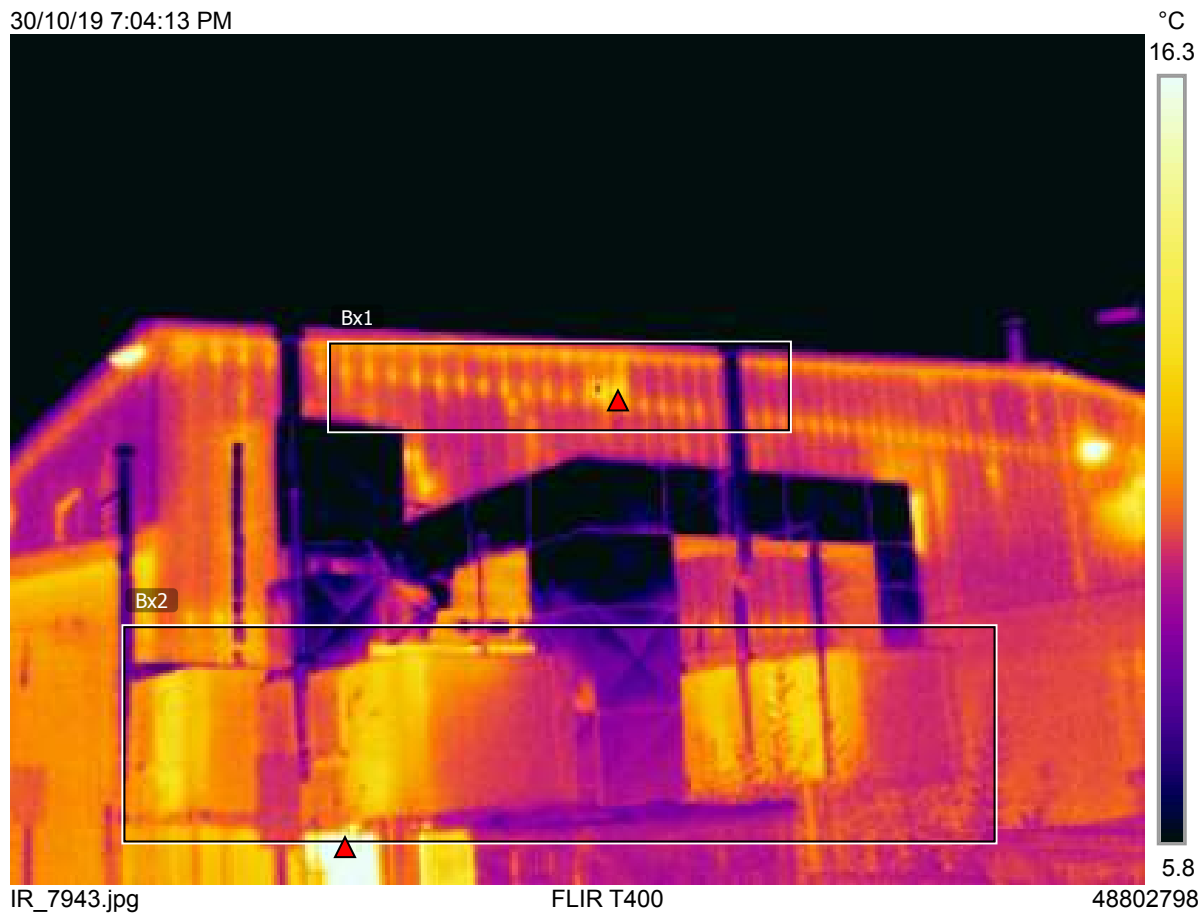
Note: Duct work appears dark due to clear night and reflective cladding.

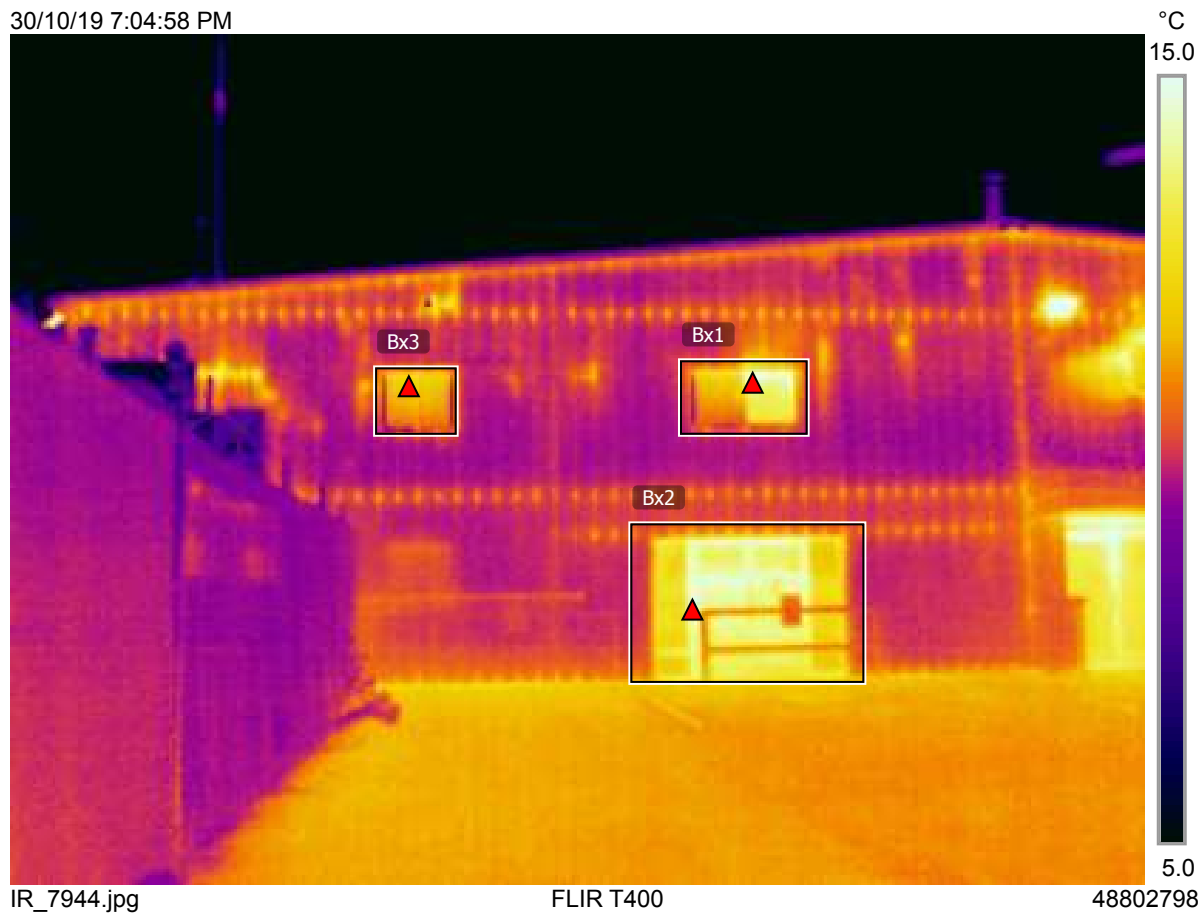
Bx1 Window higher than average leakage at perimeter overall insulation value average.

Bx3 Window average leakage rate and insulation value.

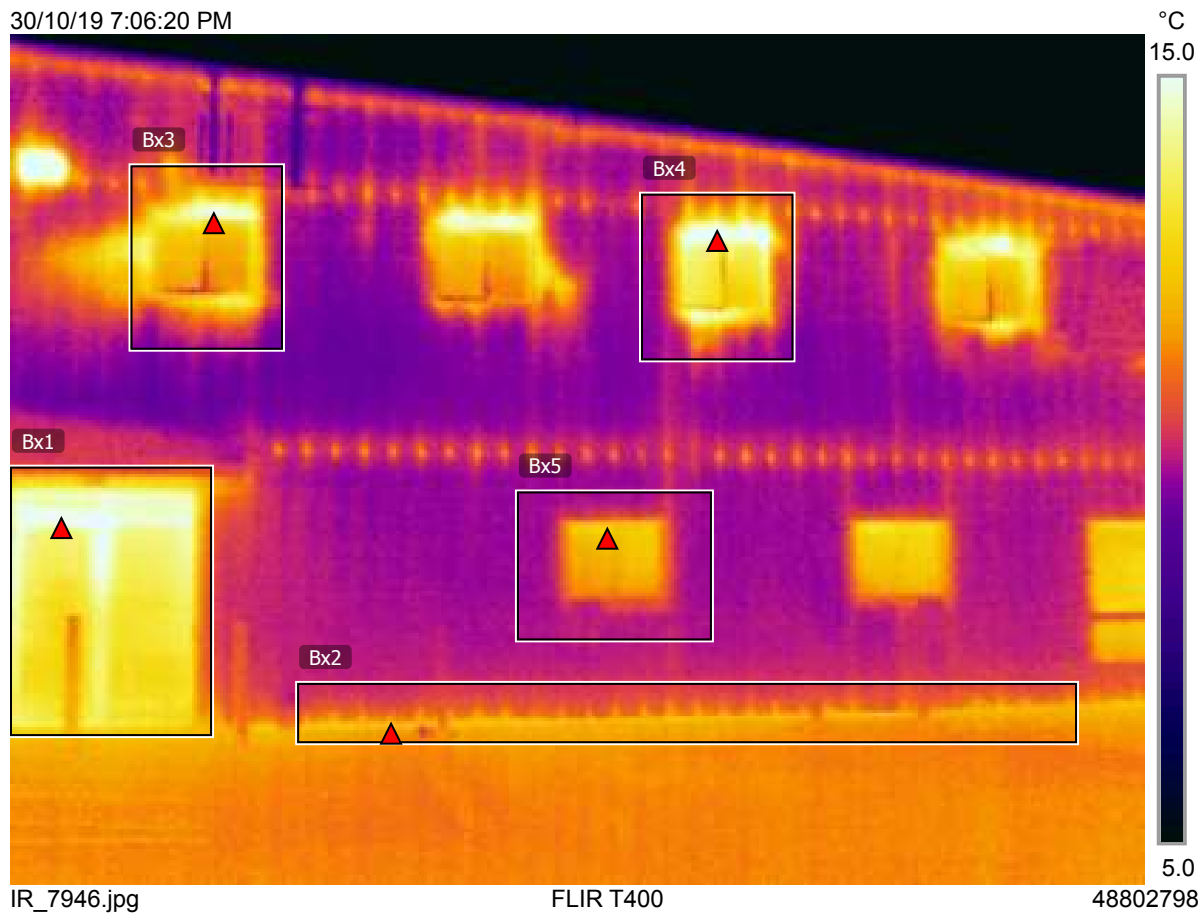
West Side  
 Bx1 Public Entrance worse than average leakage. Worse than average insulation value.  
 Bx2 Thermal bridging at foundation interface. Thermal bridging at junction between first and second floor and at top of second floor.  
 Bx3 & Bx4 Excessive leakage around perimeter of windows on upper floor. Other windows in picture very similar.  
 Bx5 Lower floor window performing better.

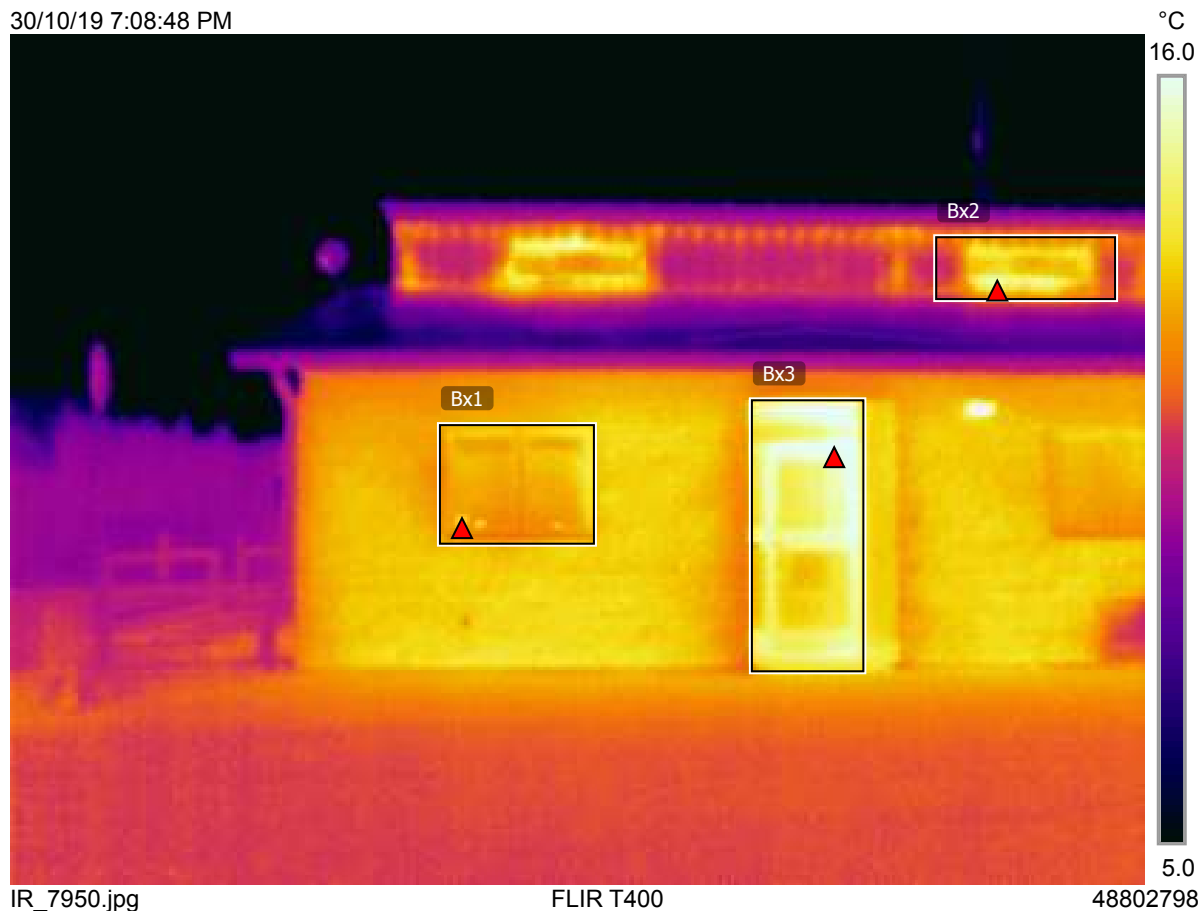
30/10/19 7:08:48 PM

Bx1 Window above average leakage and below average insulation value.

Bx2 Window significantly above average leakage and below average insulation value.

Bx3 Staff entrance south side addition. Above average leakage and below average insulation value.

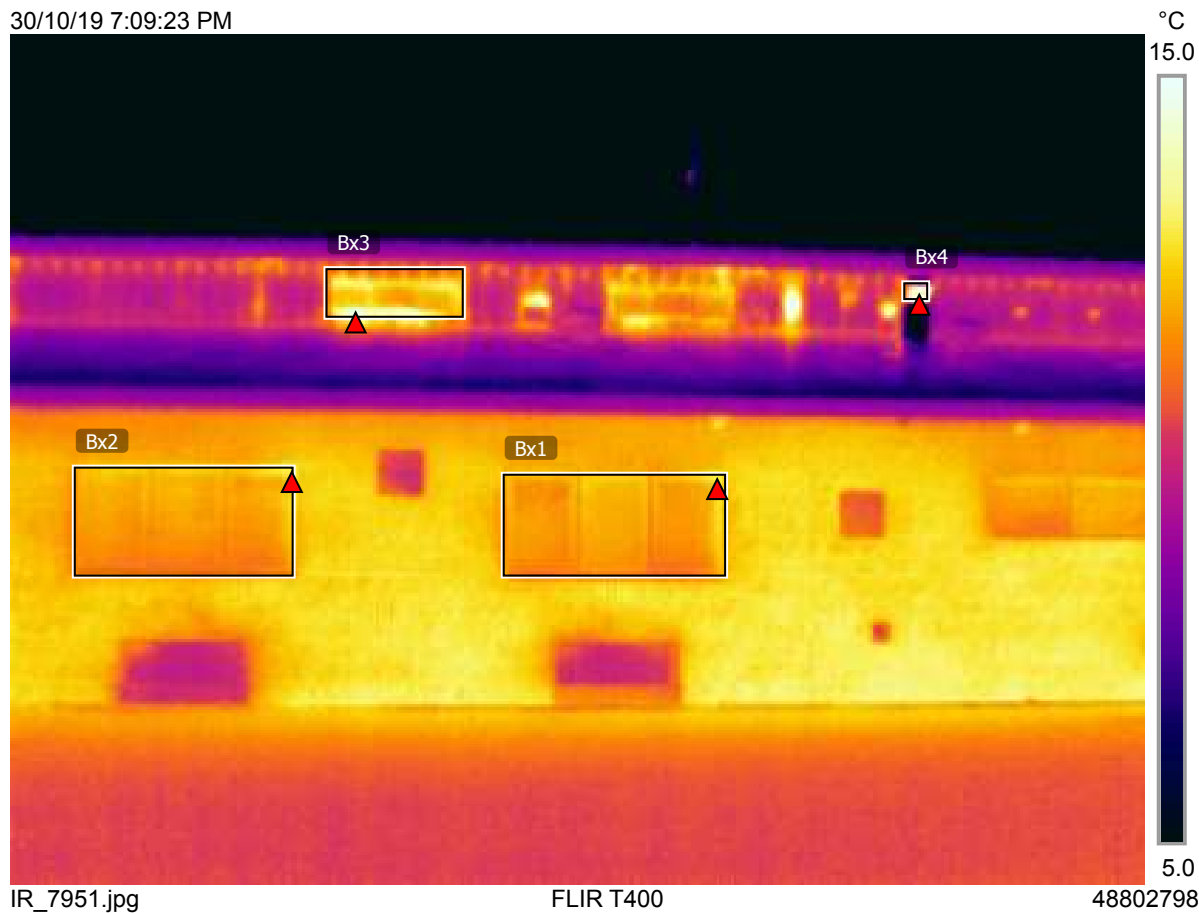
30/10/19 7:09:23 PM

Southside Addition  
Bx1 & Bx2 Windows average leakage and average insulation value.  
Bx3 Window in main bldg above average leakage and average insulation value.  
Bx4 Vent.

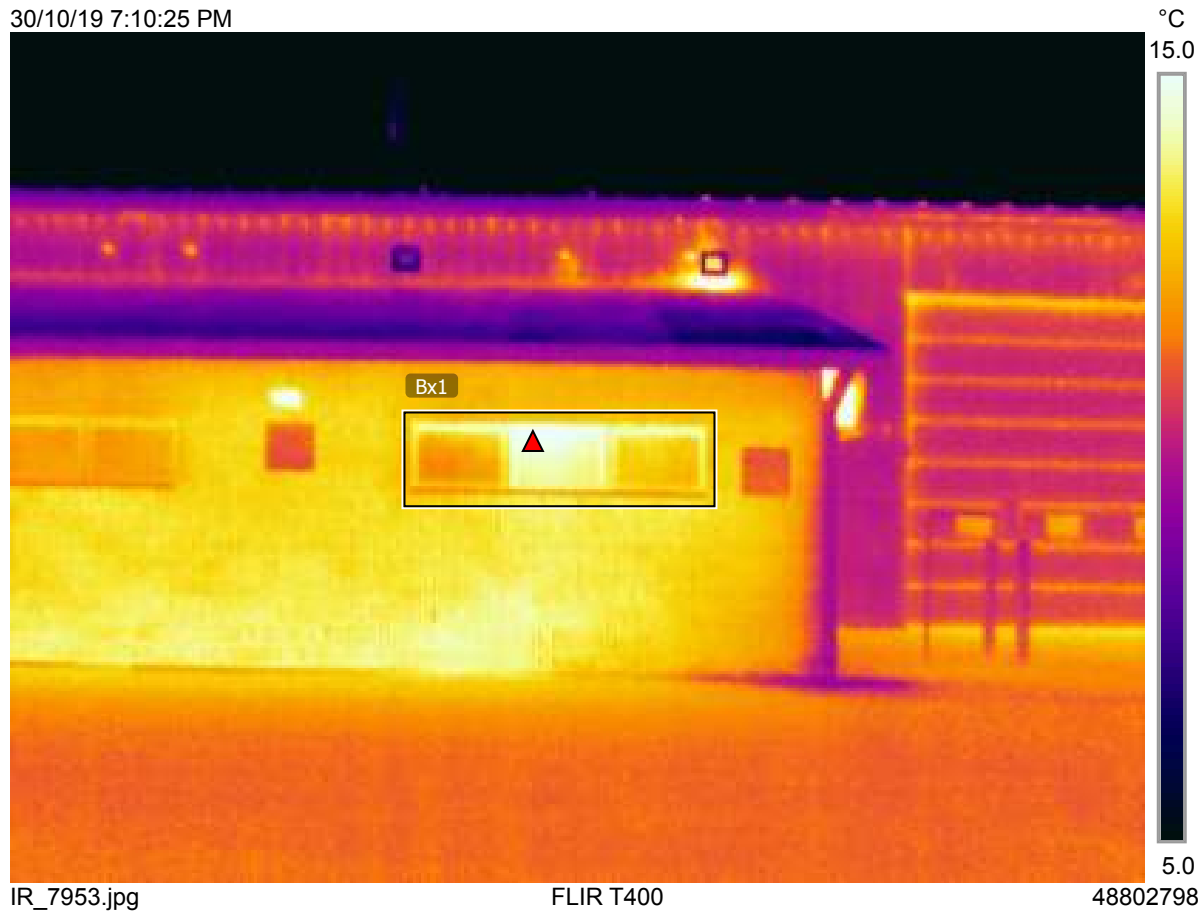
30/10/19 7:10:25 PM

South Addition  
Bx1 Window above average leakage and average insulation value.

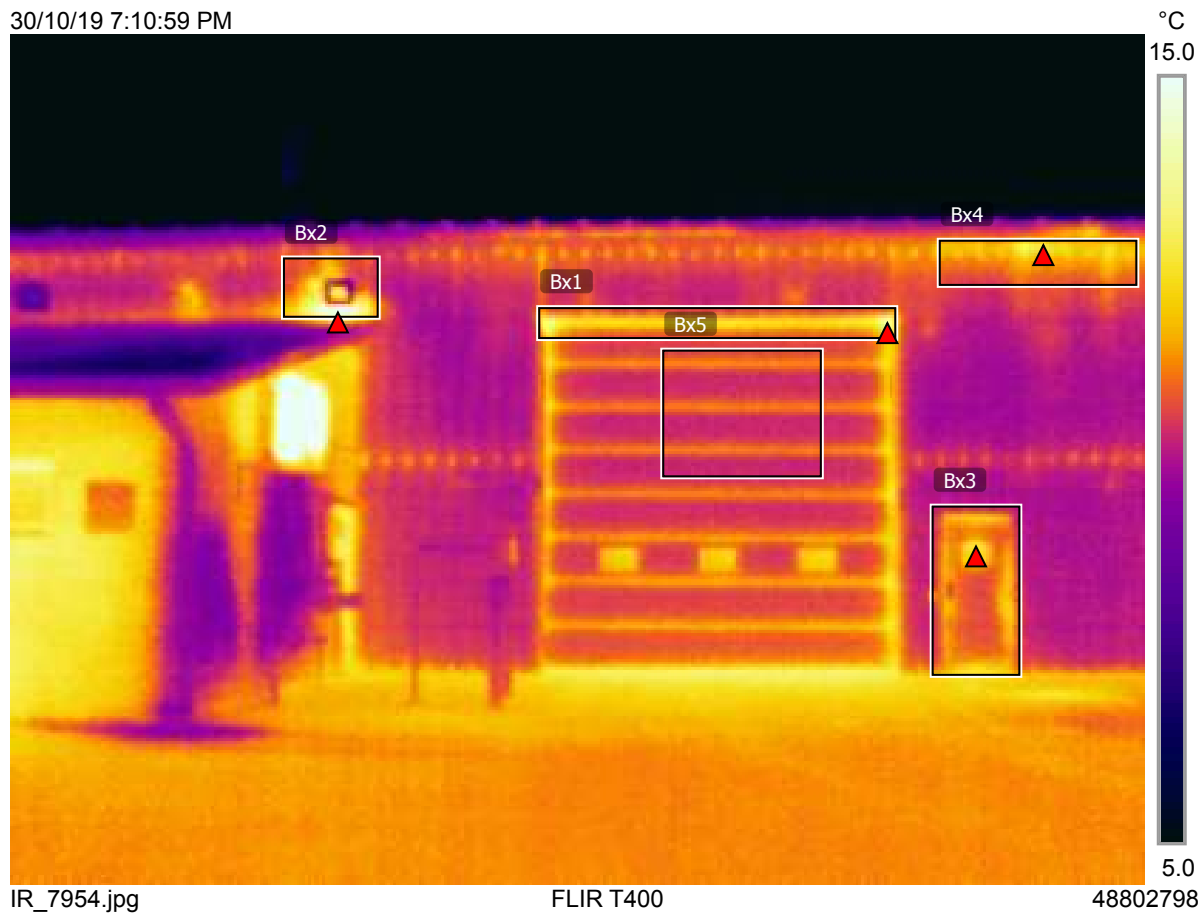
30/10/19 7:10:59 PM

South side Main Bldg  
 Bx1&Bx5 Garage door average leakage and better than average insulation value. Some thermal bridging between panels.  
 Bx2 HRV vent.  
 Bx3 Door better than average air leakage and better than average insulation.  
 Bx4 Thermal bridging below eave.

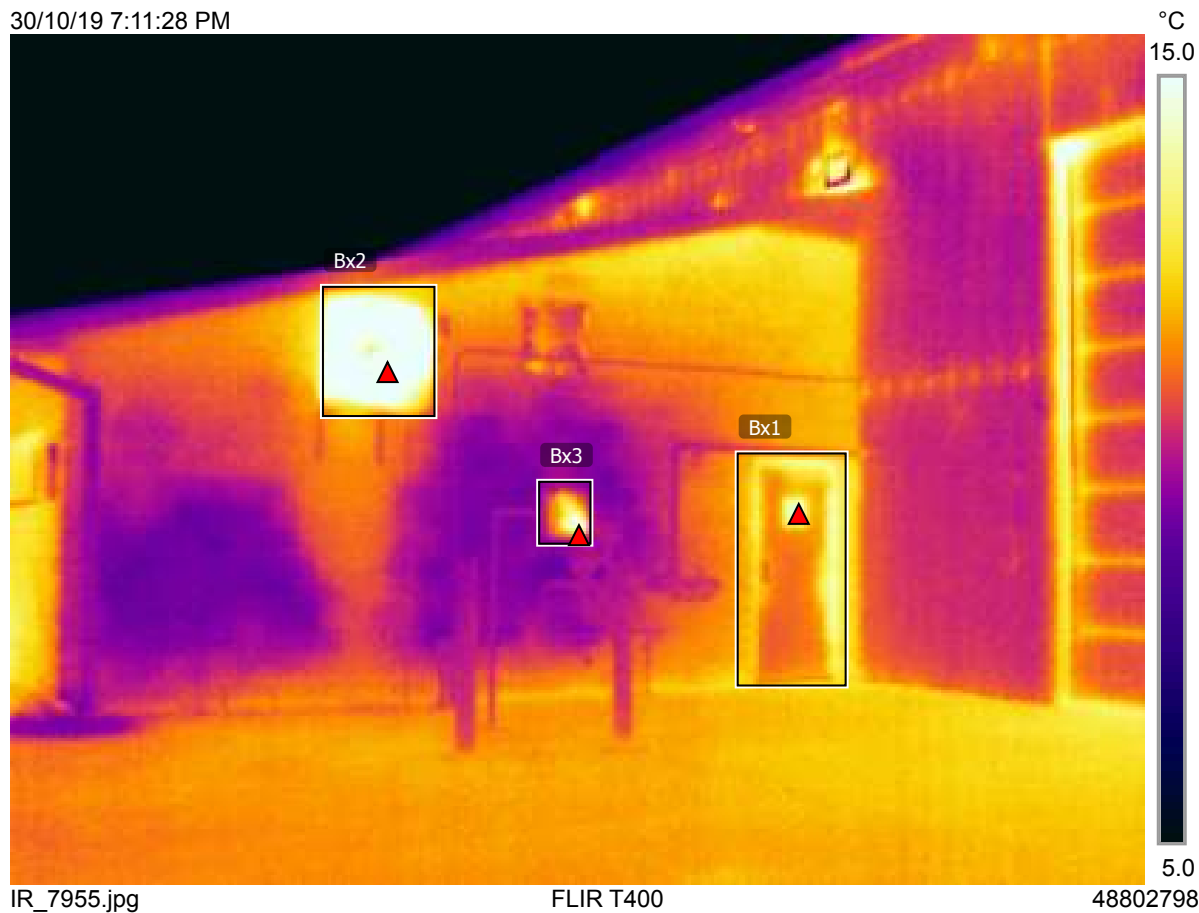
30/10/19 7:11:28 PM

East End of Addition  
Bx1 worse than verage air leakage, average insulation value.  
Bx2 Condensing Unit  
Bx3 Gas Meter Corrector

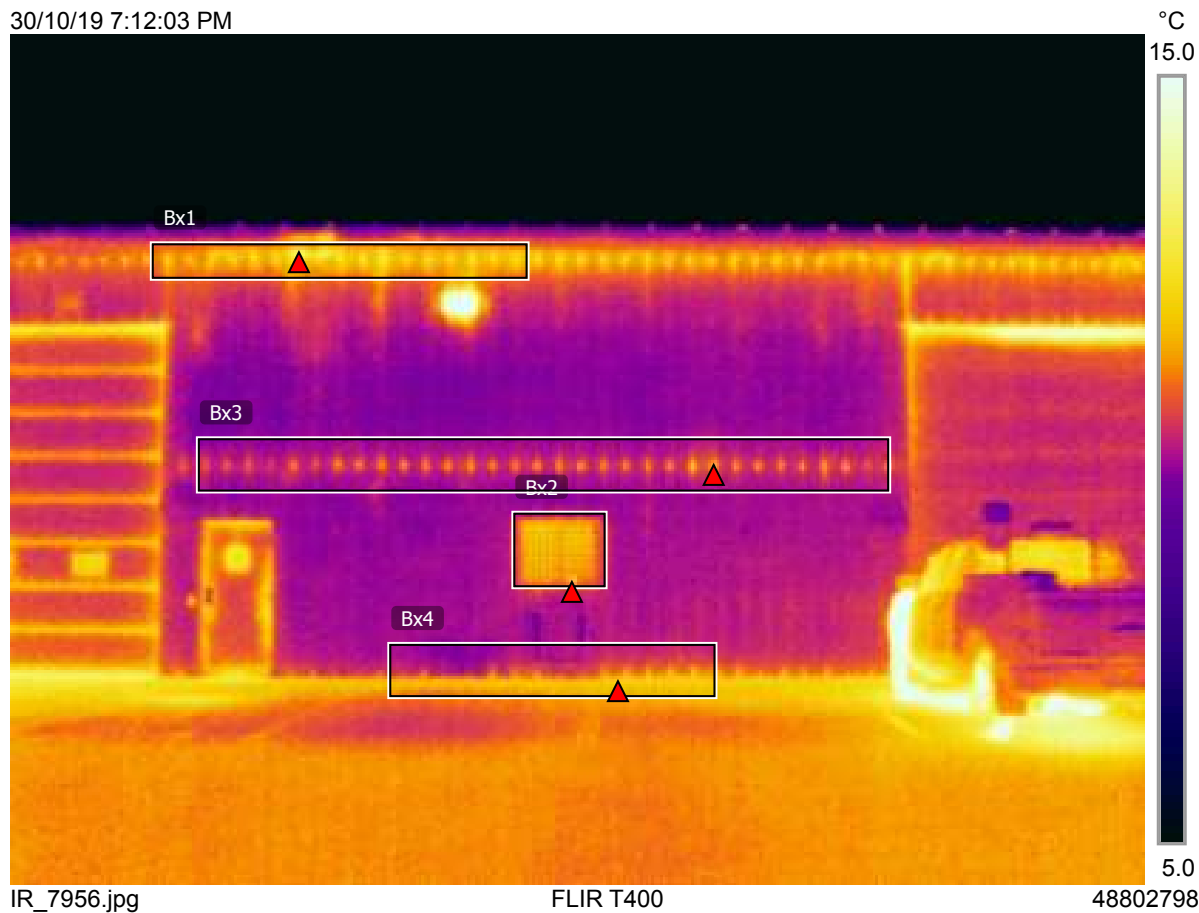
30/10/19 7:12:03 PM

South Side Main Bldg  
 Bx1 Thermal bridging at eave.  
 Bx2 Window average leakage and average insulation value.  
 Bx3 Thermal bridging where exterior connects to building.  
 Bx4 Thermal bridging where wall meets foundation.

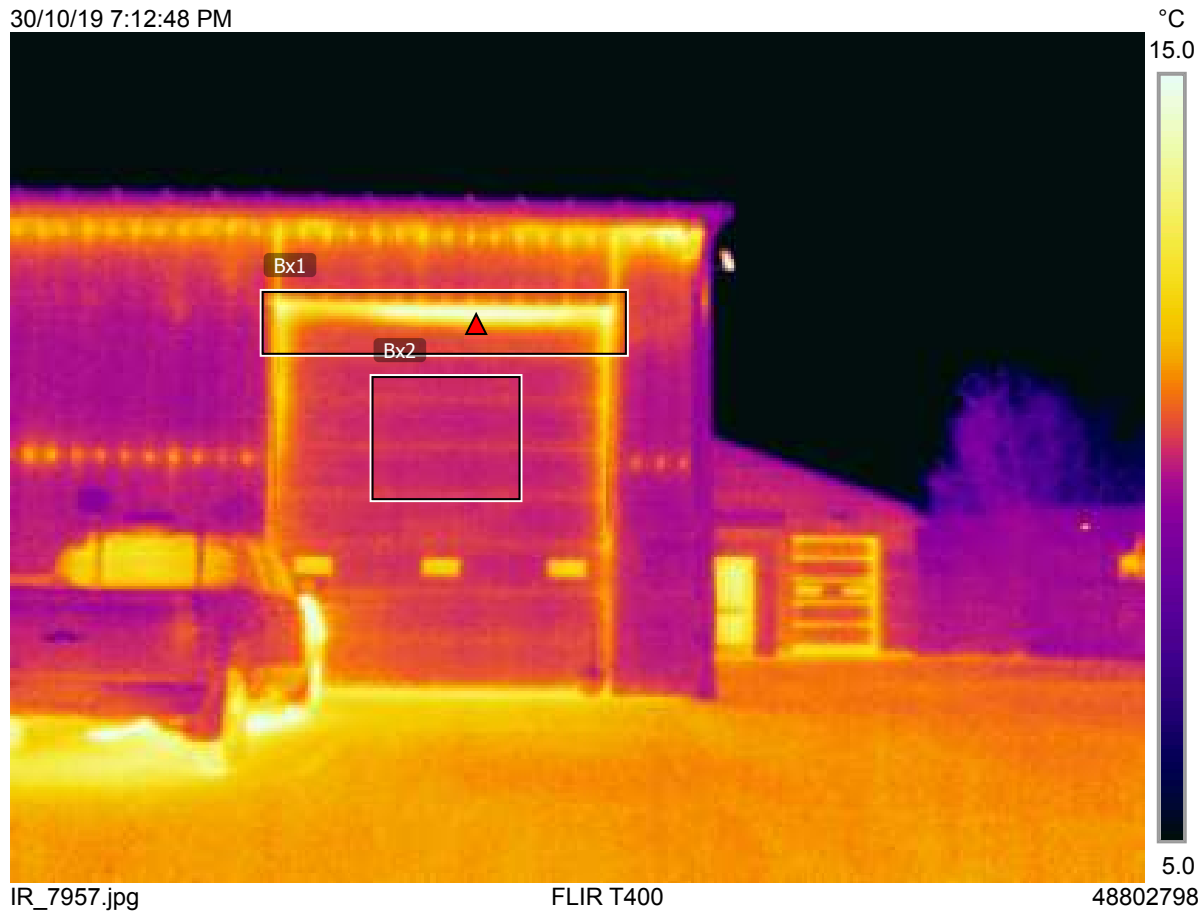
30/10/19 7:12:48 PM

South Side Main Bldg  
Bx1 Warehouse door air leakage deemed average.  
Bx2 Better than average insulation.

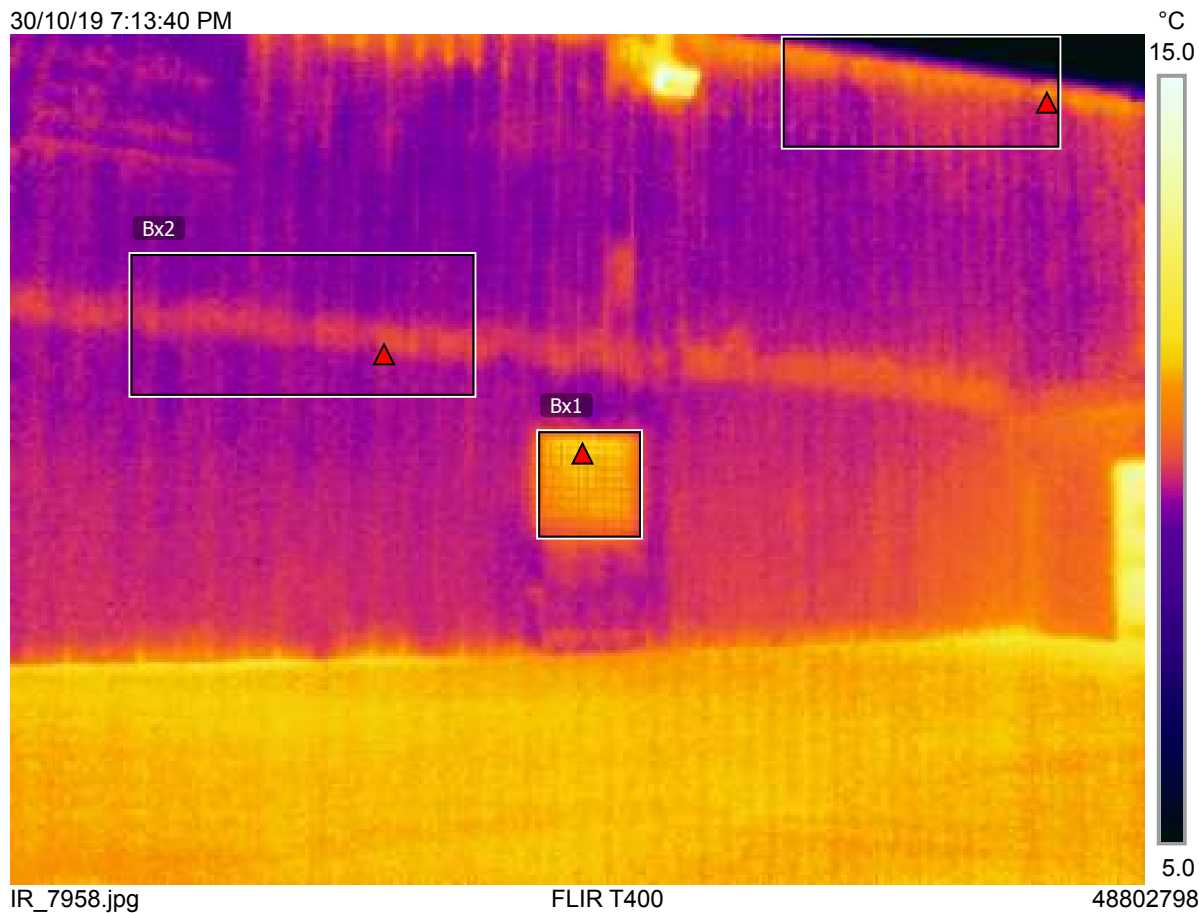
30/10/19 7:13:40 PM

East End Main Bldg  
Bx1 Window better than average seal and better than average insulation.  
Bx2 & Bx3 less thermal bridging.

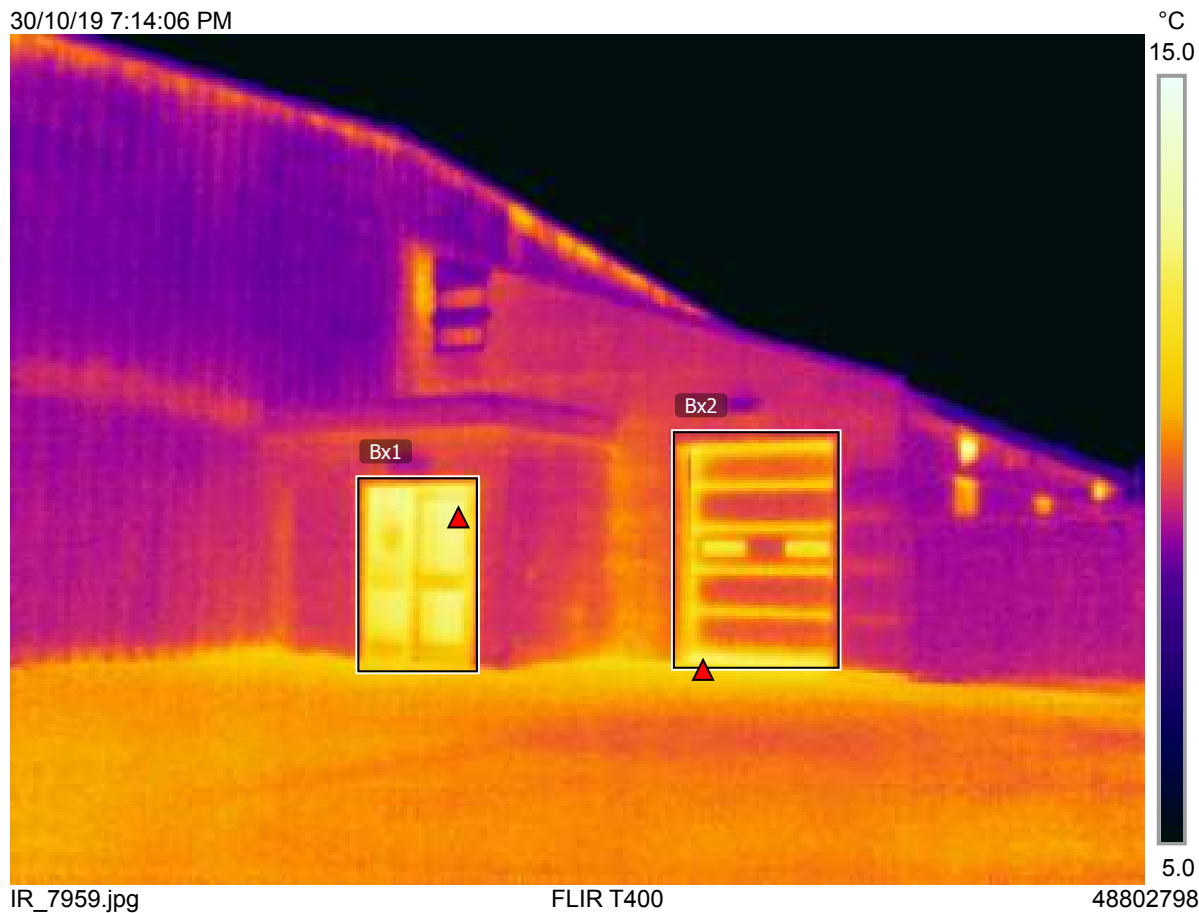
30/10/19 7:14:06 PM

South Side Meter Shop  
Bx1 Entrance average leakage and average insulation value.  
Bx2 Meter shop garage door better than average leakage and insulation value. Some thermal bridging at the panel points.

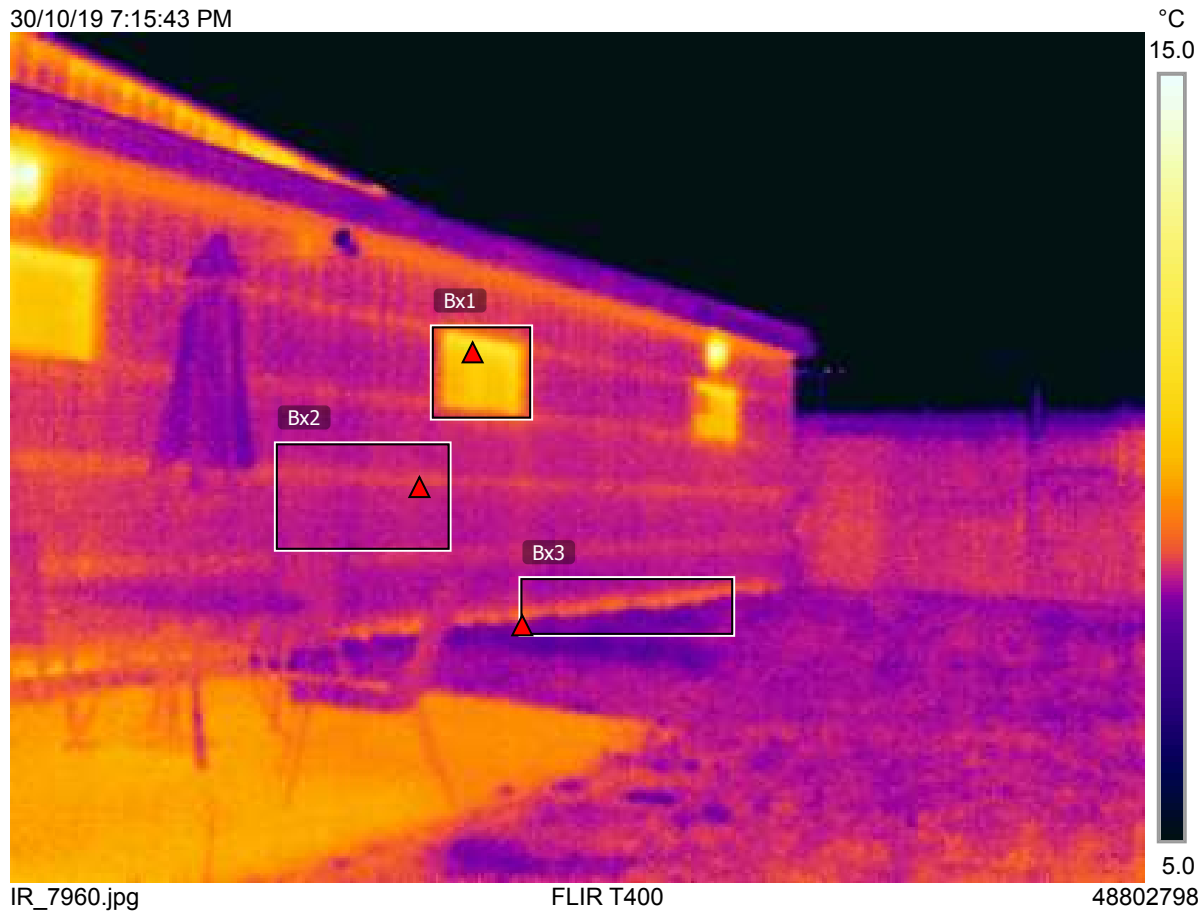
30/10/19 7:15:43 PM

West Wall Meter Shop  
 Bx1 Window less than average leakage and better than average insulation.  
 Bx2 Wall better than average insulation.  
 Bx3 Less than average thermal bridging between wall and foundation.

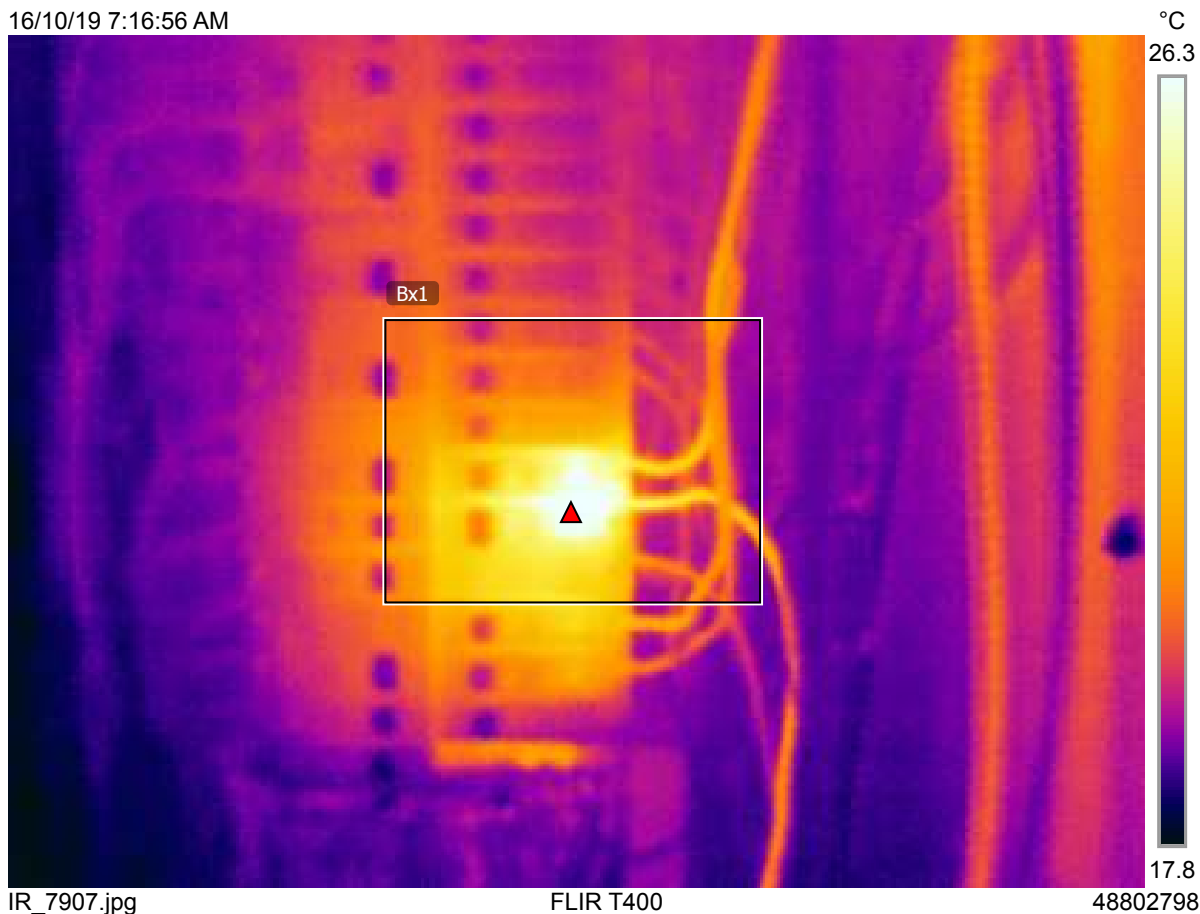
16/10/19 7:16:56 AM

GARAGE BREAKER PANEL  
Single breaker for roof heating showing warm due to load (9.5 amps). Panel is loaded 17(A) / 9(B) / 21(C).  
No concern noted.

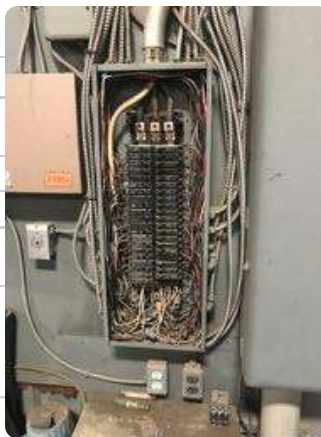
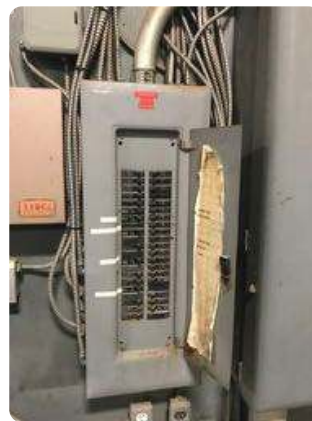
Panel for Addition  
Panel loaded at 13(A)/12(B)/31(C)  
Breaker labelled as "Clothes Dryer Heating" was loaded at 19 amps.  
Breaker temperature at >41 degC is excessive and should be addressed.
