# **EXHIBIT 2:**

# **RATE BASE**

# Distribution System Plan

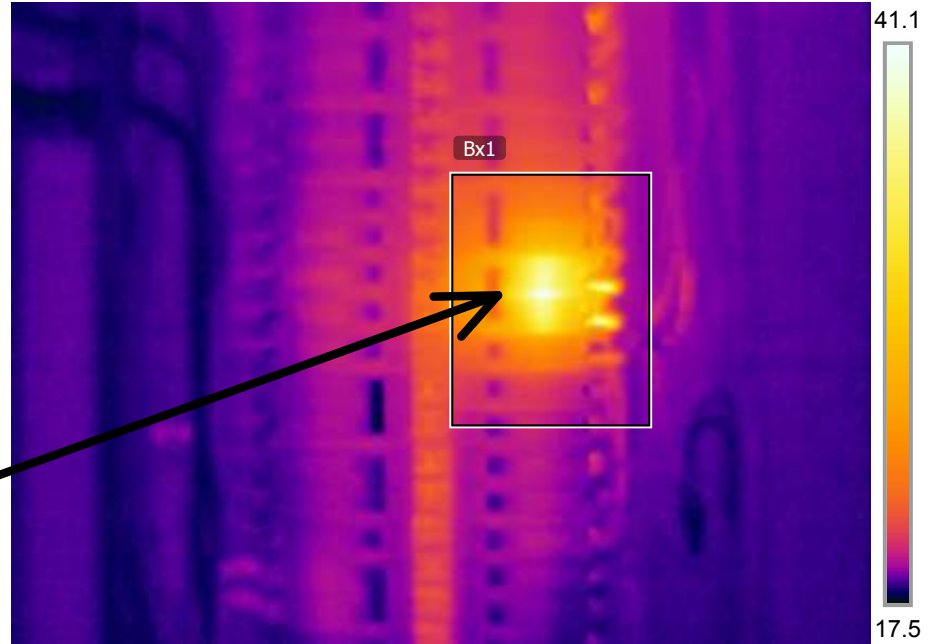
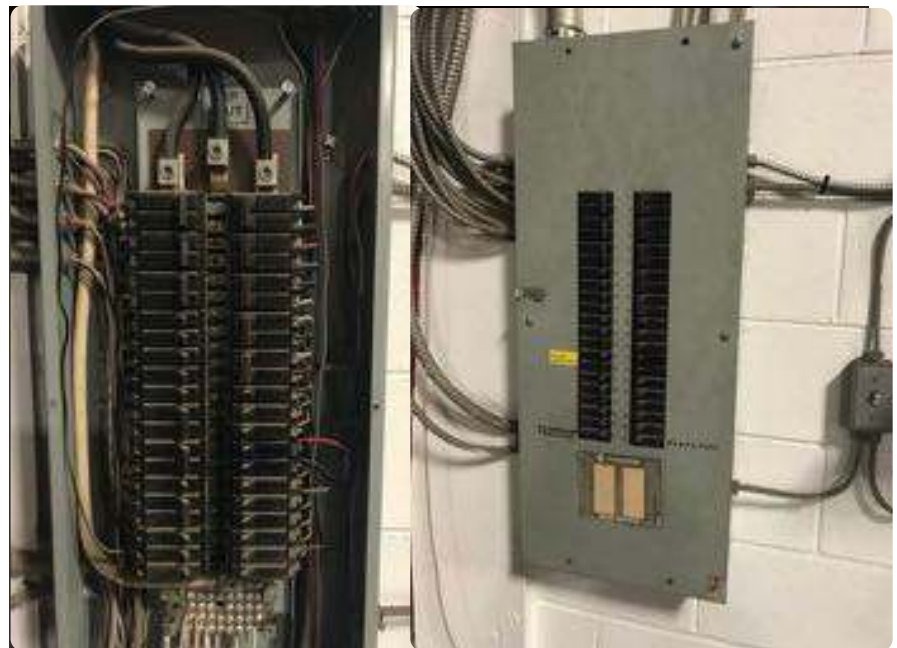
16/10/19 7:19:28 AM

SPARE GARAGE SUB PANEL  
Low current draw and maximum  
temperature at ambient. No concerns  
noted.

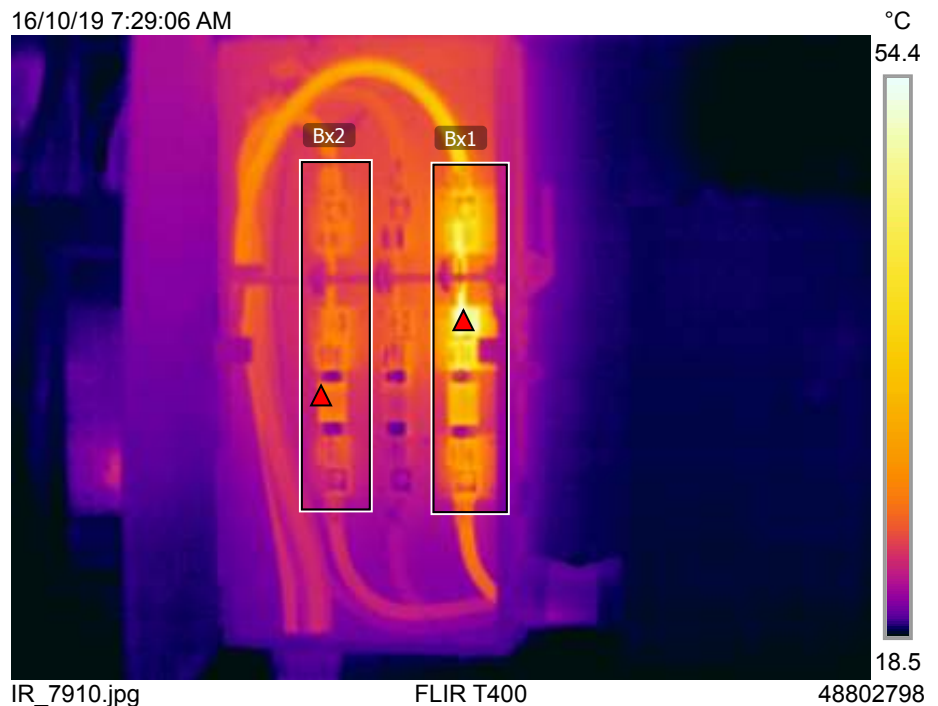
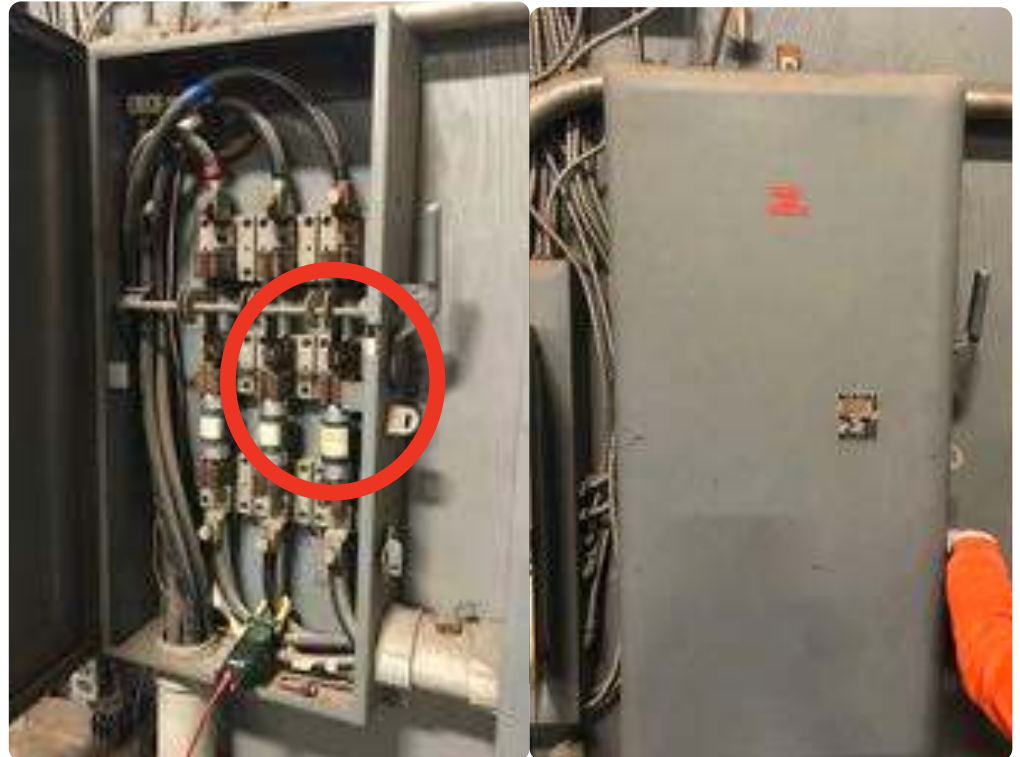
16/10/19 7:29:06 AM

There may be a minor issue on the load side connection of A leg

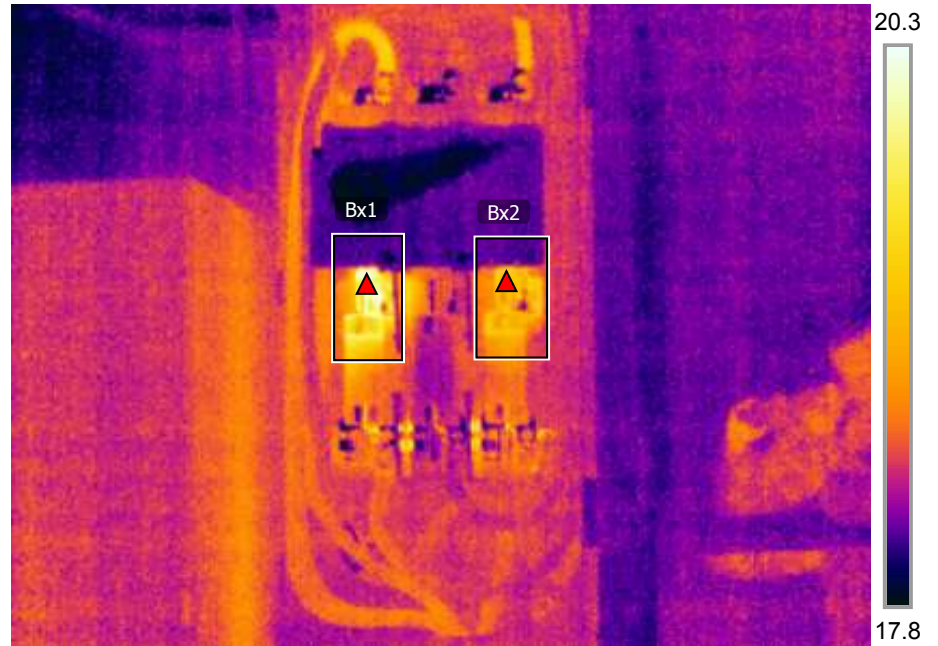
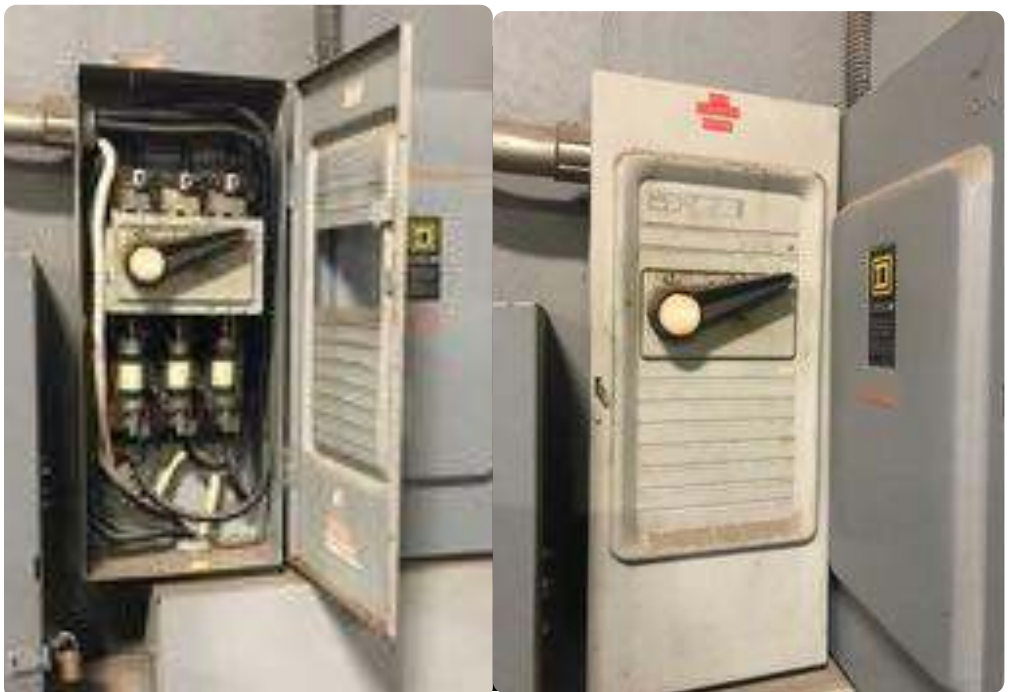
16/10/19 7:33:05 AM

No concerns noted

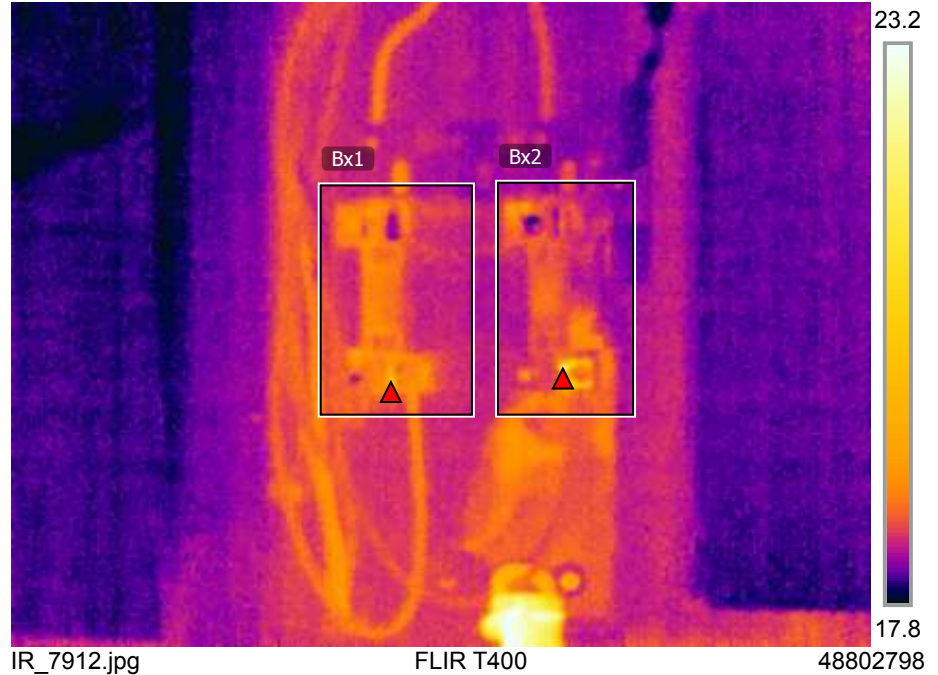
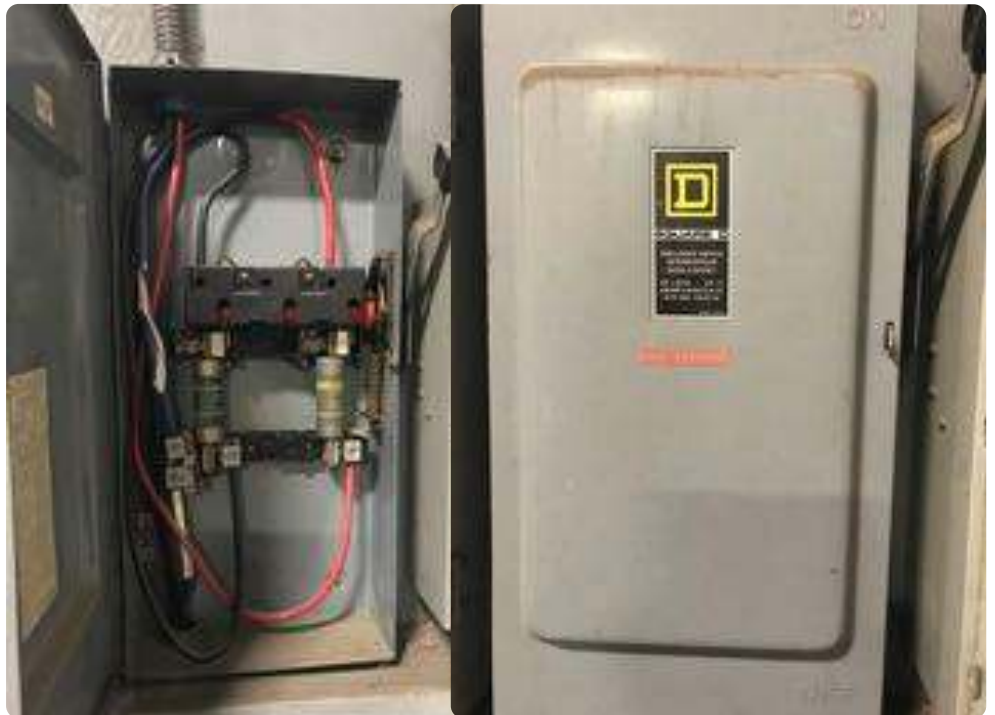
16/10/19 7:37:53 AM

There is a potential of a minor issue on the connection of the A phase lug (load side).

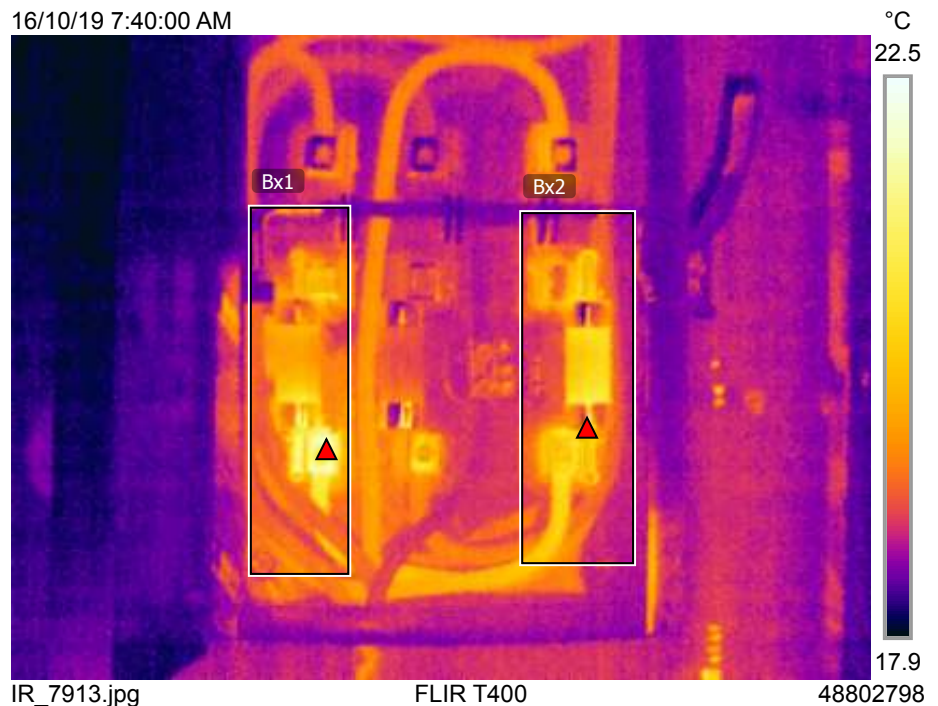
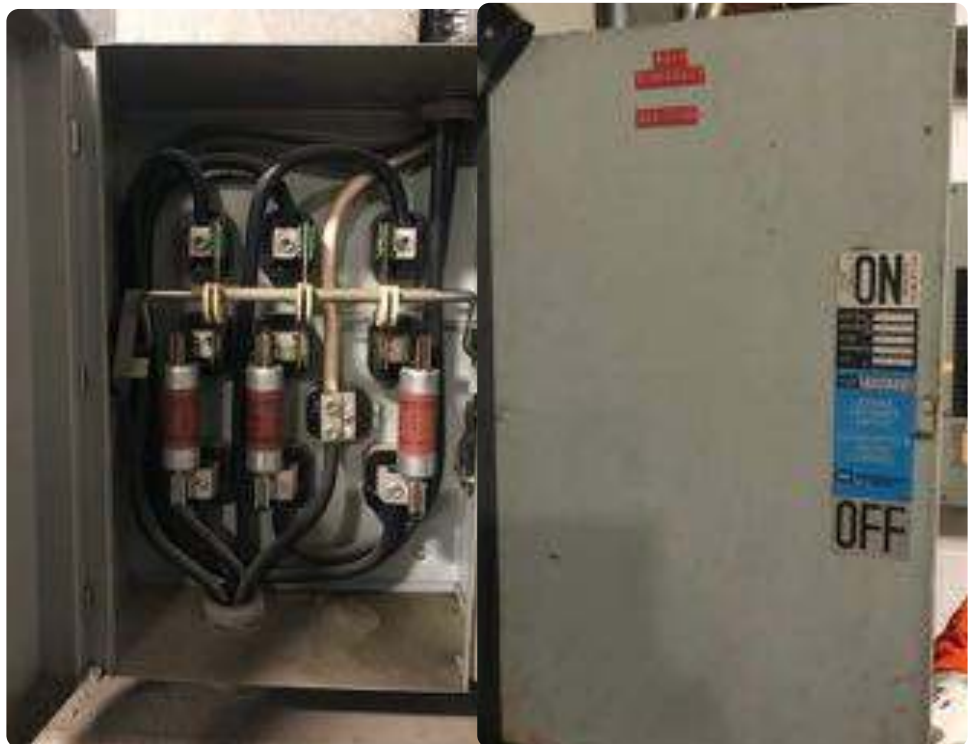
16/10/19 7:40:00 AM

B leg seems slightly warm on load side

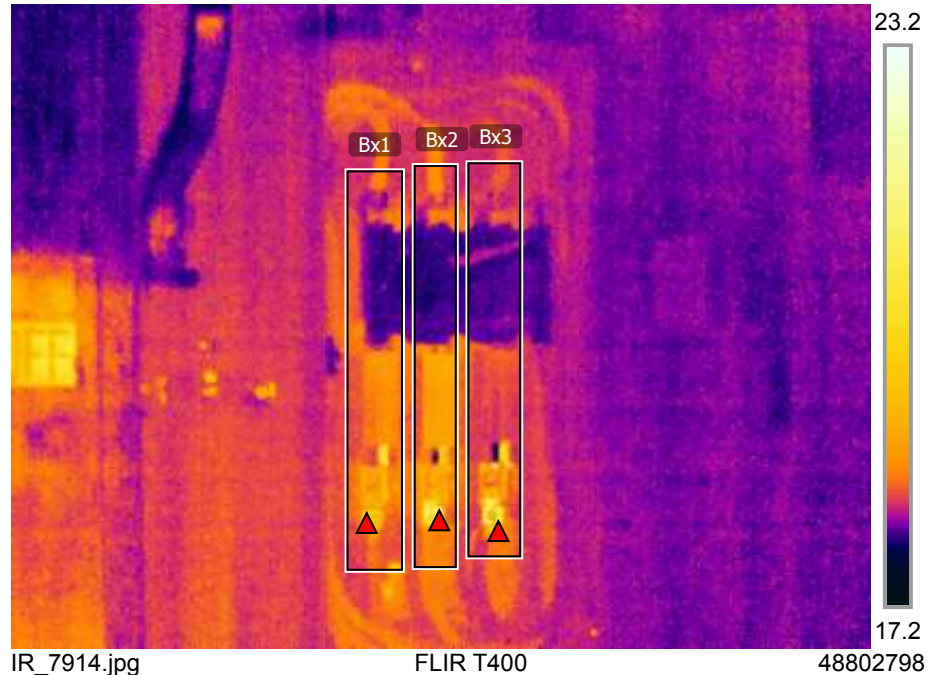
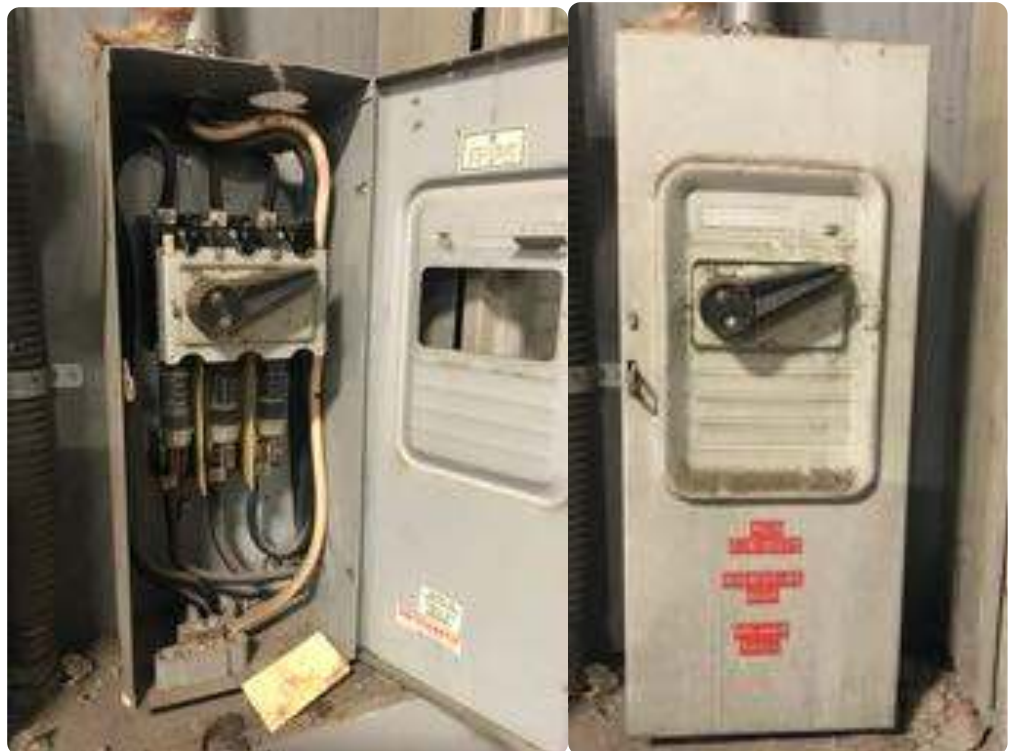
16/10/19 7:41:44 AM

There may be a minor issue on a connection on the load side of B phase.

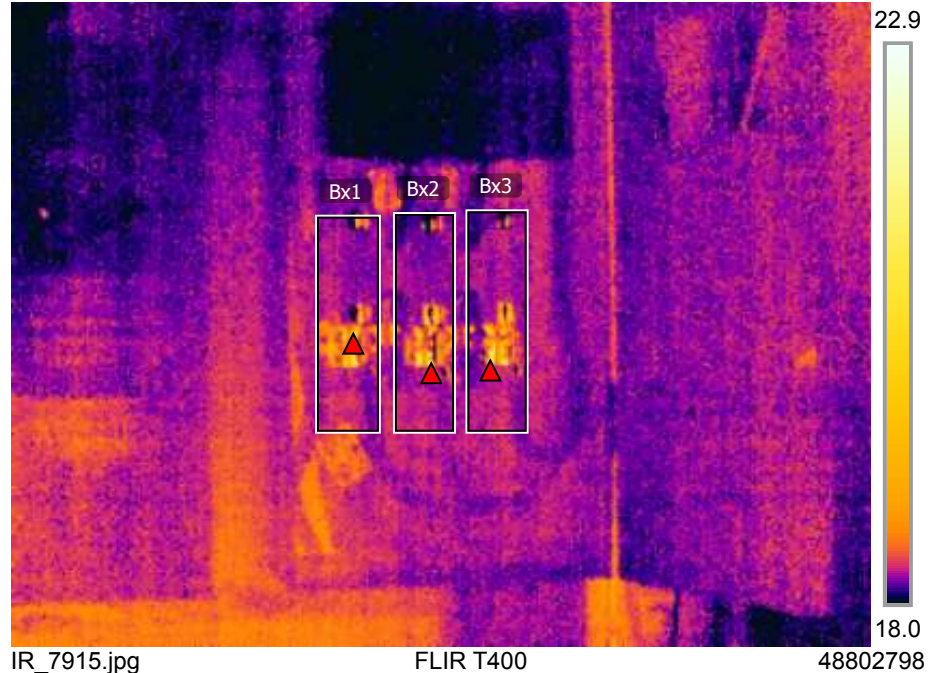
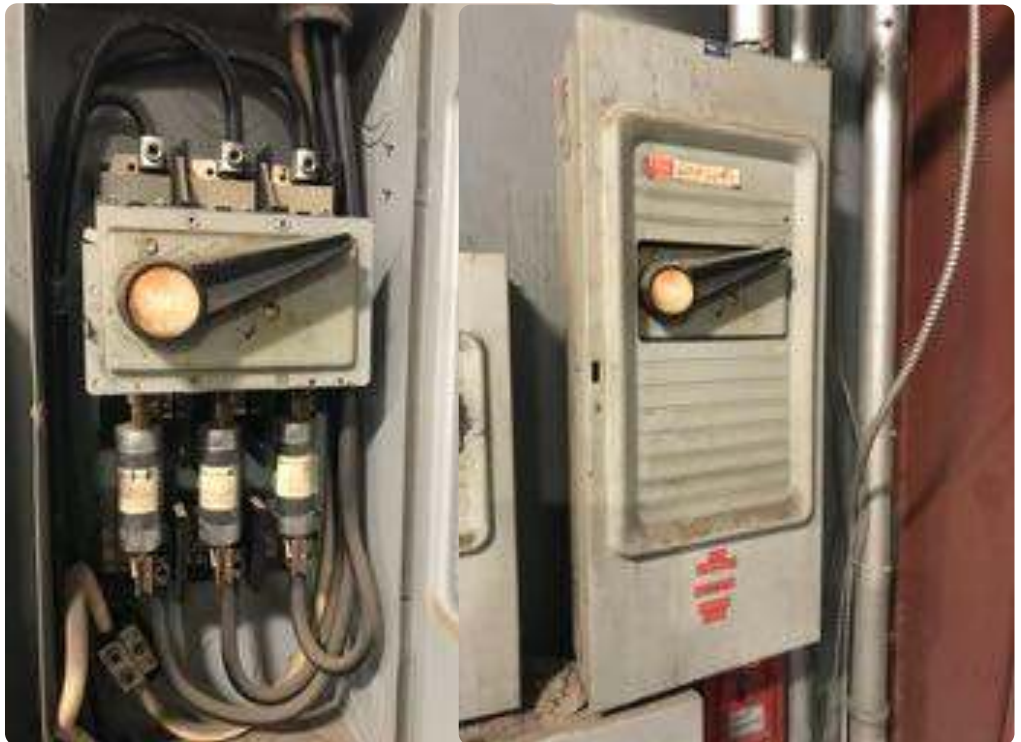
16/10/19 7:44:32 AM

No issues noted.

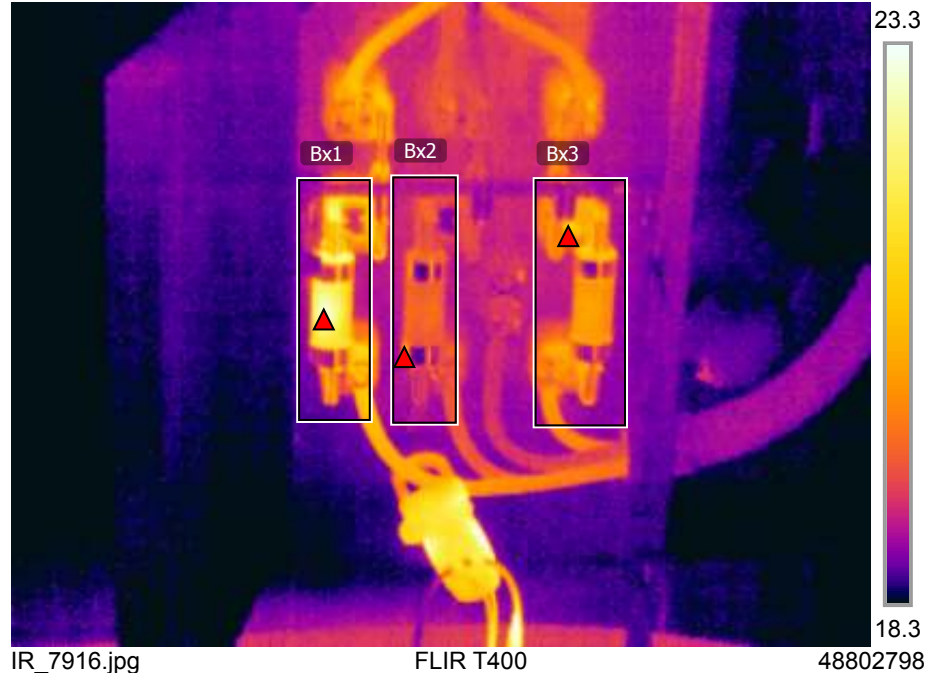
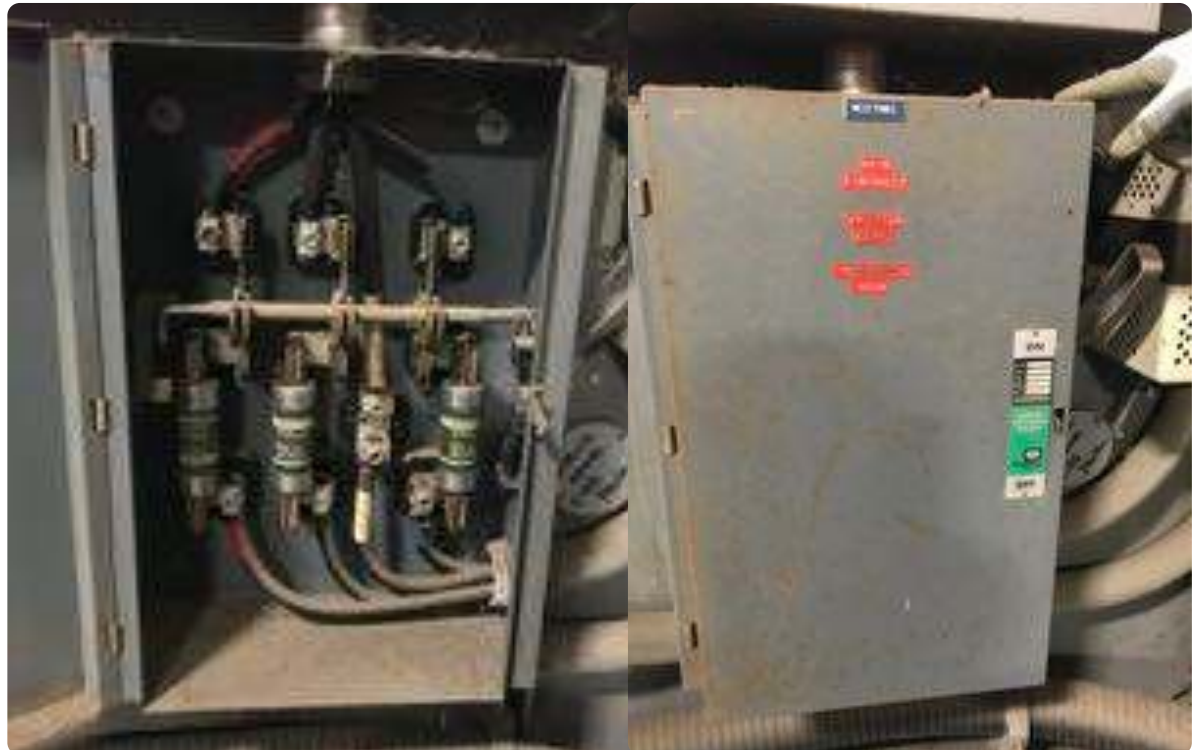
16/10/19 7:48:00 AM

It is strongly recommended that the switch mechanism be repaired to ensure full knife engagement.

Due to the very low loading, thermal information is deemed to be somewhat unreliable. No further faults found at low loading.

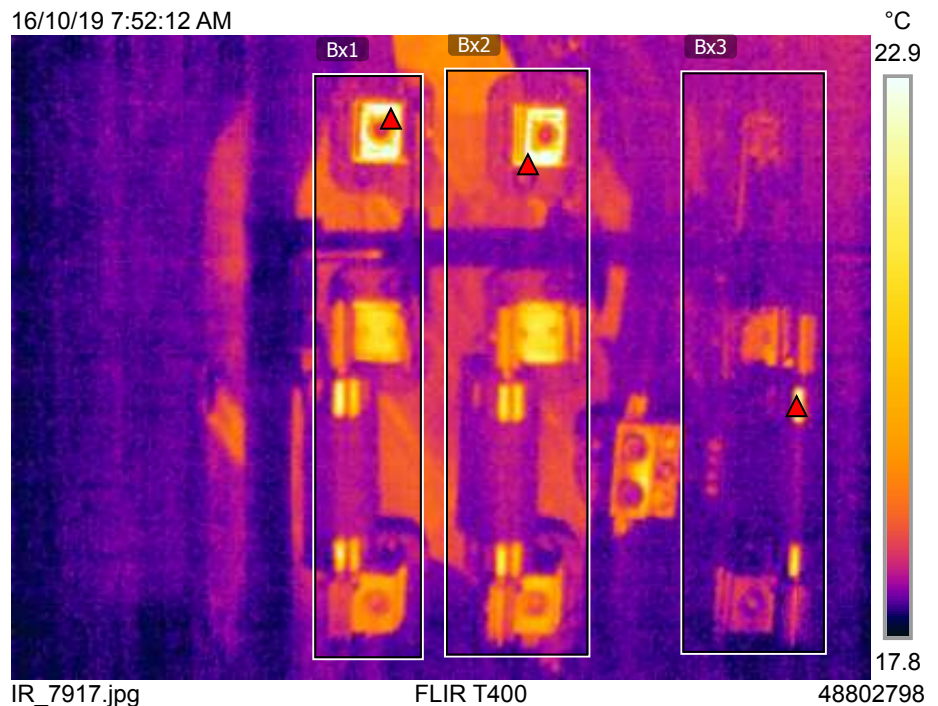
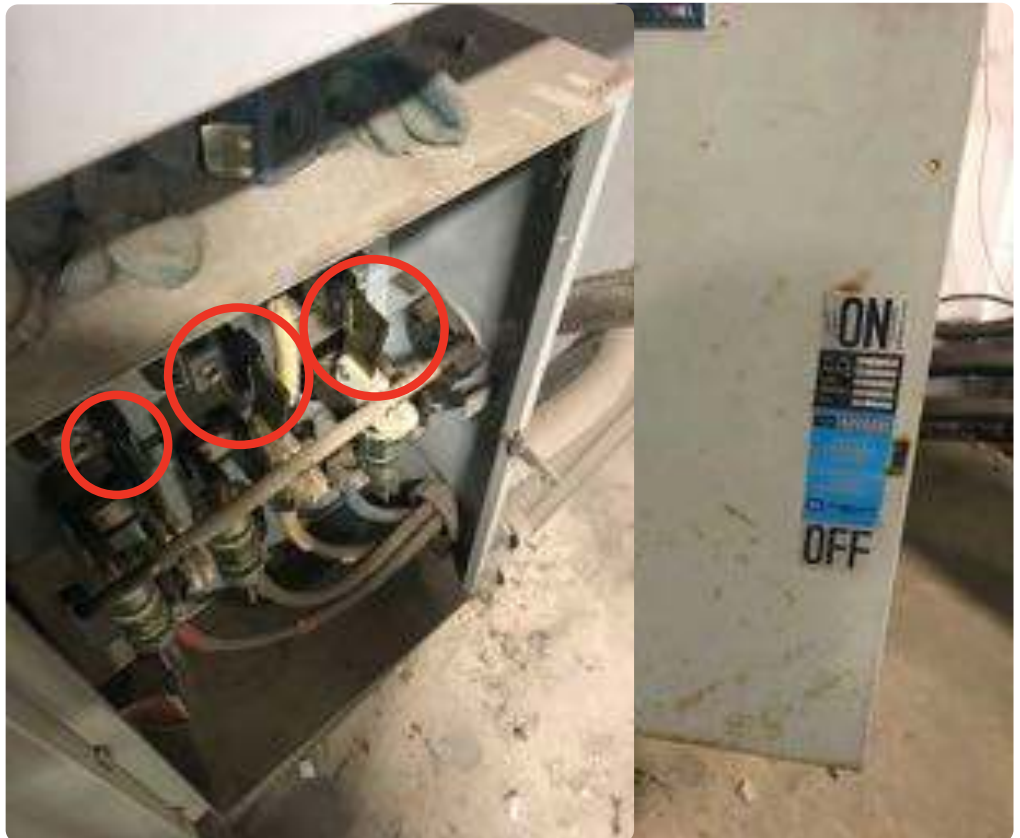
No concerns noted.

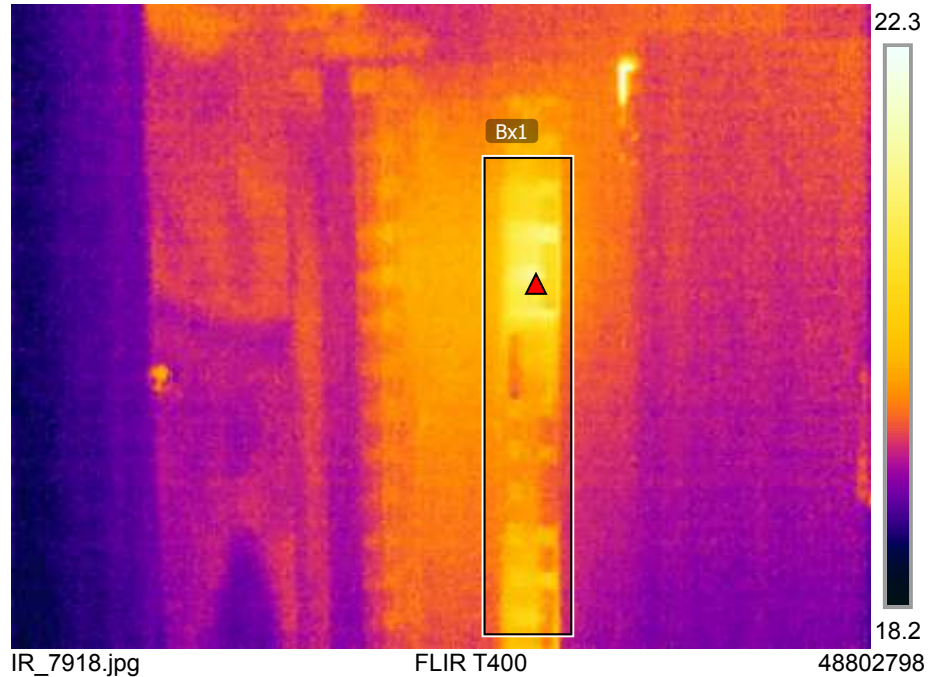
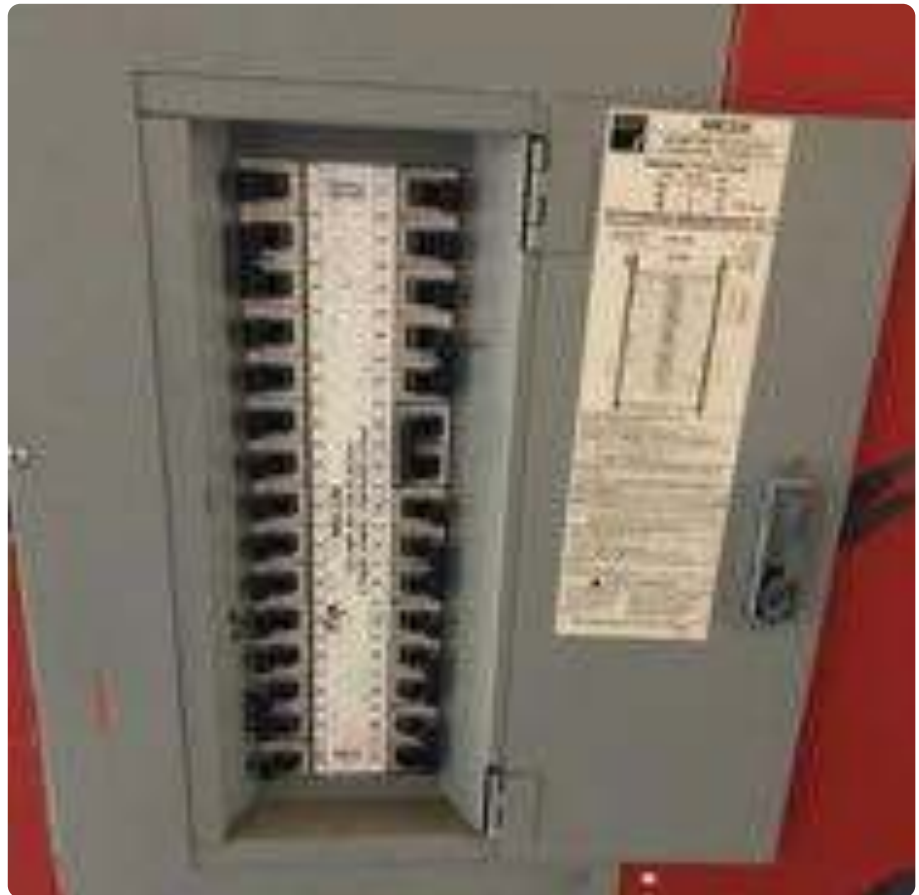
16/10/19 7:57:02 AM

150 Amp main disconnect.

No concerns noted

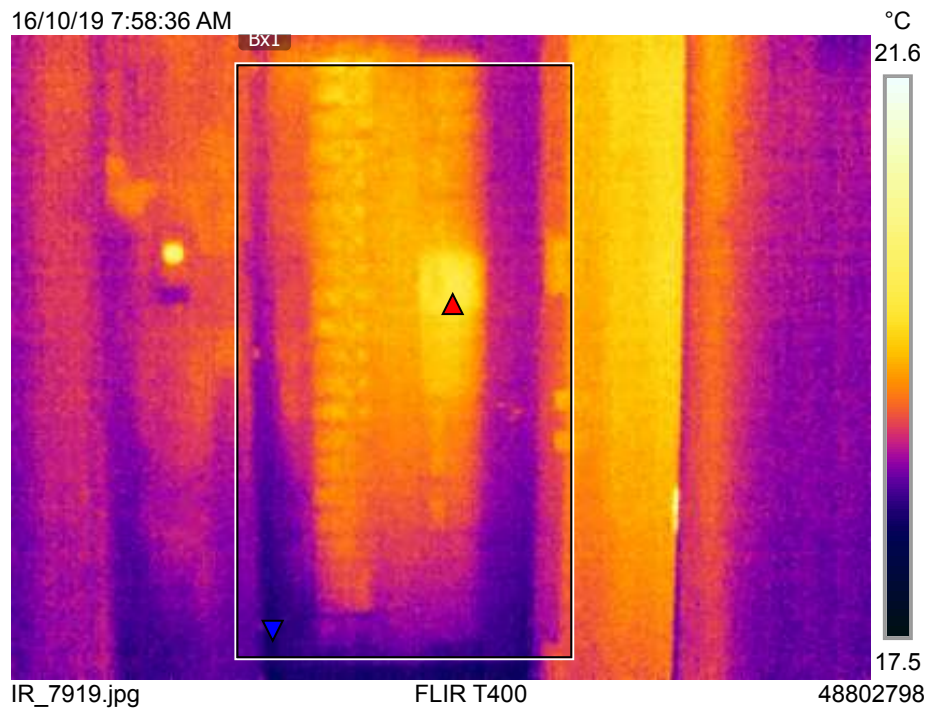
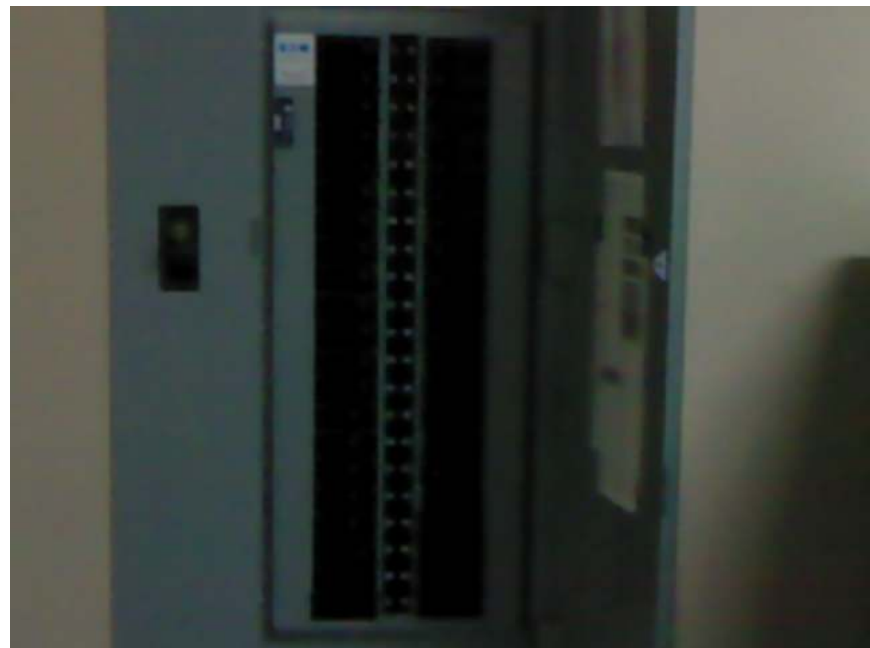
16/10/19 7:58:36 AM

No concerns noted

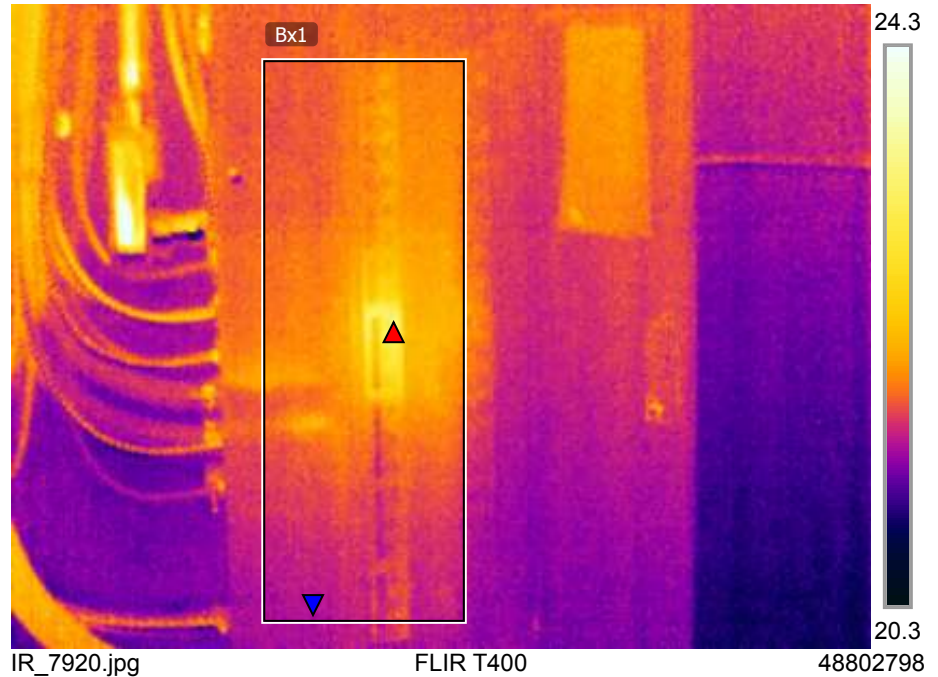
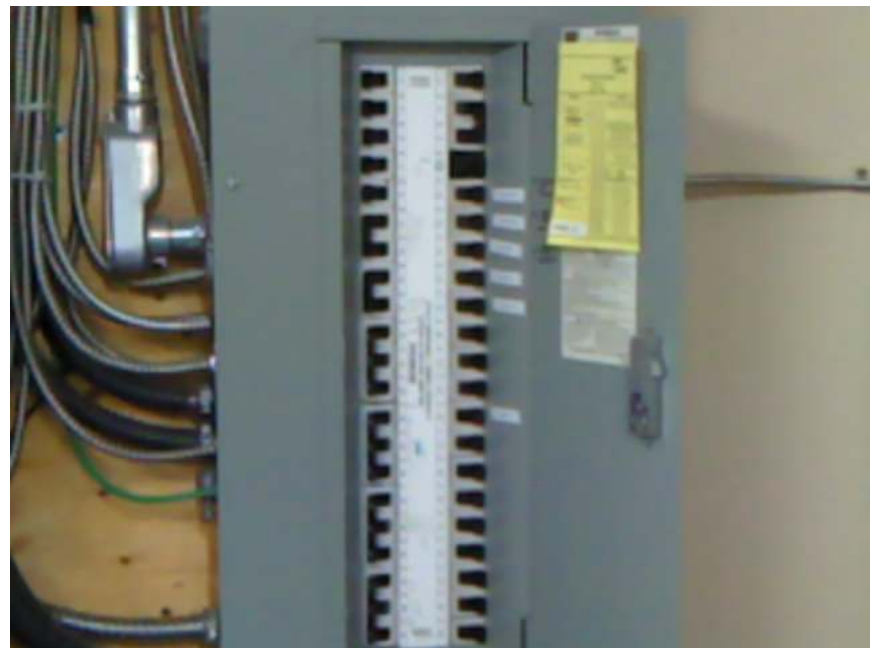
16/10/19 8:02:33 AM

Loading on Breaker #2 should be investigated and circuit corrected.

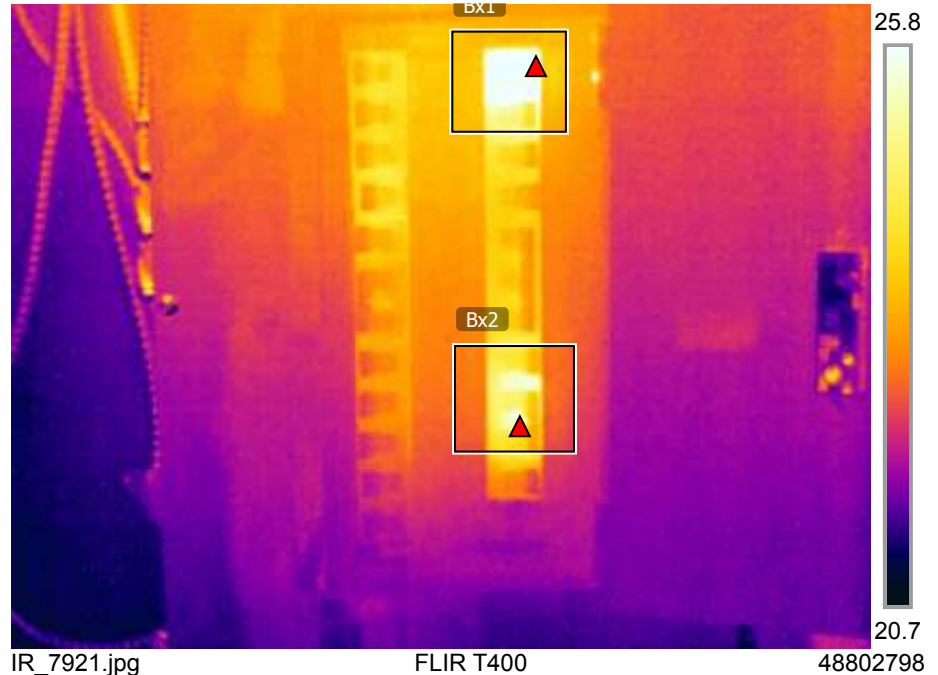
16/10/19 8:03:20 AM

Circuit loaded at 18 amps on 15 amp breaker. Overload condition should be corrected.

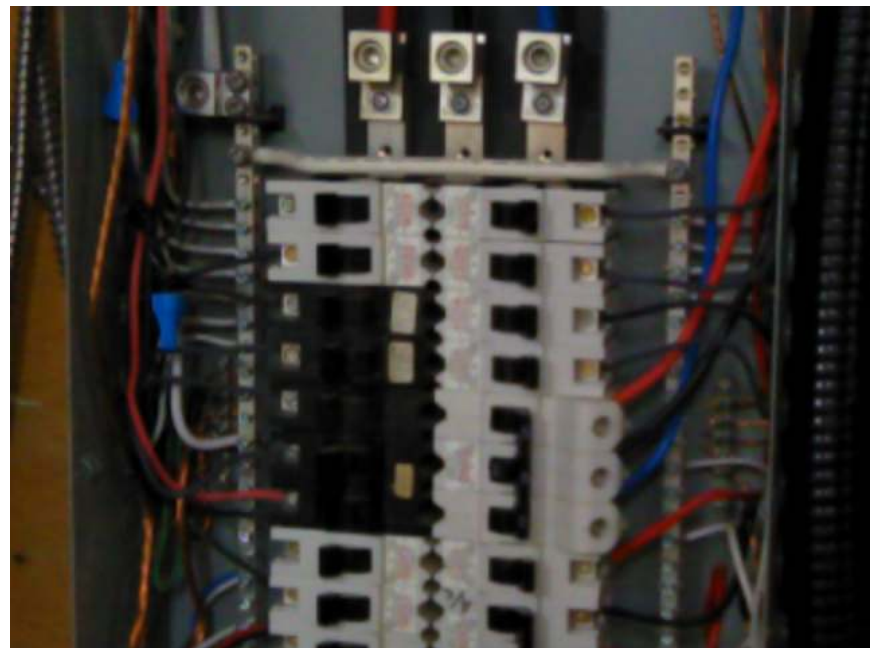
No concern noted.

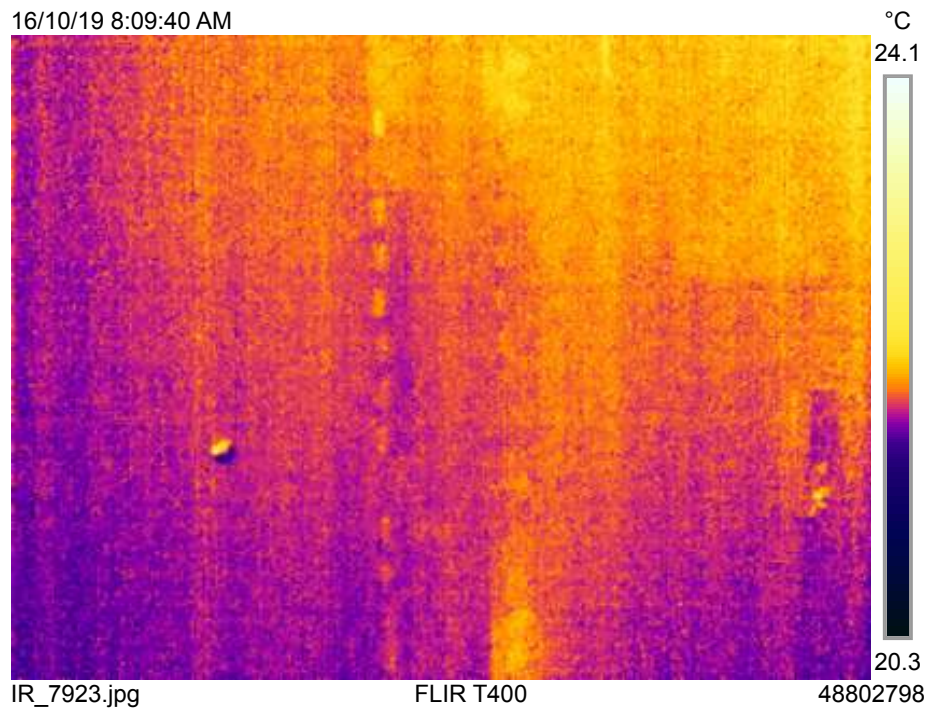
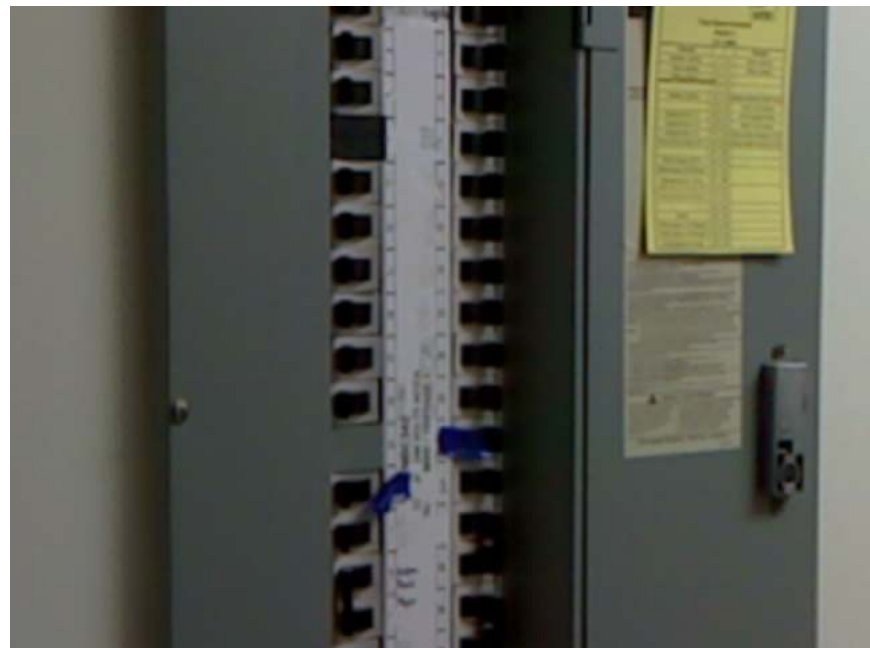
PANEL IN OFFICE HALLWAY

225 amp panel appears to be very lightly loaded. No concerns noted.

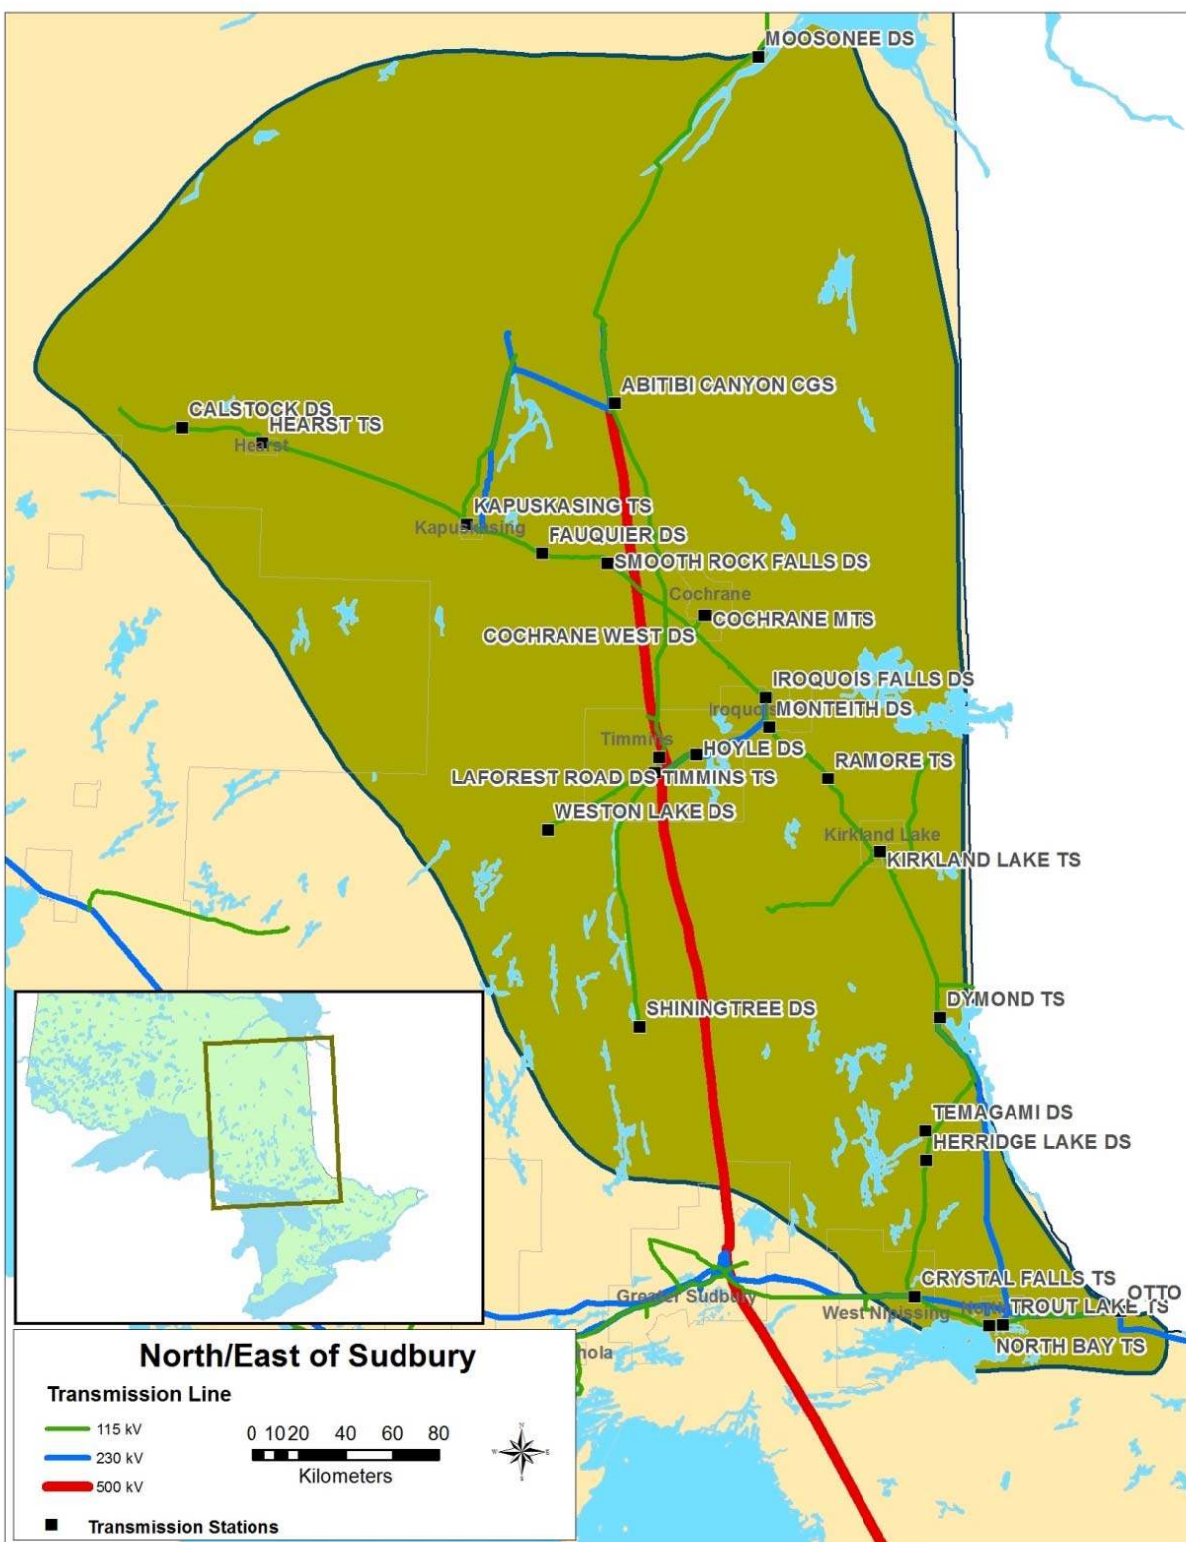
Figure 1: North & East of Sudbury Region Map

The North & East of Sudbury Region are bounded by regions of North Bay, Timmins, Hearst, Moosonee, Kirkland Lake and Dymond. A map of the region is shown below in Figure 1.

Electrical supply for this region is provided through a network of 230kV and 115kV transmission circuits. This area is further reinforced through the 500kV circuits P502X and D501P connecting Pinard TS to Hanmer TS. This region has the following four local distribution companies (LDC):

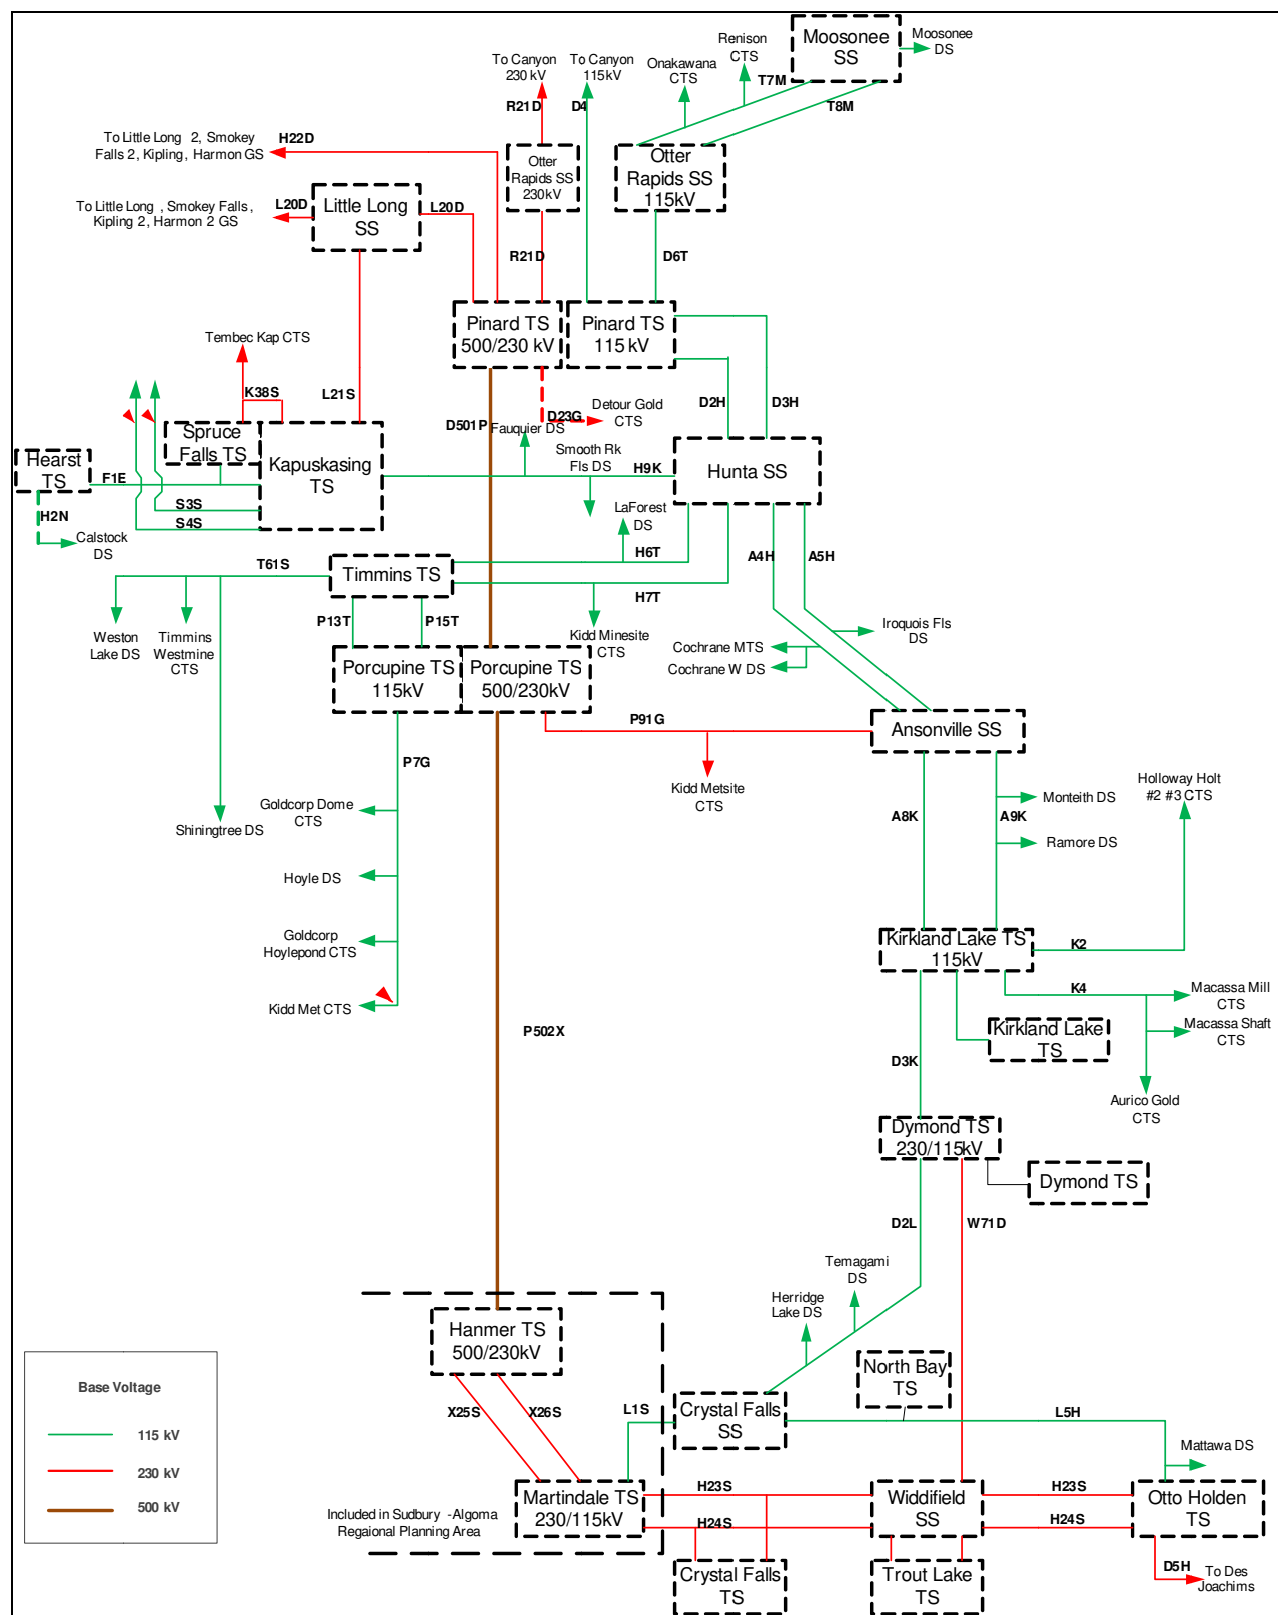
**Figure 2: North and East of Sudbury Regional Planning Electrical Diagram**

| 115kV circuits | 230kV circuits | 500kV circuits | Hydro One Transformer Stations |
|---|---|---|---|
| L5H, L1S<br>D2L, D3K<br>A8K, A9K<br>K2, K4<br>A4H, A5H<br>D2H, D3H<br>P7G, H9K<br>P13T, P15T<br>T61S, F1E<br>L8L, T7M<br>T8M, H6T<br>H7T, D6T | H23S, H24S<br>W71D, P91G<br>D23G, K38S<br>R21D, L20D<br>L21S, H22D | P502X,<br>D501P | Ansonville TS *<br>Crystal Falls TS<br>Dymond TS *<br>Hearst TS<br>Hunta SS<br>Kapuskaing TS<br>Kirkland Lake TS<br>Little Long SS<br>Moosonee SS<br>North Bay TS<br>Otter Rapids SS<br>Otto Holden TS *<br>Pinard TS *<br>Porcupine TS *<br>Spruce Falls TS*<br>Timmins TS<br>Trout Lake TS<br>Widdifield SS |

\*Stations with Autotransformers installed
