# **EXHIBIT 2:**

# **RATE BASE**

# Distribution System Plan

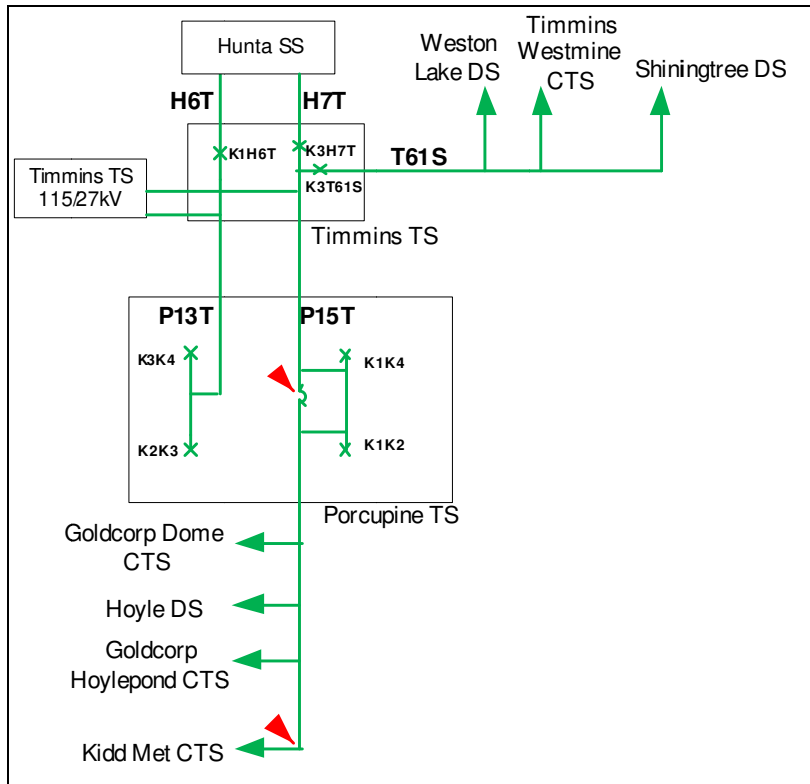
Figure 3: Timmins area connection diagram

- Timmins TS voltage regulation - The loss of Porcupine TS 115kV circuit breakers (K1K4 and K1K2) may result in voltage declines at Timmins TS 115kV bus in excess of 10%. This is considered an n-1-1 contingency and load rejection following the loss of the second element was proposed by IESO to improve post contingency voltage performance. See Figure 3 – Timmins area connection diagram for reference.
- Kirkland Lake TS voltage regulation - The loss of Ansonville T2 and D3K may result in voltage declines at Kirkland Lake TS 115kV bus in excess of 10%. This is considered an n-1-1 contingency and all new loads in the area will be required to participate in a local load rejection scheme to help improve post contingency voltage performance.

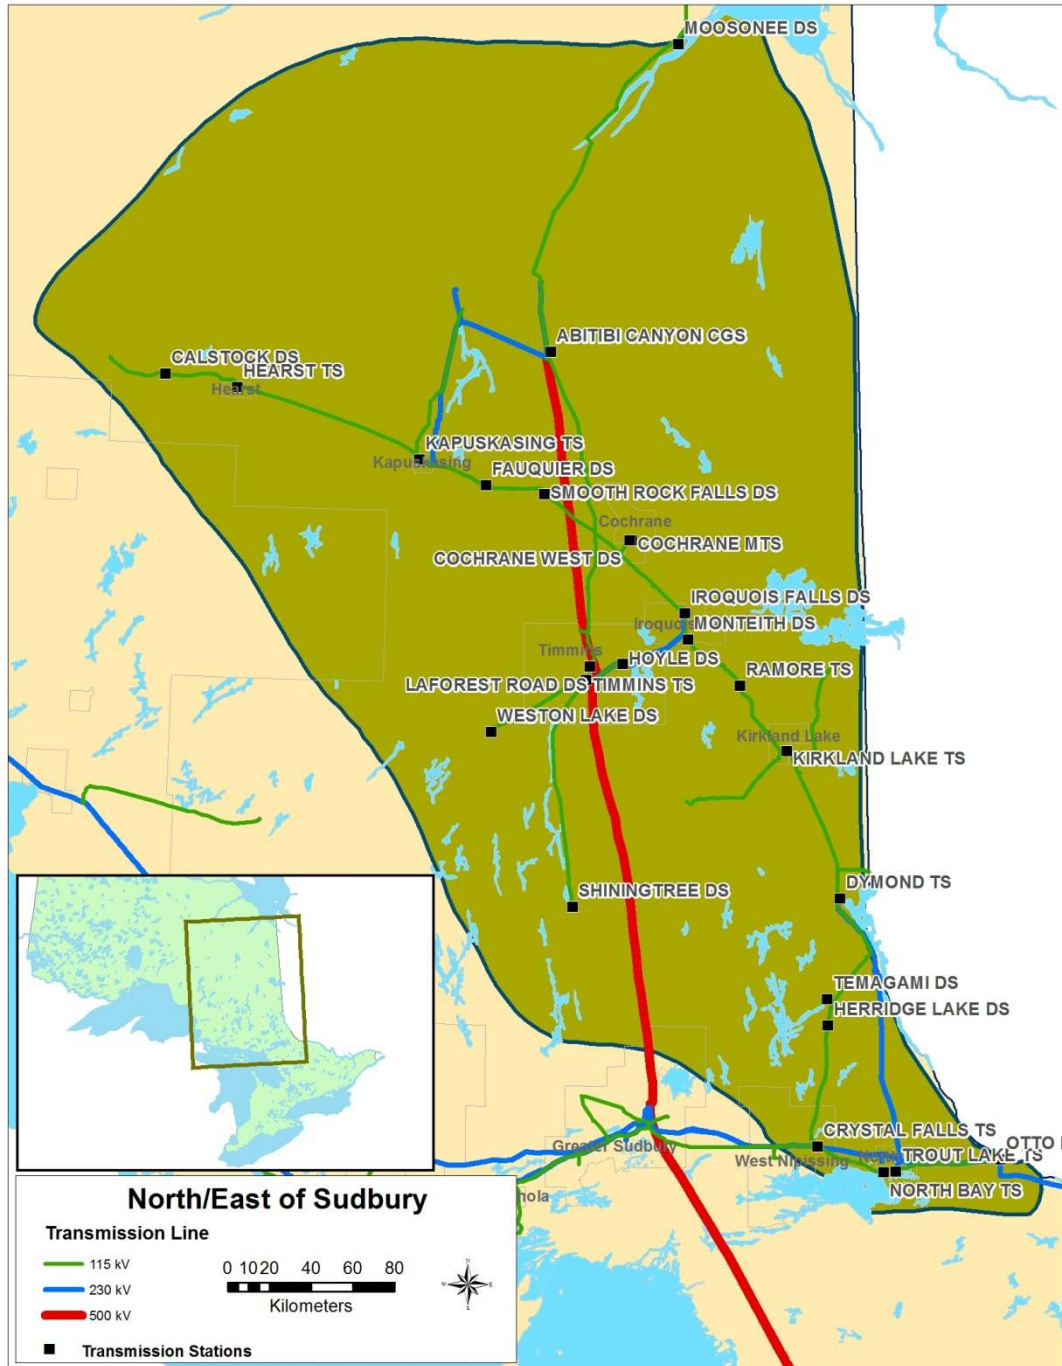
**Figure 1: North & East of Sudbury Region Map**

The North & East of Sudbury Region are bounded by regions of North Bay, Timmins, Hearst, Moosonee, Kirkland Lake and Dymond. A map of the region is shown below in Figure 1.

Electrical supply for this region is provided through a network of 230kV and 115kV transmission circuits. This area is further reinforced through the 500kV circuits P502X and D501P connecting Pinard TS to Hanmer TS.

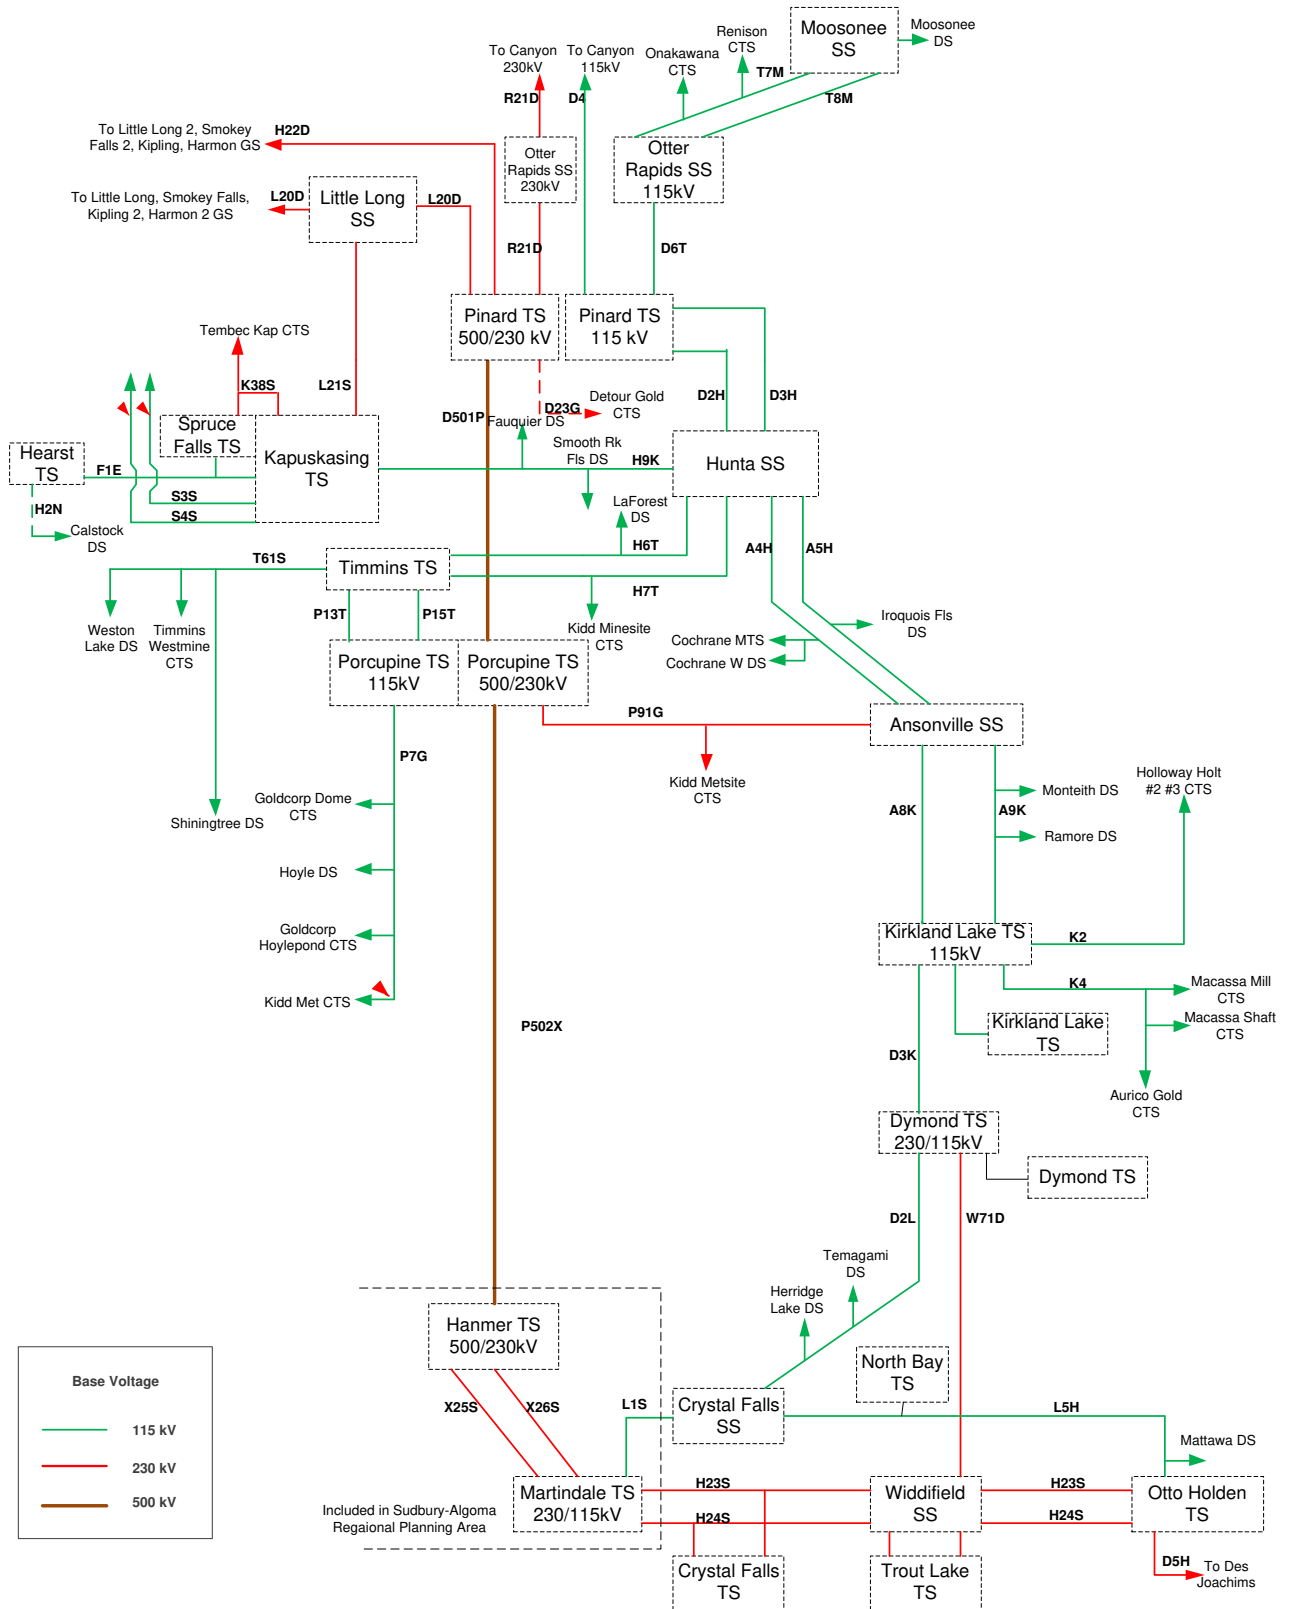
Figure 2 – North and East of Sudbury Regional Planning Electrical Diagram

Table 2: Transmission Lines and Stations in North & East of Sudbury Region

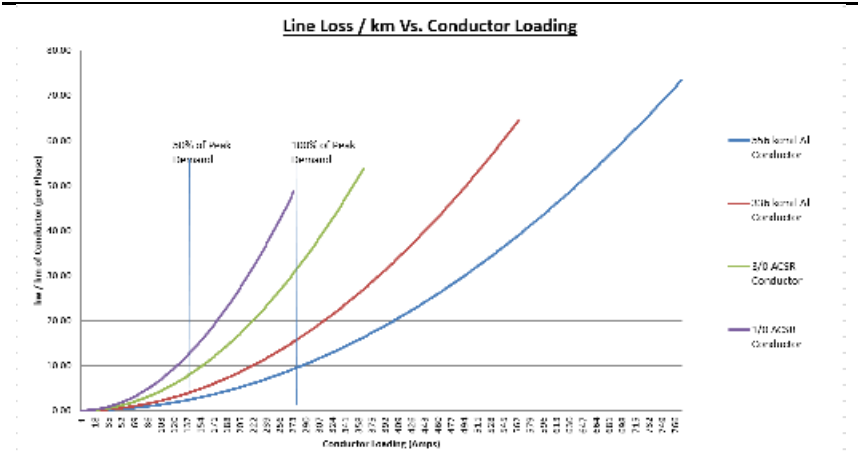
| <p><b>Secondary Drivers</b></p> | <p>Insufficient conductor capacity (undersized conductor) that makes this line inadequate for meeting peak demands is a secondary driver of this project.</p> <p>Currently the Sub Transmission (44kV) conductor on the existing line is substantially undersized at 1/0 ACSR and presents capacity constraints and high line losses (energy dissipated over the resistance of the conductor and lost as heat). As part of North Bay Hydro's distribution system design to ensure resiliency through redundancy, this line must be able to handle a peak load of 21 MVA in present day plus a small growth factor for future considerations. This requirement will ensure that if something was to happen to the other line during peak loading, this line can supply the entire area. This would be greater than 100% of the existing line's ampacity however.</p> <p>Aside from the capacity constraints, the larger conductor size of 556 kcmil Al to be installed in the new rebuild will also save approximately 10 to 40 kW of line losses per conductor during winter peaks (depending on system loading configurations). The relationship between conductor losses and conductor sizes as a function of electrical current is represented in the graph below.</p> |

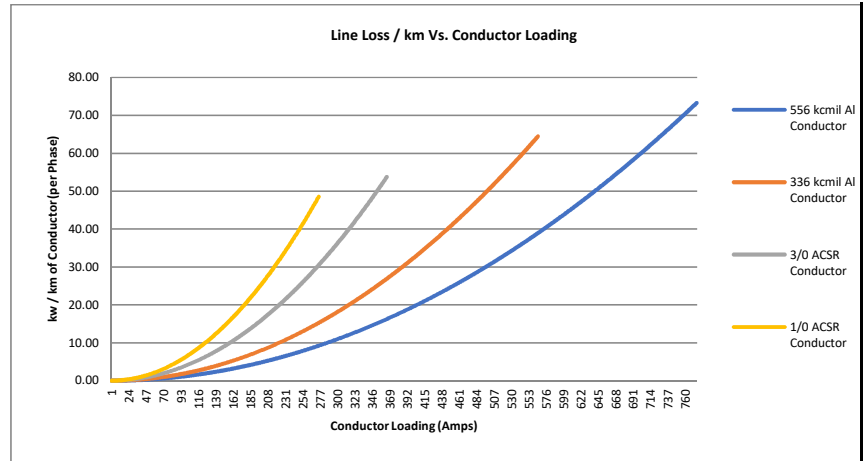
This project will remove the need for an existing 1200m pole line, eliminating all perpetual O&M costs associated with that line and the need to rebuild once it reaches its end of life. There will also be a small reduction in line losses with larger conductor installed with the 3/0 ACSR conductor being replace with 336 kcmil Al.

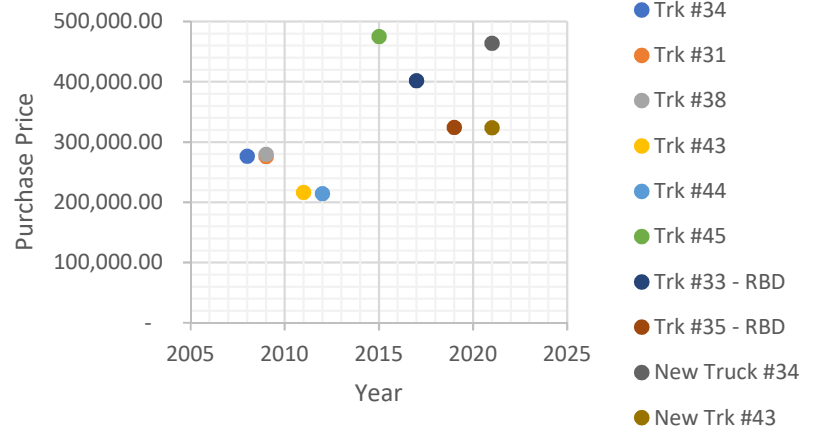
Line Truck Purchase Price

The new Truck 34 cost is slightly less expensive than Truck 45, the only other truck with a reach above 55'. This is reasonable since Truck 45 has a longer reach (up to 83'). Truck 34 will be more expensive than the other 2 RBDs and Truck 43 since those are smaller line trucks. The cost of Truck 34 is reasonable. The chart below identifies the relative costs of trucks purchased since 2008.

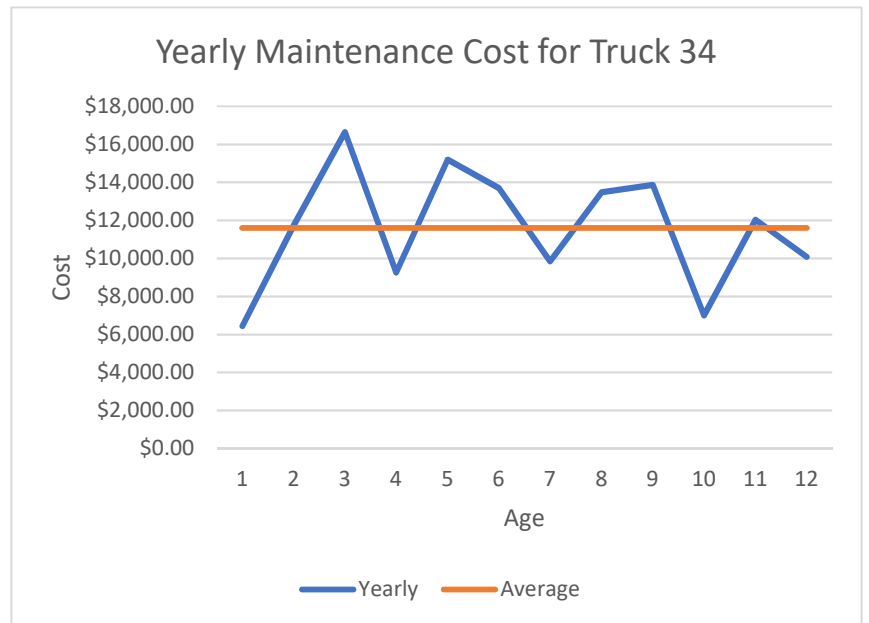
The following chart represents the yearly spending for Truck 34 with an average spending of \$11,609. There are some fluctuations with the maintenance, but it is holding well up to now.

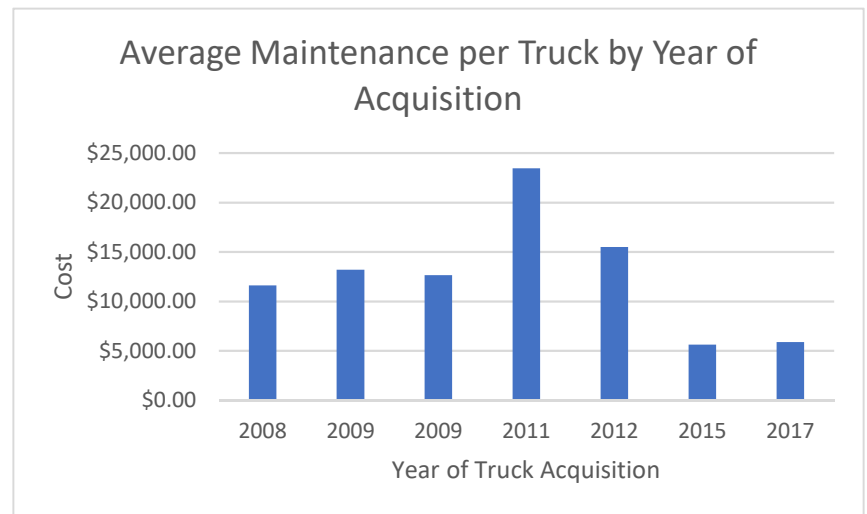
A new truck will minimize trucks repairs as the parts will be further away from their end of life timelines, such as for the components identified above under “Secondary Drivers”. It will reduce down time and improve efficiency of construction. It will also help reduce restoration time in a major outage. The following chart demonstrates the total maintenance per vehicle based on their age of acquisition. Except for the 2 service trucks acquired in 2012, there is a downward trend in truck maintenance.

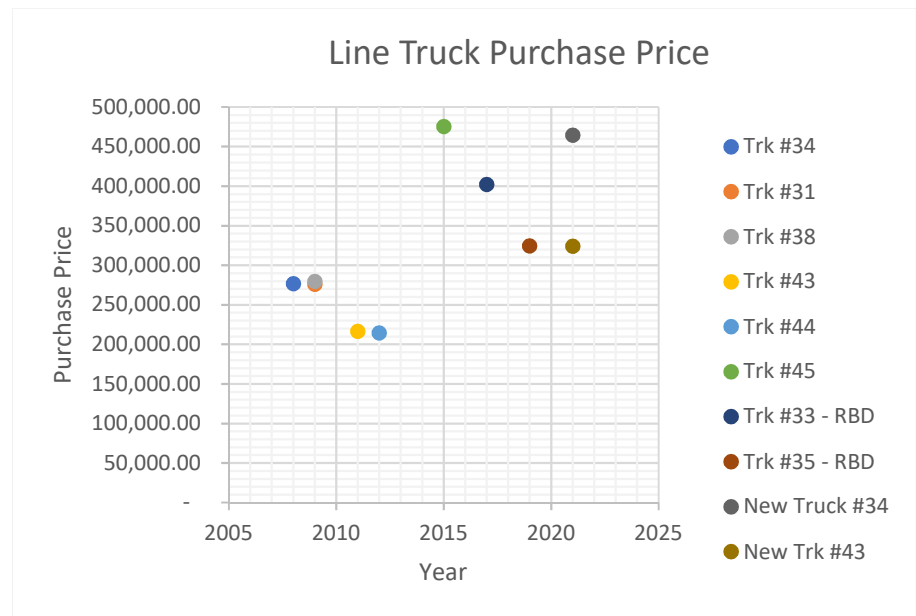
Gross vehicle replacement costs for the previous similar trucks are as follows:

2012: Truck 43: \$216,000  
 2012: Truck 44: \$214,000  
 2015: Truck 45: \$475,201  
 2017: Truck 33: \$402,067  
 2019: Truck 35: \$324,244

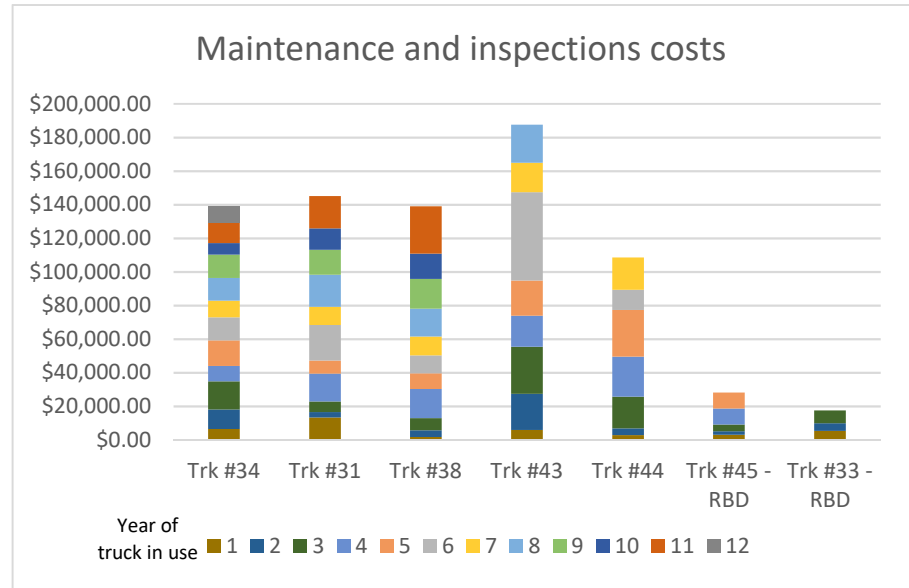
The maintenance costs for this vehicle reached \$160,036.91 at the end of 2019 which is 74% of the total \$216,479.03 cost of the vehicle. Maintenance activities for each other line trucks with at least 8 years of service is currently sitting at 40% or less.

As can be observed, of the seven trucks that have been acquired over the more recent years, Truck 43 has seen the highest maintenance costs.

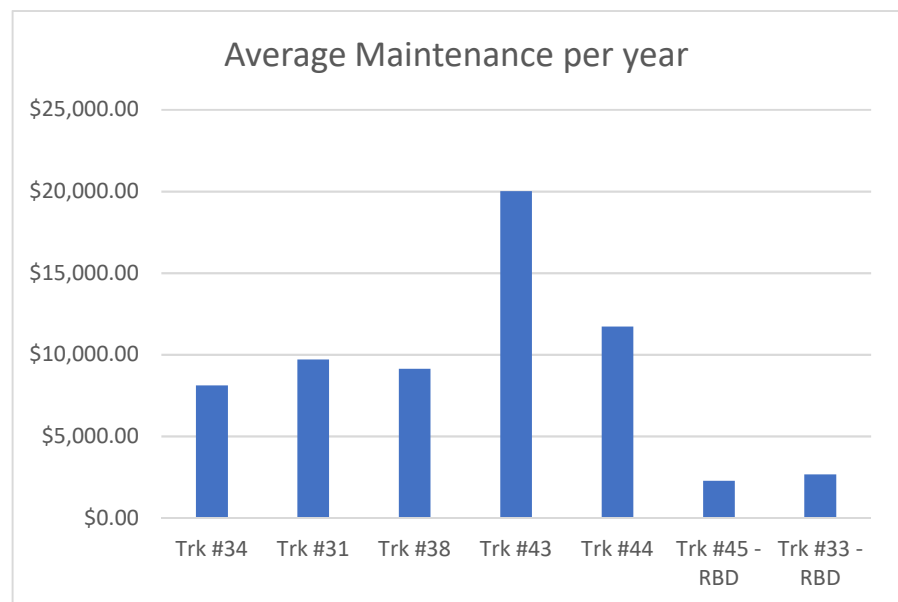
When comparing average annual maintenance costs, Truck 43 also leads in overall spending with an average spending of \$20,005/year.

At a purchase price of \$216,479 and using the existing yearly average maintenance costs, the maintenance costs of Truck 43 will exceed the initial purchase price by 2022.

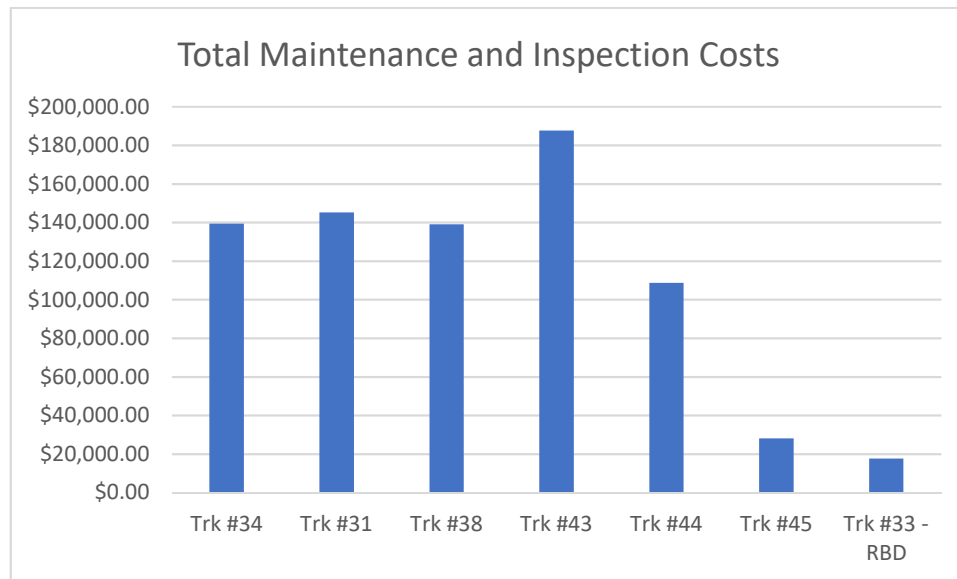
The following is a chart demonstrating the maintenance and inspections costs per year of acquisition for various line trucks in the NBHDL fleet. Except for Truck #43, purchased in 2012, there is a general trend of lower maintenance costs for newer trucks compared to older trucks. Therefore, purchasing a new truck as scheduled can be expected to have lower maintenance and inspection costs. Removing this high maintenance truck from the lineup will enhance production, lower maintenance costs and provide NBHDL with a reliable fleet.
